OIL ANALYSIS REPORT

ELEVATOR COLLECTION DRAG **COLLECTION DRAG**

Gearbox

HYDROTEX Ultra-Kleen ISO 220 (13 QTS)

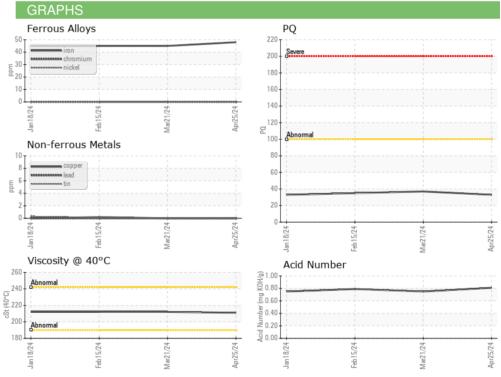
VISUAL		method	limit/base	current	history1	history2
White Metal	scalar	*Visual	NONE	NONE	NONE	NONE
Yellow Metal	scalar	*Visual	NONE	NONE	NONE	NONE
Precipitate	scalar	*Visual	NONE	NONE	NONE	NONE
Silt	scalar	*Visual	NONE	NONE	NONE	NONE
Debris	scalar	*Visual	NONE	NONE	NONE	NONE
Sand/Dirt	scalar	*Visual	NONE	NONE	NONE	NONE
Appearance	scalar	*Visual	NORML	NORML	NORML	NORML
Odor	scalar	*Visual	NORML	NORML	NORML	NORML
Emulsified Water	scalar	*Visual	>0.2	NEG	NEG	NEG
Free Water	scalar	*Visual		NEG	NEG	NEG
FLUID PROPE	RTIES	method	limit/base	current	history1	history2
Visc @ 40°C	cSt	ASTM D445		211	212	212
SAMPLE IMAG	ES	method	limit/base	current	history1	history2
Color
