OIL ANALYSIS REPORT

Machine Id
HINO 398275
 Component
Diesel Exhaust Fluid (DEF)
 Fluid
DEF (Diesel Exhaust Fluid) (--- QTS)

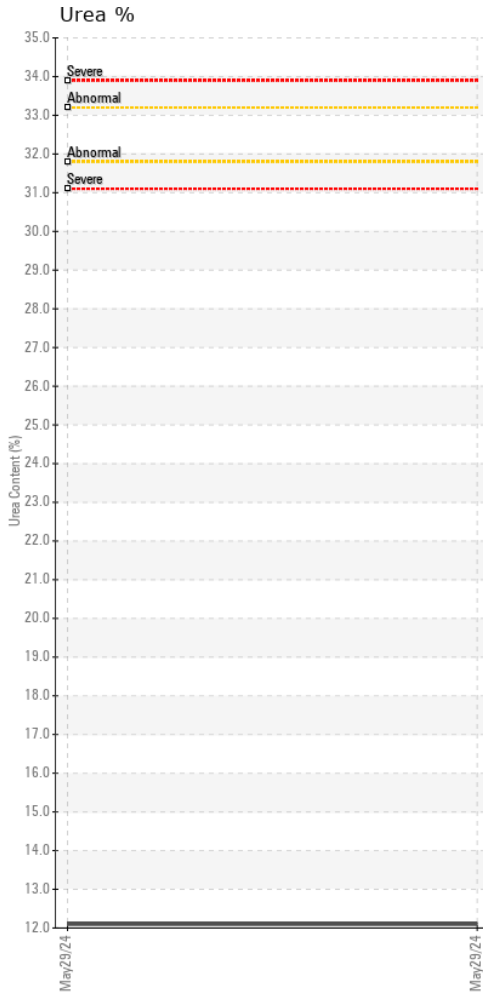
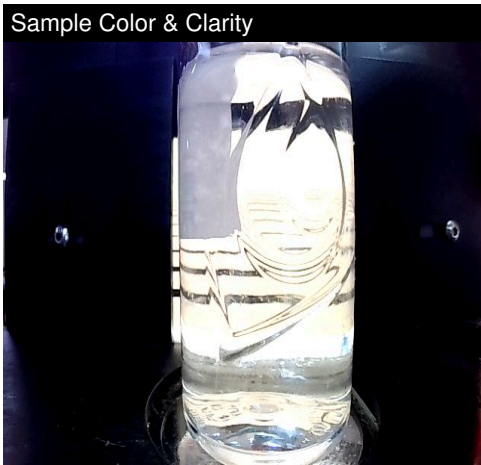
GRAPHS

The diesel exhaust fluid (def) specification testing is lower than normal. Urea content is low.

method	limit/base	current	history1	history2
Urea Content	%	ISO 22241	<31.8	▲ 12.1	---
Density @ 20°C	g/cm3	ISO 22241	>1.0930	▲ 1.0314	---
Refracting Index		ISO 22241	<1.3814	▲ 1.3508	---
Appearance	scalar	*Visual		Clear & Bright	---

Fluid does not meet ISO 22241-2 requirements. Contact supplier.
