OIL ANALYSIS REPORT

Area
G.LOPES CONSTRUCTION INC./Off-Road
 Machine Id
BH42
 Component
Front Differential
 Fluid
MOBIL MOBILTRANS HD 50 (--- GAL)

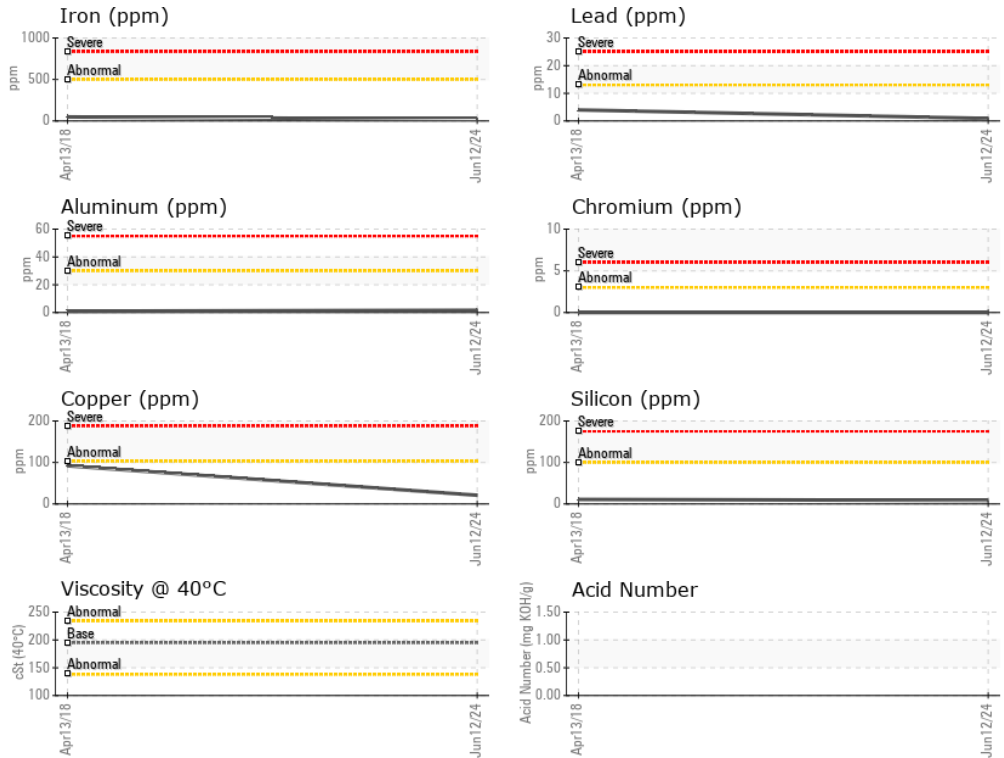
GRAPHS

All component wear rates are normal.

There is no indication of any contamination in the oil.

The AN level is acceptable for this fluid. The condition of the oil is acceptable for the time in service.

Resample at the next service interval to monitor.
