OIL ANALYSIS REPORT

Area
KEMP QUARRIES / HULBERT
Machine Id
OHT047
Component
Rear Right Final Drive
Fluid
MOBIL MOBILTRANS HD 50 (--- GAL)

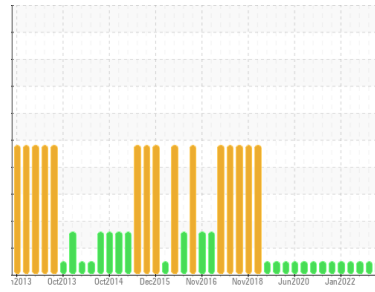
Sample Rating Trend

NORMAL

All component wear rates are normal.

There is no indication of any contamination in the oil.

The condition of the oil is acceptable for the time in service.

Resample at the next service interval to monitor.
