OIL ANALYSIS REPORT

Area
KEMP QUARRIES / RIVER VALLEY BACKBONE
 Machine Id
WL100
 Component
Rear Left Final Drive
 Fluid
MOBIL MOBILTRANS HD 50 (--- GAL)

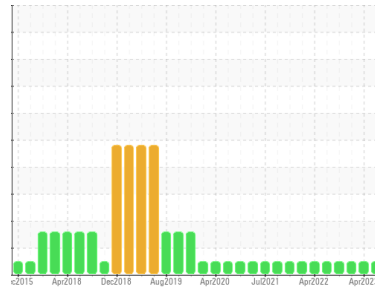
Sample Rating Trend

NORMAL

- Recommendation**
 Resample at the next service interval to monitor.
- Wear**
 All component wear rates are normal.
- Contamination**
 There is no indication of any contamination in the oil.
- Fluid Condition**
 The condition of the oil is acceptable for the time in service.

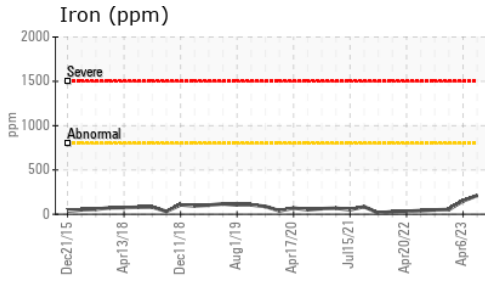
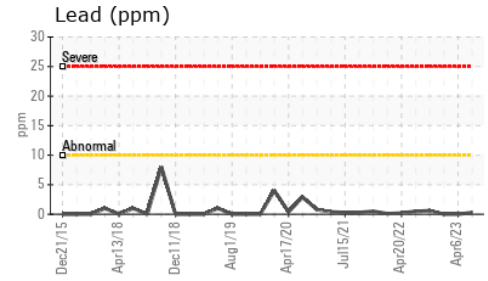
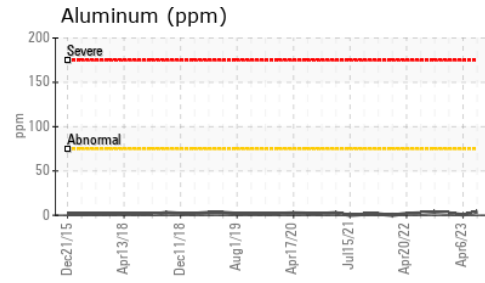
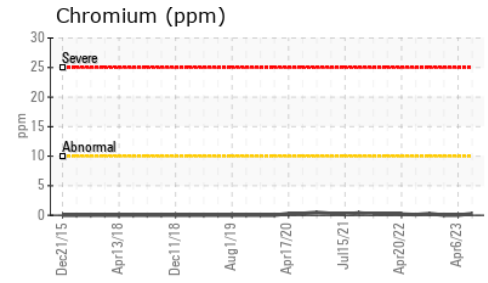
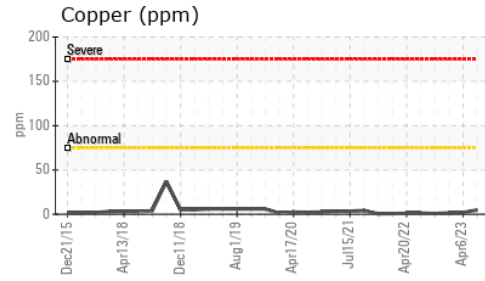
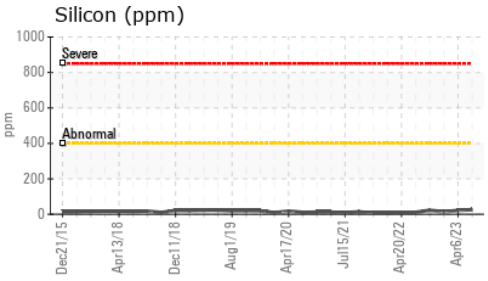
GRAPHS

method	limit/base	current	history1	history2
Iron	ppm	ASTM D5185m >800	212	150	53
Chromium	ppm	ASTM D5185m >10	<1	0	0
Nickel	ppm	ASTM D5185m >5	0	0	0
Titanium	ppm	ASTM D5185m >15	<1	0	<1
Silver	ppm	ASTM D5185m >2	0	0	0
Aluminum	ppm	ASTM D5185m >75	4	<1	2
Lead	ppm	ASTM D5185m >10	<1	0	0
Copper	ppm	ASTM D5185m >75	5	2	2
Tin	ppm	ASTM D5185m >8	0	0	0
Vanadium	ppm	ASTM D5185m	0	0	0
Cadmium	ppm	ASTM D5185m	0	0	0
