OIL ANALYSIS REPORT

Area
KEMP QUARRIES / RIVER VALLEY BACKBONE
 Machine Id
WL100
 Component
Rear Right Final Drive
 Fluid
MOBIL MOBILTRANS HD 50 (--- GAL)

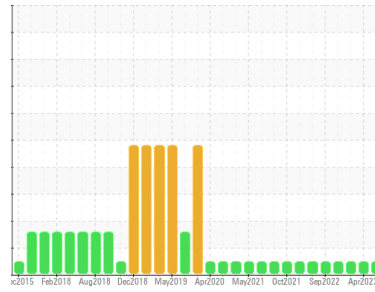
Sample Rating Trend

NORMAL

- Recommendation**
 Resample at the next service interval to monitor.
- Wear**
 All component wear rates are normal.
- Contamination**
 There is no indication of any contamination in the oil.
- Fluid Condition**
 The condition of the oil is acceptable for the time in service.
