# OIL ANALYSIS REPORT

Machine Id  
**17L ACM2**

Component  
**Gearbox**

Fluid  
**PETRO CANADA ENDURATEX EP 220 (--- GAL)**

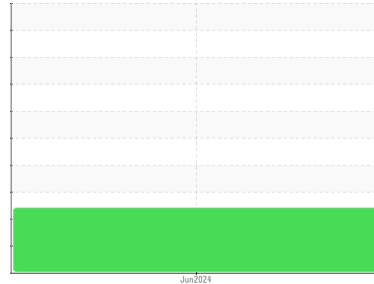
## Sample Rating Trend

**WATER**

Appearance is milky. There is a moderate concentration of water present in the oil.

We advise that you check for the source of water entry. We recommend an early resample to monitor this condition.
