# OIL ANALYSIS REPORT

Area  
**POUCH [99063221]**  
 Machine Id  
**L36 JBT OUTFEED**  
 Component  
**Gearbox**  
 Fluid  
**GEAR OIL ISO 220 (--- GAL)**

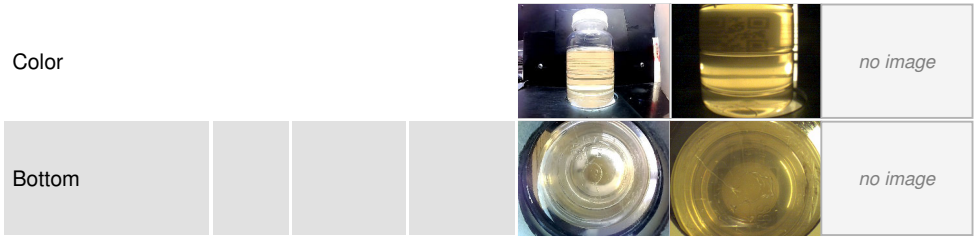
### SAMPLE IMAGES

There is a high amount of silt (particulates < 14 microns in size) present in the oil.

We recommend you service the filters on this component if applicable. Resample at the next service interval to monitor.

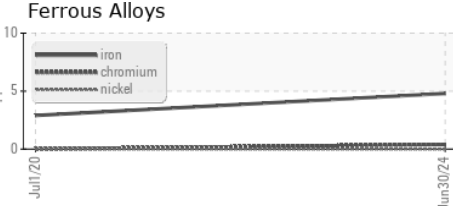
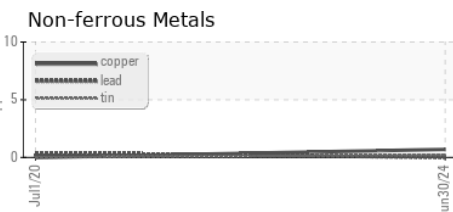
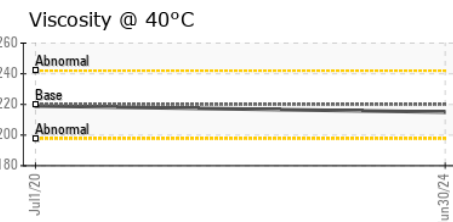
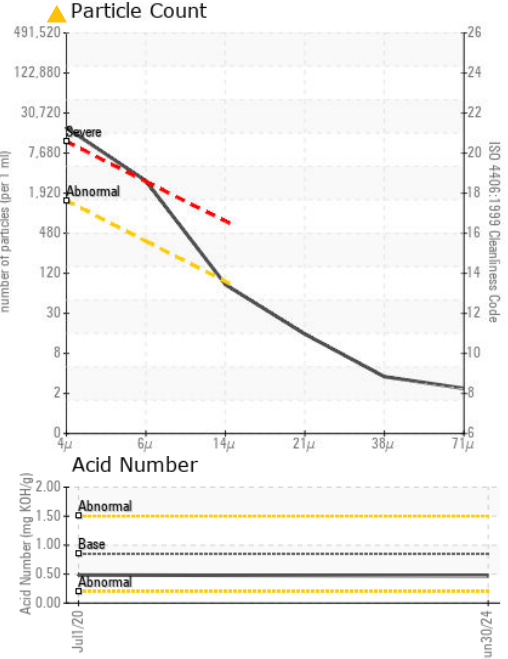
### GRAPHS

FLUID CLEANLINESS		method	limit/base	current	history1	history2
Particles >4µm		ASTM D7647	>1300	<b>▲ 16021</b>	▲ 89792	---
Particles >6µm		ASTM D7647	>320	<b>▲ 2558</b>	▲ 9245	---
Particles >14µm		ASTM D7647	>80	<b>72</b>	▲ 91	---
Particles >21µm		ASTM D7647	>20	<b>13</b>	13	---
Particles >38µm		ASTM D7647	>4	<b>3</b>	1	---
Particles >71µm		ASTM D7647	>3	<b>2</b>	0	---
Oil Cleanliness		ISO 4406 (c)	>17/15/13	<b>▲ 21/19/13</b>	▲ 24/20/14	---
