# CONSTRUCTION EQUIPMENT

## VOLVO A30G 742128 - TRANSMISSION (AUTO)

**Sample No:** PP387380  
**Oil Type:** VOLVO AUTOMATIC TRANSMISSION FLUID AT102  
**Job No:**

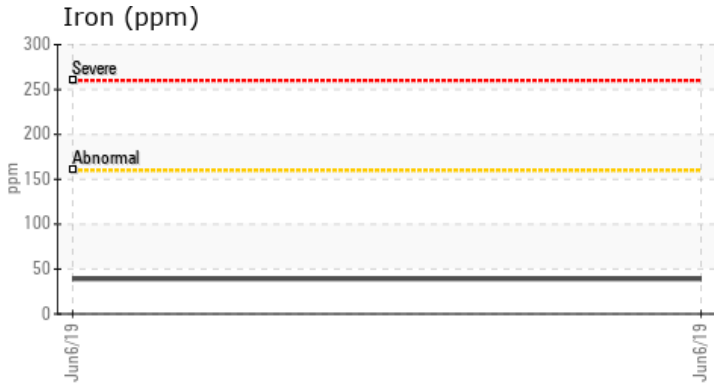
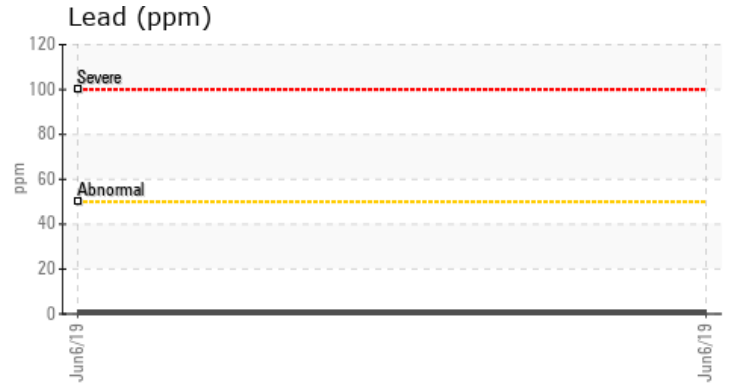
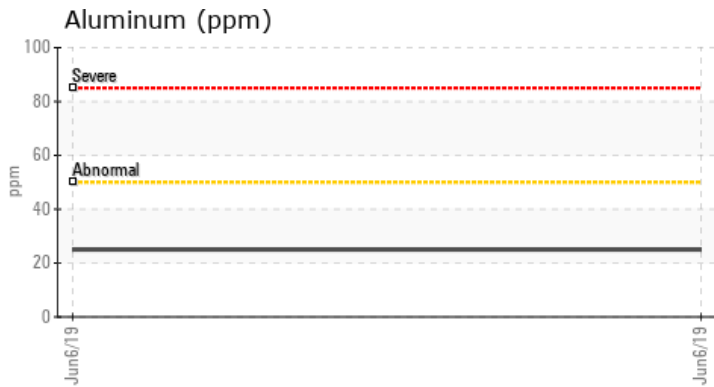
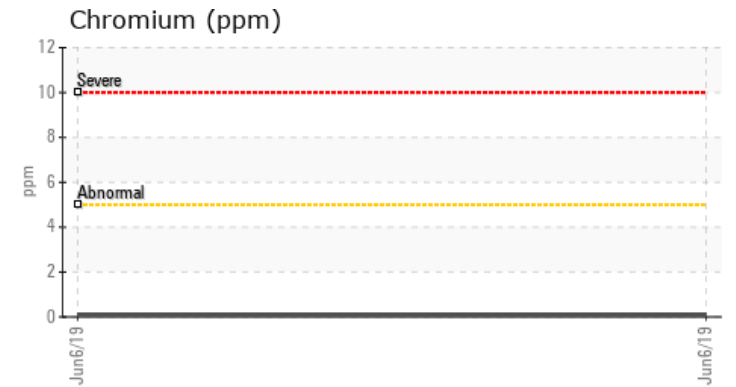
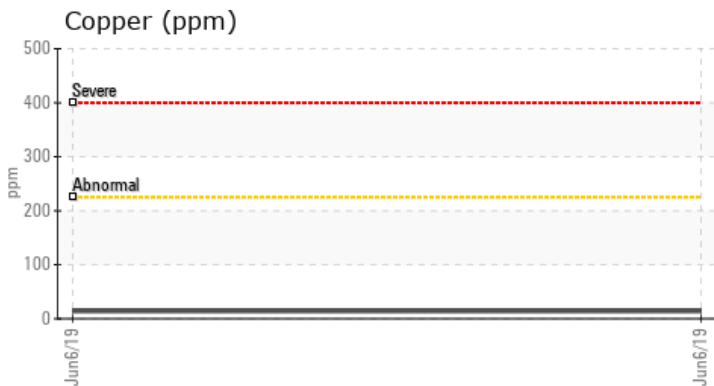
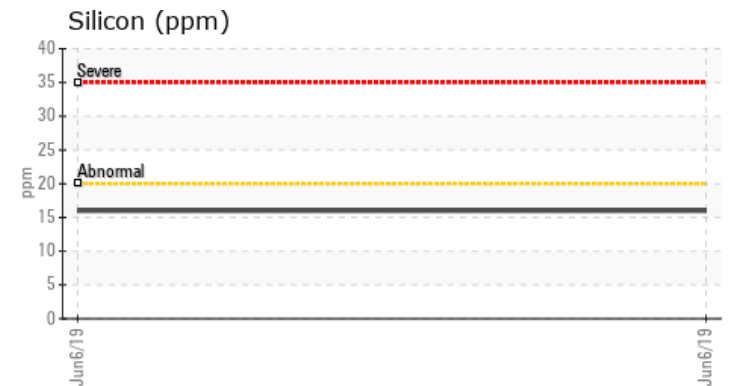
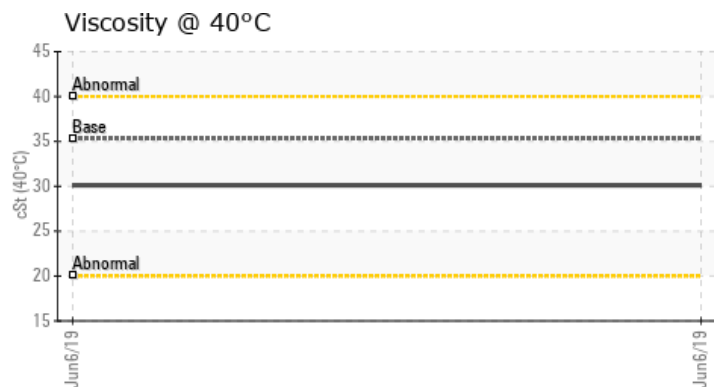
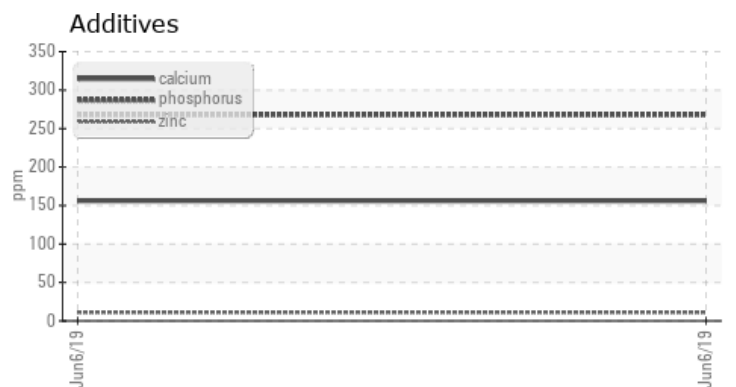
## VOLVO GRAPHS

Resample at the next service interval to monitor. All component wear rates are normal. There is no indication of any contamination in the fluid. The condition of the fluid is acceptable for the time in service.
