CONSTRUCTION EQUIPMENT

213910 VOLVO A25E 13189 - TRANSMISSION (AUTO)

Sample No: VCP243245

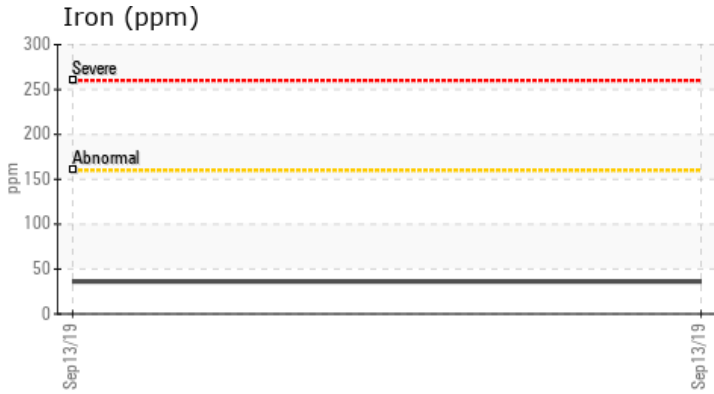
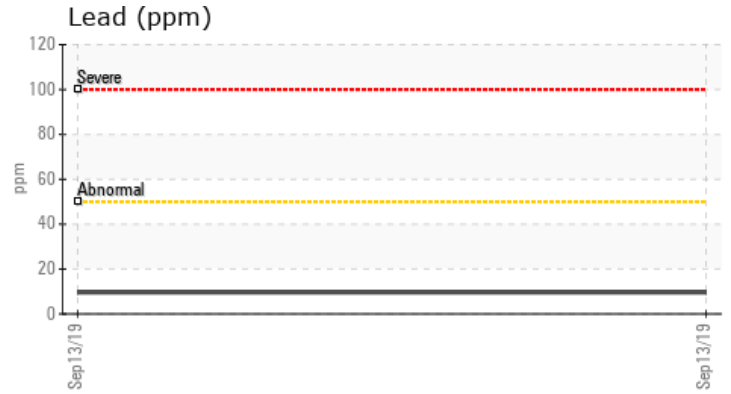
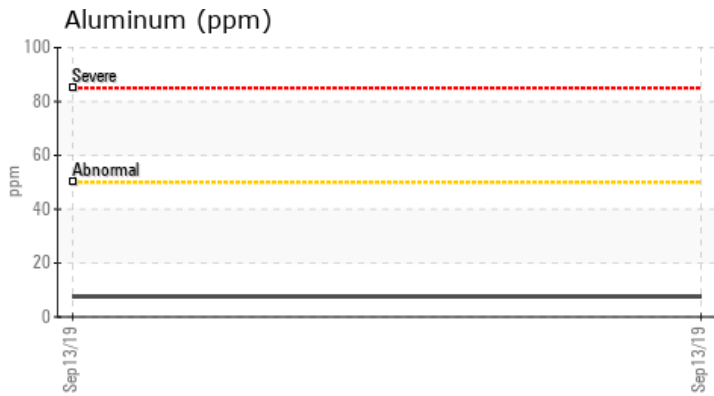
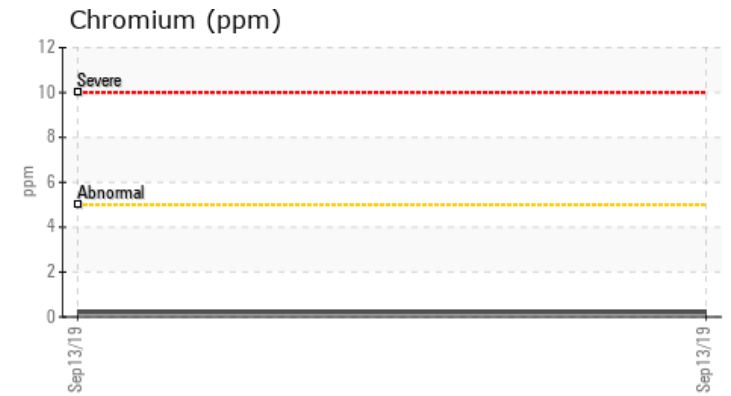
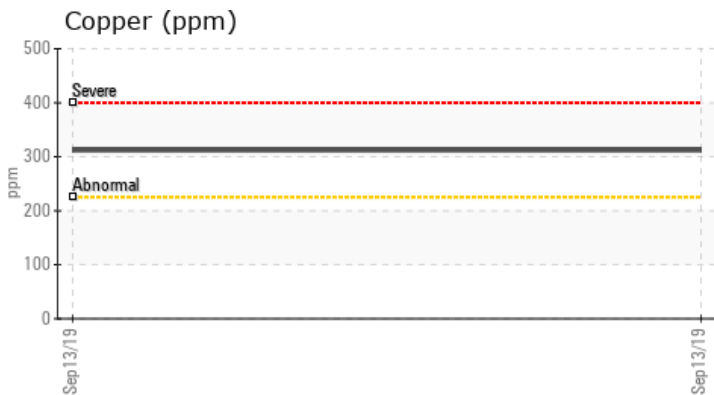
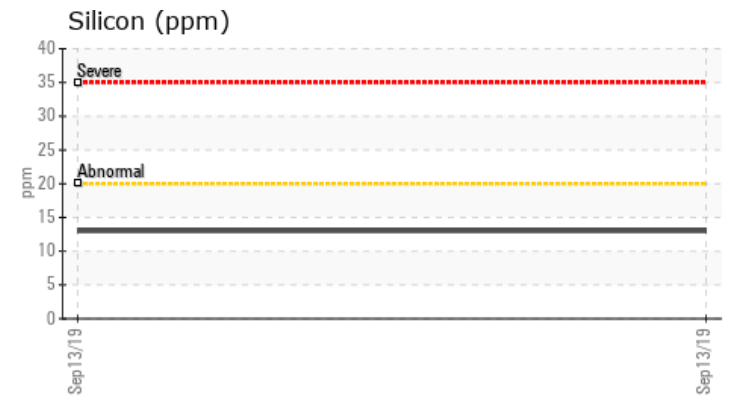
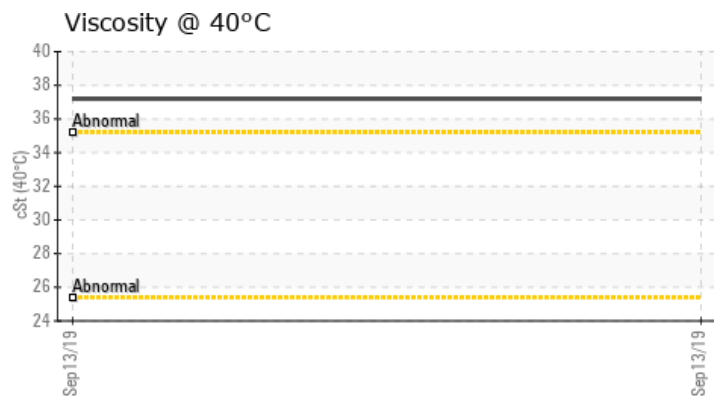
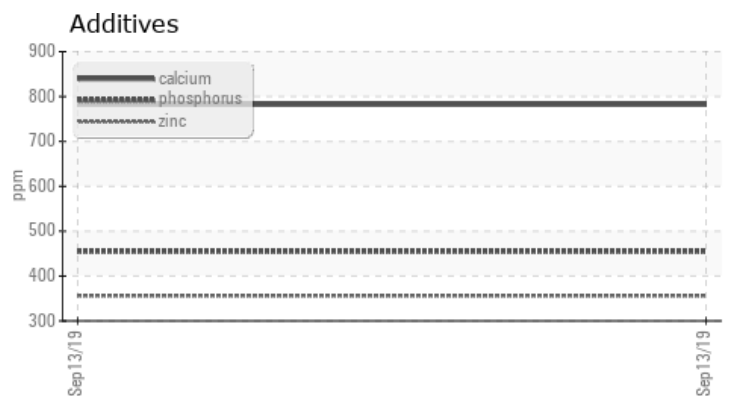
GRAPHS

Échantillonner de nouveau l'équipement au prochain intervalle de vidange afin d'en surveiller la condition. Veuillez préciser la marque, le type et la viscosité de l'huile lors de votre prochain échantillon. Les taux d'usure de tous les composants sont normaux. Il n'y a aucun indice de contamination dans le le fluide. L'état de le fluide est acceptable pour la durée de service.
