CONSTRUCTION EQUIPMENT

238210 VOLVO A40G 340287 - TRANSMISSION (AUTO)

Sample No: VCP209467
Oil Type: VOLVO AT 102
Job No: 238210

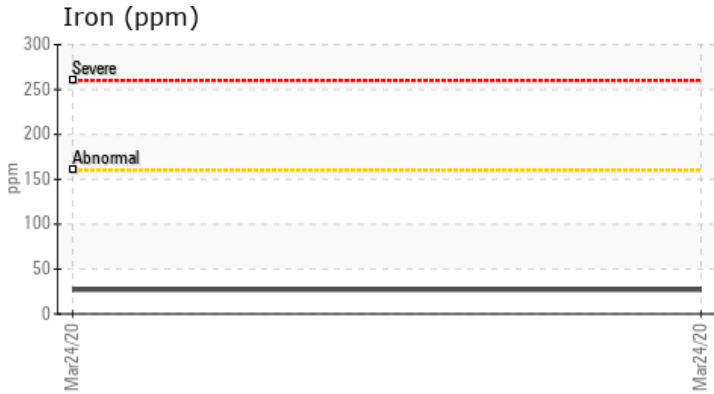
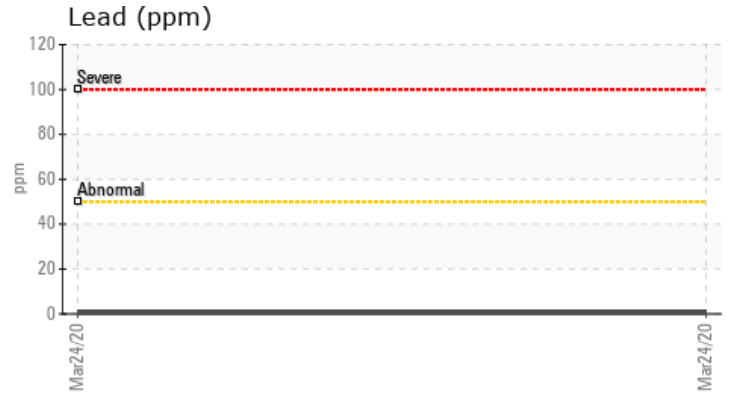
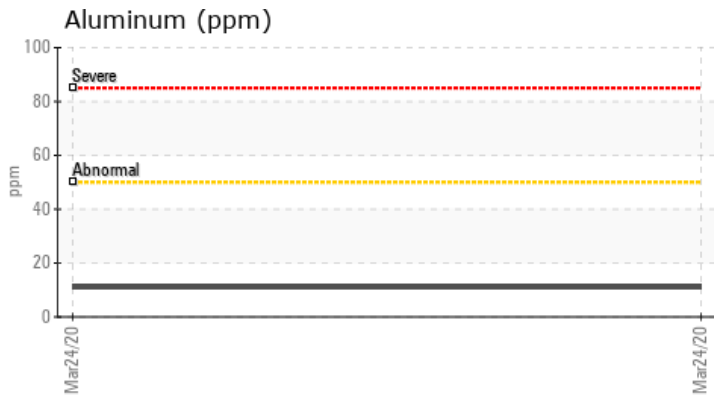
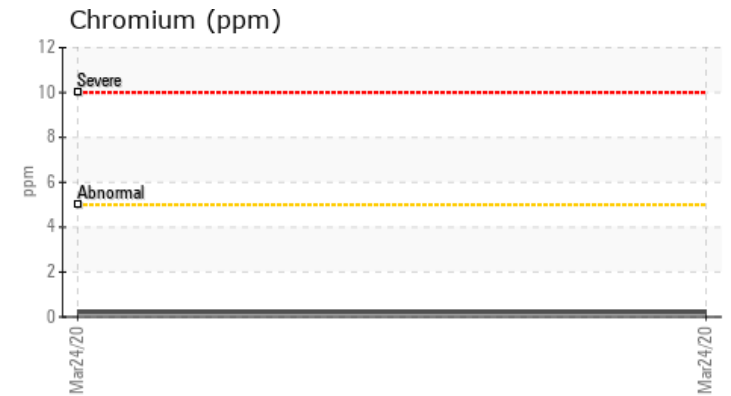
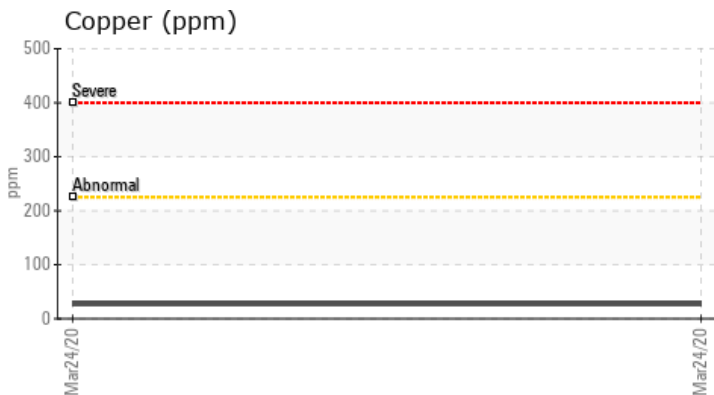
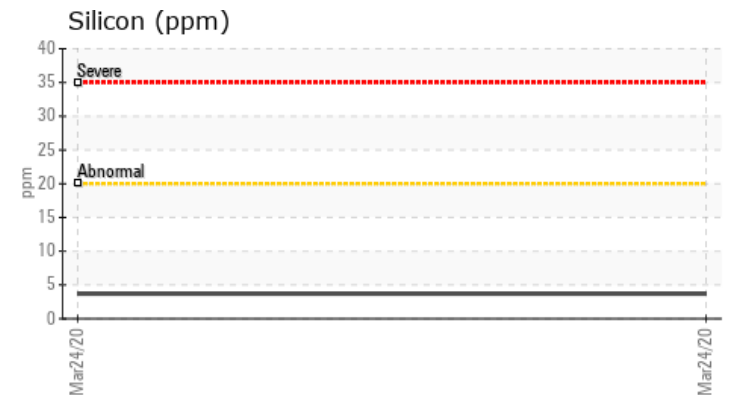
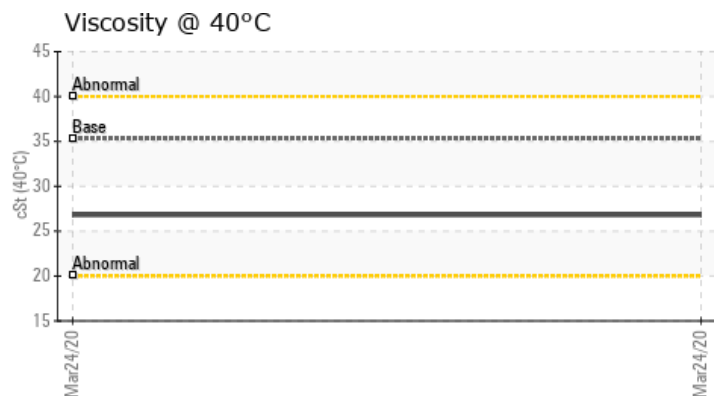
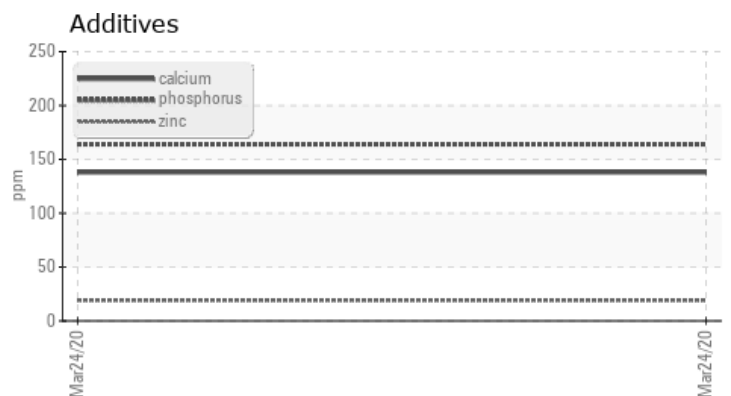
GRAPHS

Échantillonner de nouveau l'équipement au prochain intervalle de vidange afin d'en surveiller la condition. Les taux d'usure de tous les composants sont normaux. Il n'y a aucun indice de contamination dans le le fluide. L'état de le fluide est acceptable pour la durée de service.
