CONSTRUCTION EQUIPMENT

246478 VOLVO A40G 342243 - FRONT AXLE

Sample No: VCP251412
Oil Type: VOLVO API GL-5 SAE 75W90
Job No: 246478

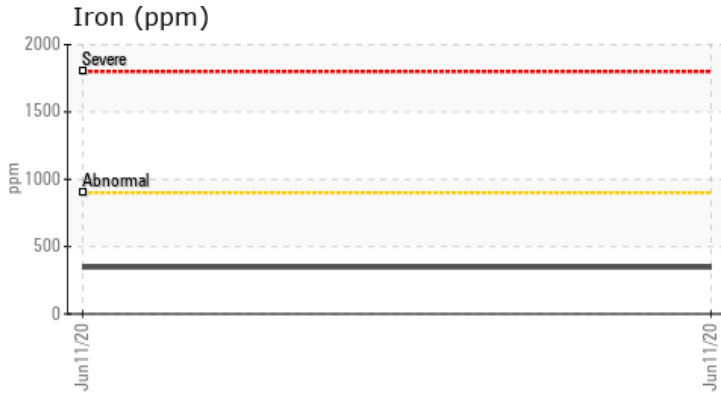
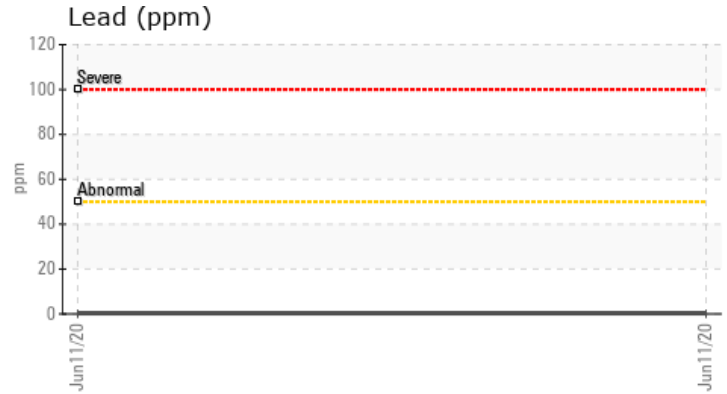
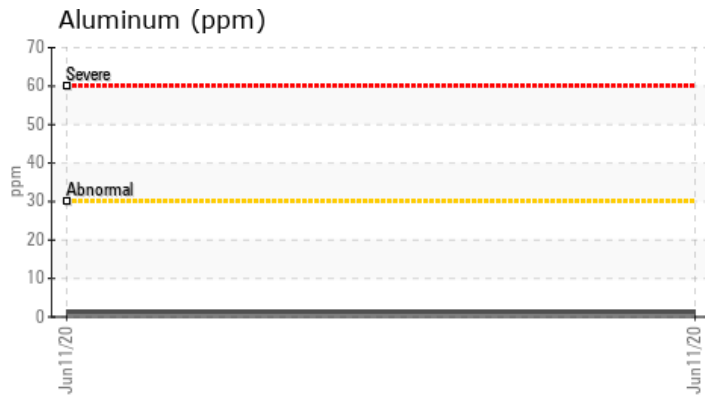
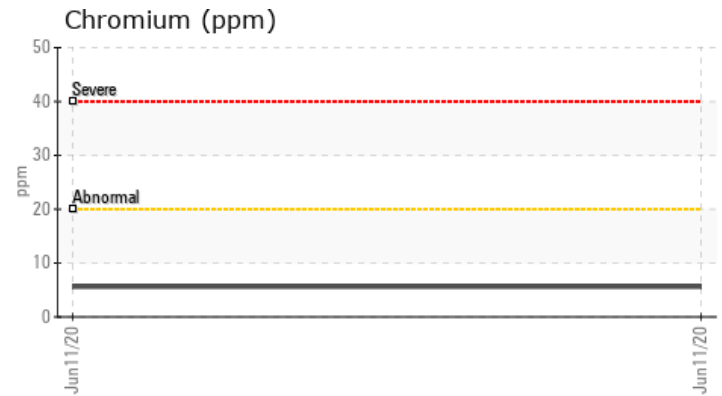
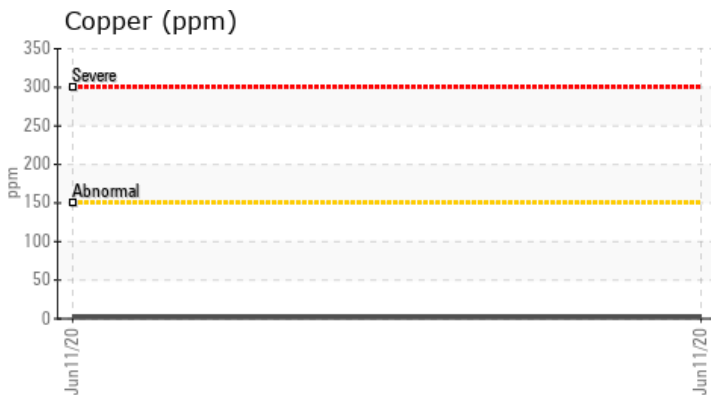
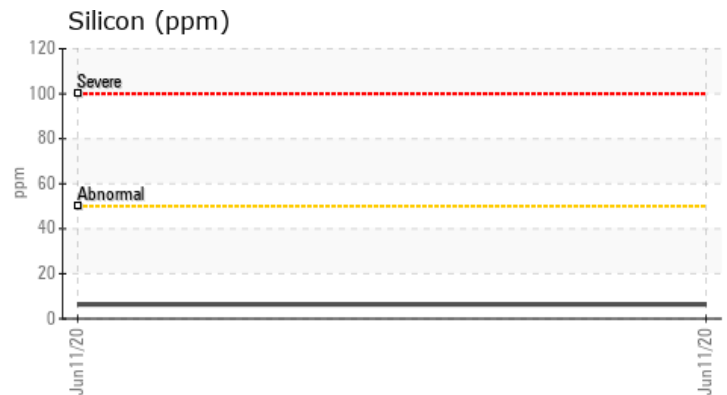
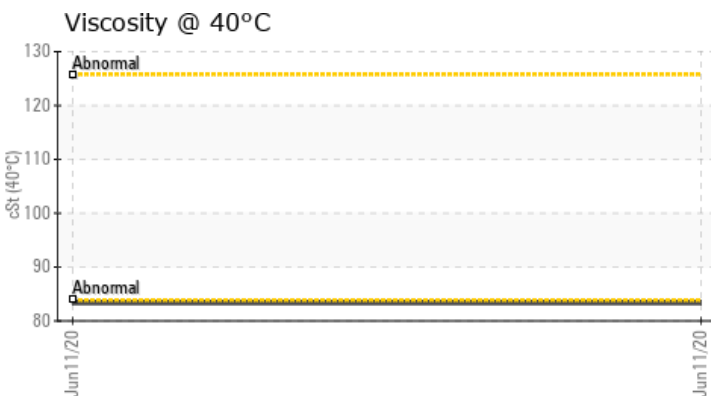
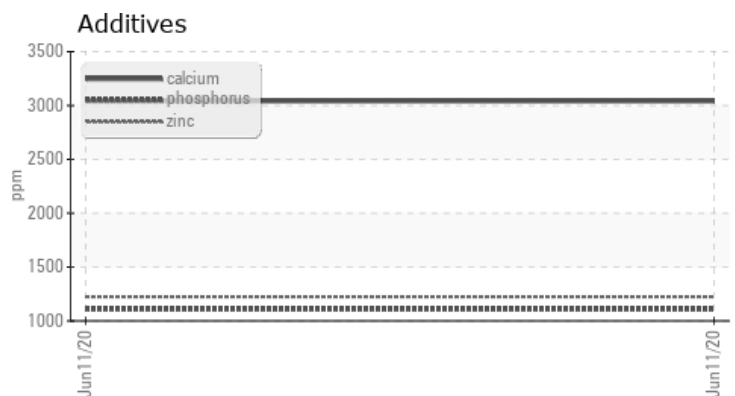
GRAPHS

Diagnosis
 Échantillonner de nouveau l'équipement au prochain intervalle de vidange afin d'en surveiller la condition. Les taux d'usure de tous les composants sont normaux. Il n'y a aucun indice de contamination dans le l'huile. L'état de l'huile est acceptable pour la durée de service.
