# CONSTRUCTION EQUIPMENT

280258 VOLVO A35C 4656 - FRONT AXLE

**Sample No:** VCP299419

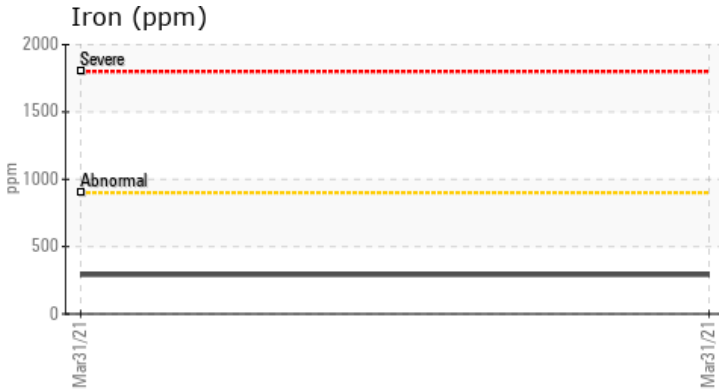
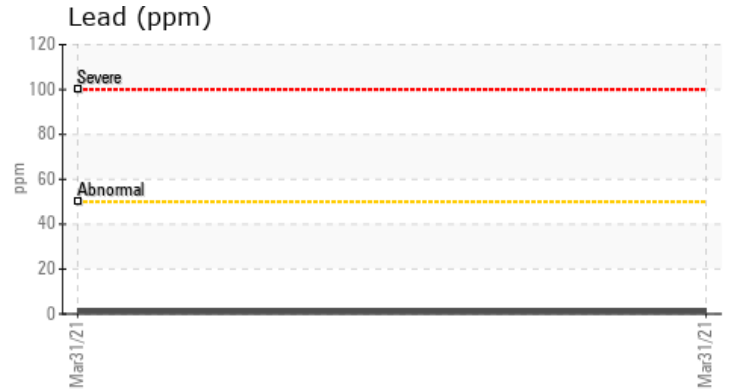
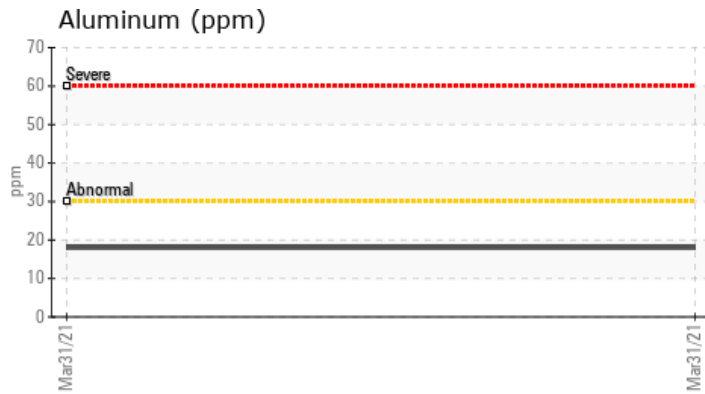
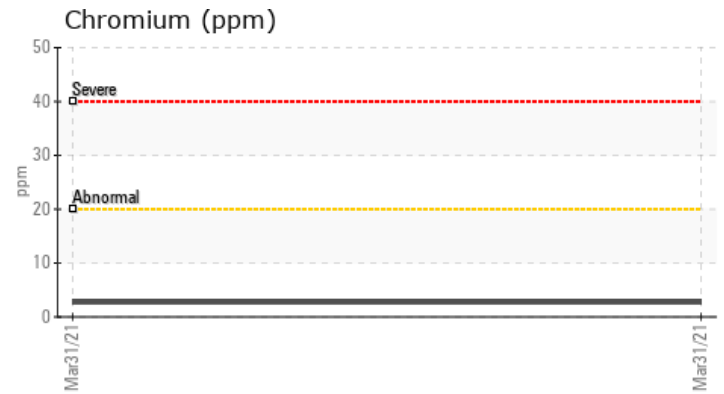
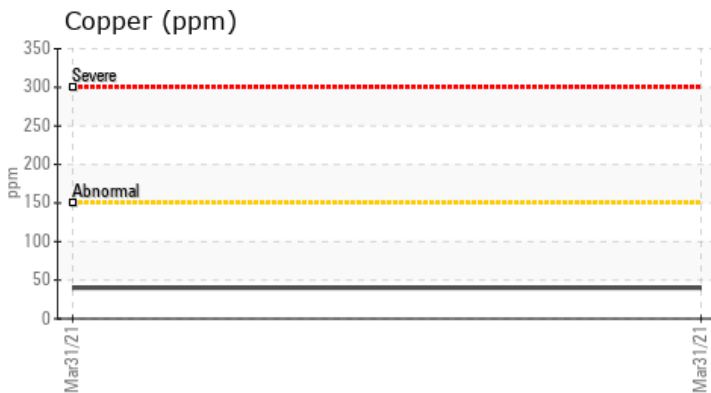
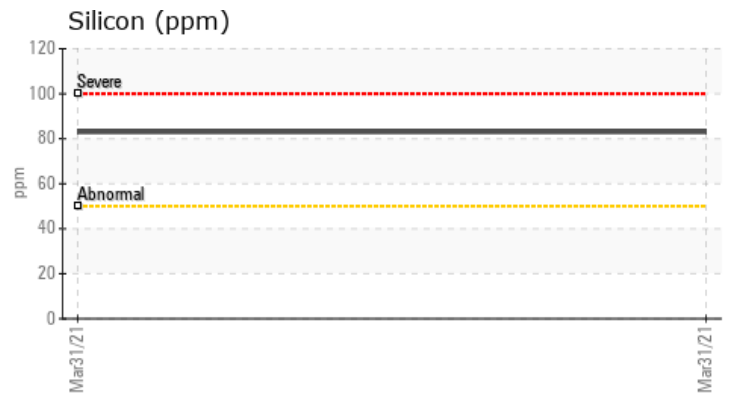
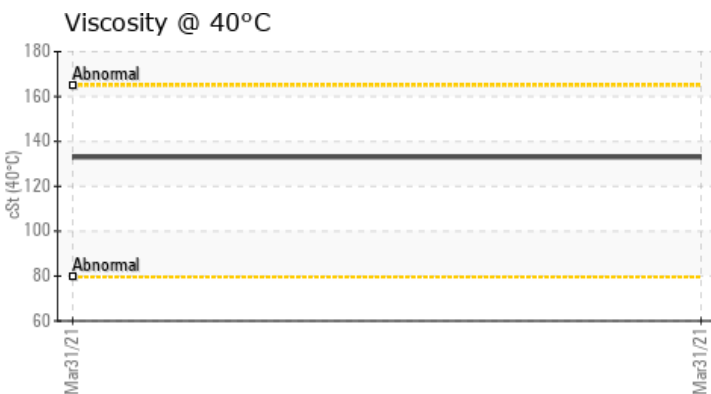
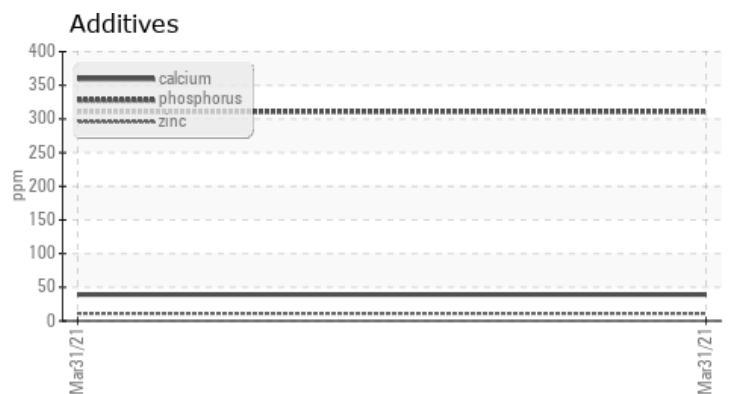
## GRAPHS

Visc @ 40°C	cSt	█ 133	---	---	---
-------------	-----	-------	-----	-----	-----

Silicon	ppm	█ 83	---	---	---
Sodium	ppm	█ 5	---	---	---
Potassium	ppm	█ 6	---	---	---

Iron	ppm	█ 291	---	---	---
Copper	ppm	█ 40	---	---	---
Lead	ppm	█ 1	---	---	---
Tin	ppm	█ 2	---	---	---
Aluminum	ppm	█ 18	---	---	---
Chromium	ppm	█ 3	---	---	---
Molybdenum	ppm	<1	---	---	---
Nickel	ppm	█ 2	---	---	---
Titanium	ppm	2	---	---	---
Silver	ppm	<1	---	---	---
Manganese	ppm	4	---	---	---
Vanadium	ppm	<1	---	---	---

Échantillonner de nouveau l'équipement au prochain intervalle de vidange afin d'en surveiller la condition. Veuillez préciser la marque, le type et la viscosité de l'huile lors de votre prochain échantillon. Les taux d'usure de tous les composants sont normaux. Il n'y a aucun indice de contamination dans le l'huile. L'état de l'huile est acceptable pour la durée de service.
