# CONSTRUCTION EQUIPMENT

313560 VOLVO A25G 752104 - FRONT AXLE

**Sample No:** VCP334317  
**Oil Type:** VOLVO API GL-5 SAE 75W90  
**Job No:** 313560

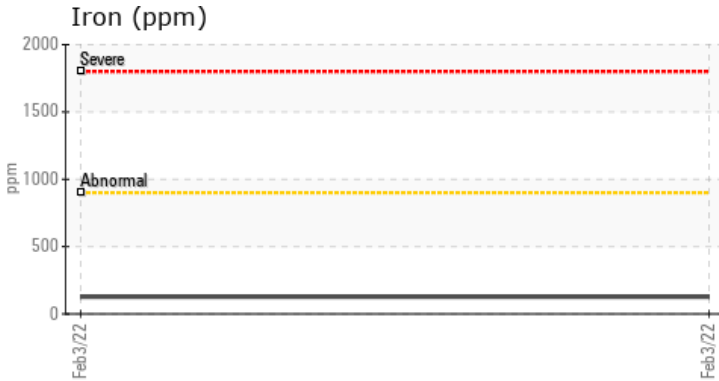
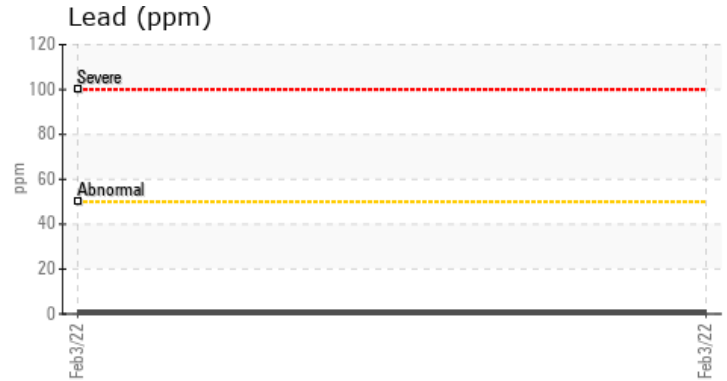
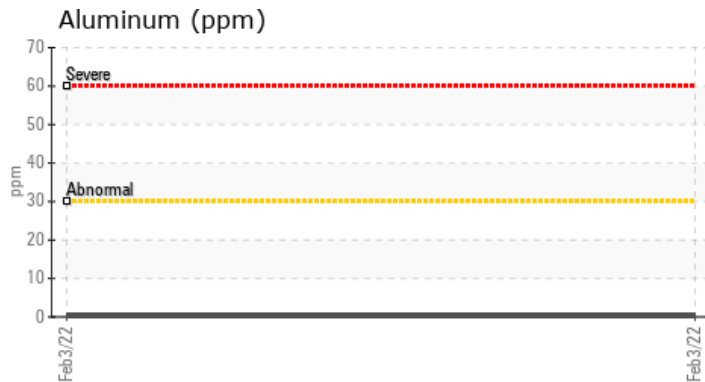
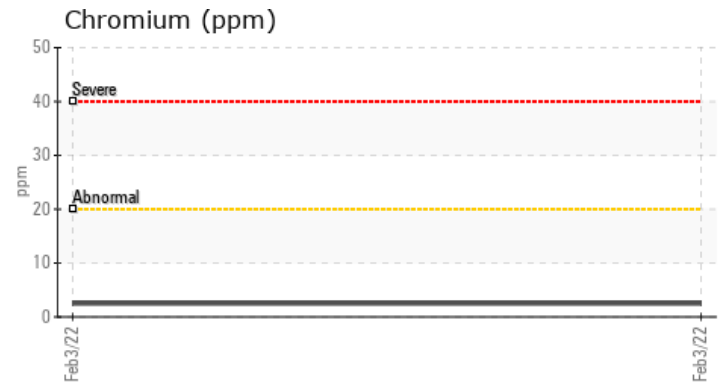
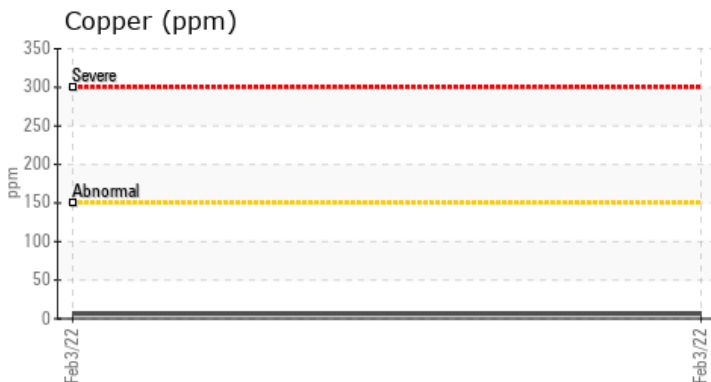
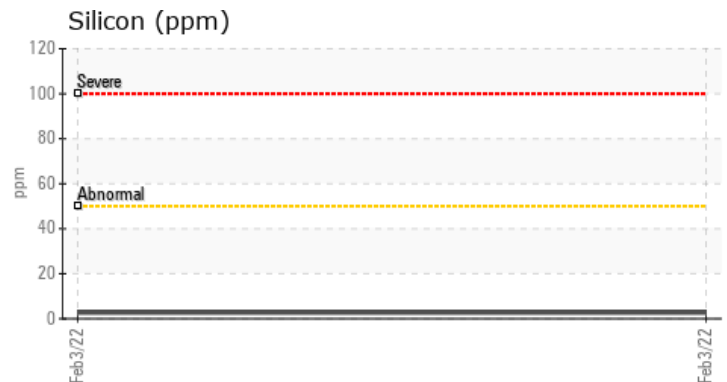
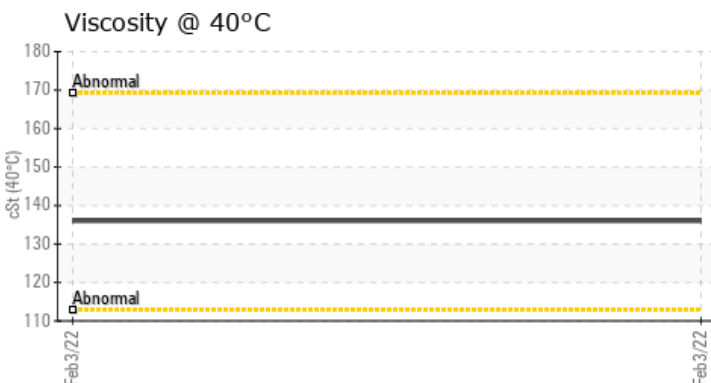
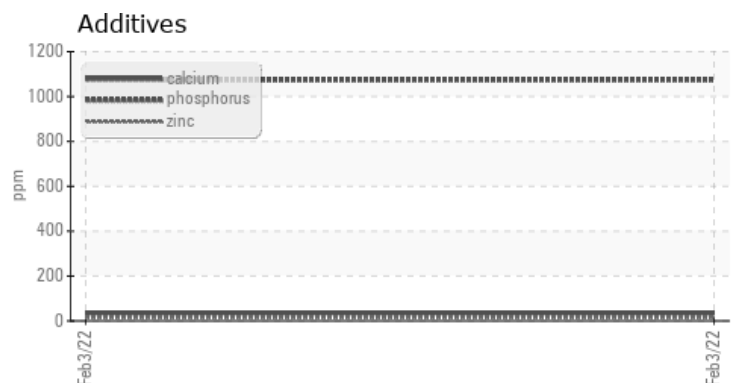
## GRAPHS

**Diagnosis**  
 Échantillonner de nouveau l'équipement au prochain intervalle de vidange afin d'en surveiller la condition. Les taux d'usure de tous les composants sont normaux. Il n'y a aucun indice de contamination dans le l'huile. L'état de l'huile est acceptable pour la durée de service.
