# CONSTRUCTION EQUIPMENT

367601 VOLVO 726B 35977 - TRANSMISSION

**Sample No:** VCP394914

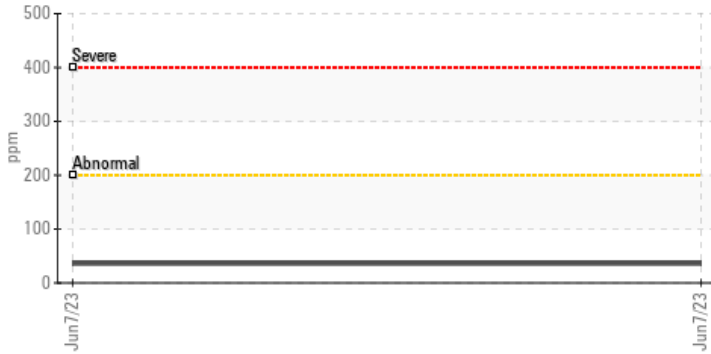
### Iron (ppm)

Iron	ppm	36	---	---	---
Copper	ppm	12	---	---	---
Lead	ppm	7	---	---	---
Tin	ppm	<1	---	---	---
Aluminum	ppm	3	---	---	---
Chromium	ppm	0	---	---	---
Molybdenum	ppm	40	---	---	---
Nickel	ppm	0	---	---	---
Titanium	ppm	<1	---	---	---
Silver	ppm	0	---	---	---
Manganese	ppm	<1	---	---	---
Vanadium	ppm	0	---	---	---

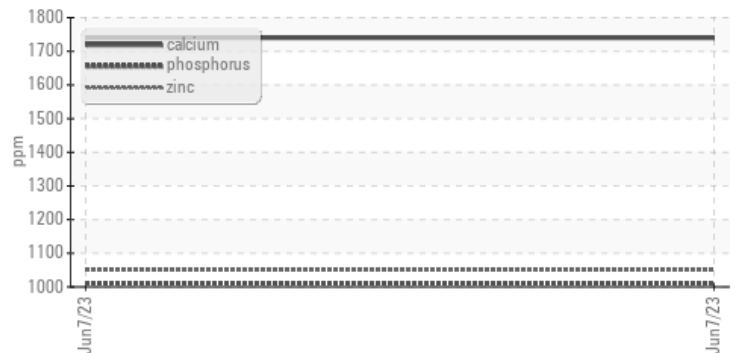
### Additives

Calcium	ppm	1740	---	---	---
Magnesium	ppm	488	---	---	---
Zinc	ppm	1050	---	---	---
Phosphorus	ppm	1011	---	---	---
Barium	ppm	0	---	---	---
Boron	ppm	68	---	---	---
