CONSTRUCTION EQUIPMENT

370496 VOLVO A45G 342018 - DROP BOX

Sample No: VCP394972
Oil Type: GEAR OIL SAE 80W90
Job No: 370496

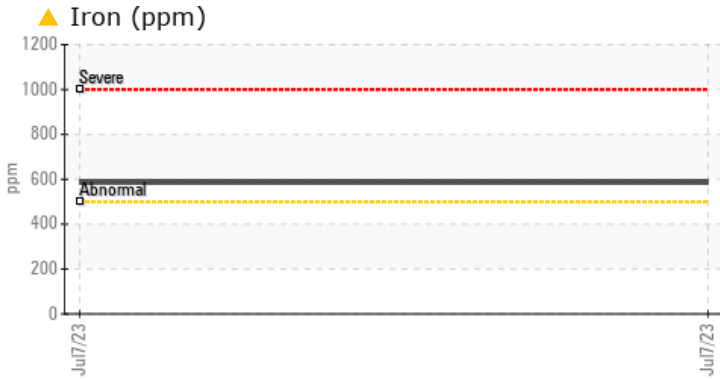
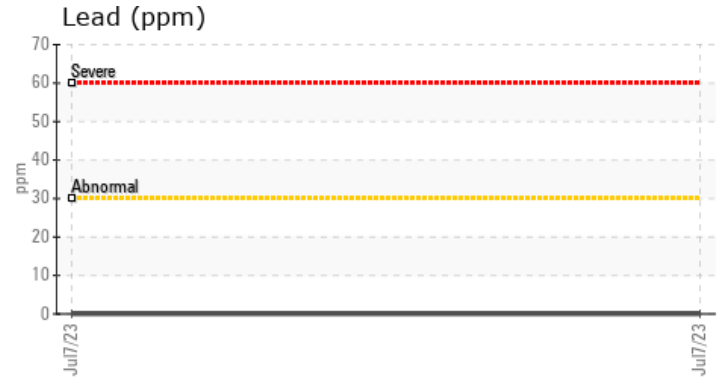
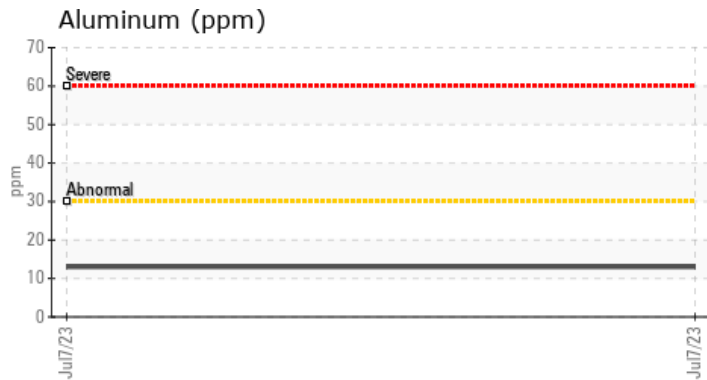
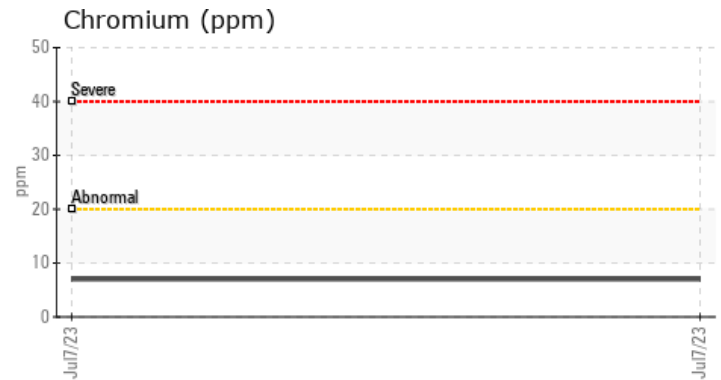
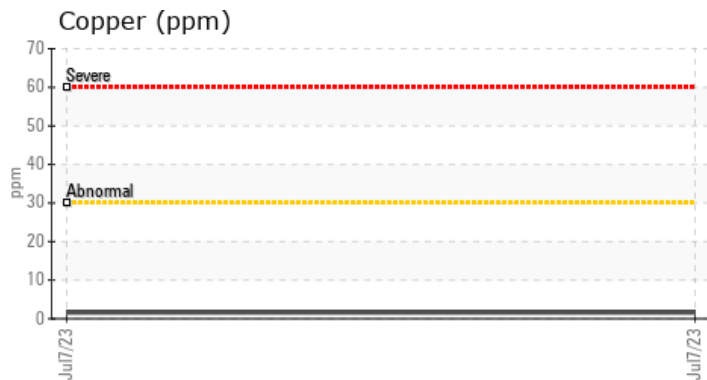
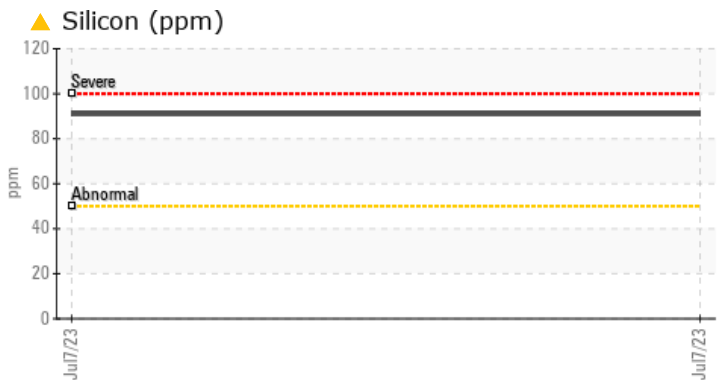
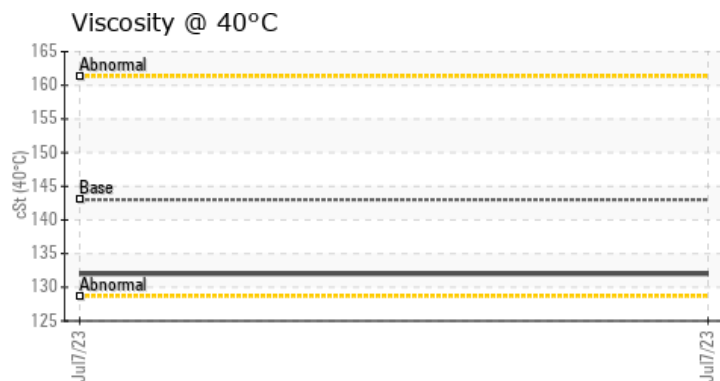
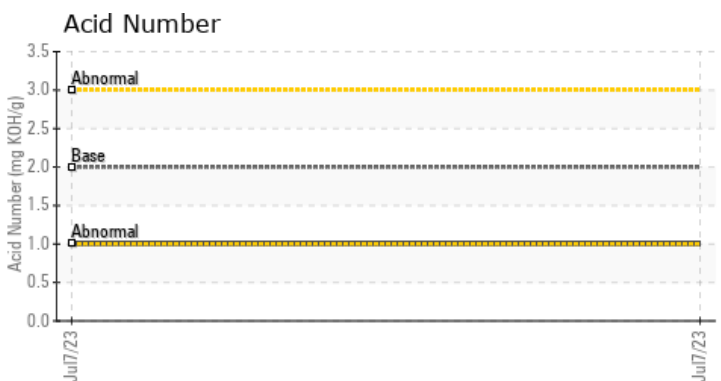
GRAPHS

We advise that you check all areas where dirt can enter the system. The oil change at the time of sampling has been noted. We recommend an early resample to monitor this condition. The fluid was not specified, however, a fluid match indicates that this fluid is (GENERIC) GEAR OIL SAE 80W90. Please confirm. Iron ppm levels are abnormal. The low ferrous density (PQ) index indicates the wear metal levels are due to corrosion. There is a moderate concentration of dirt present in the oil. High amount of ingressed dirt has caused abrasive wear to the component. The AN level is acceptable for this fluid. The oil is no longer serviceable as a result of the abnormal and/or severe wear.
