CONSTRUCTION EQUIPMENT

PAVE-AL VOLVO L70F 25821 - TRANSMISSION (AUTO)

Sample No: VCP380459

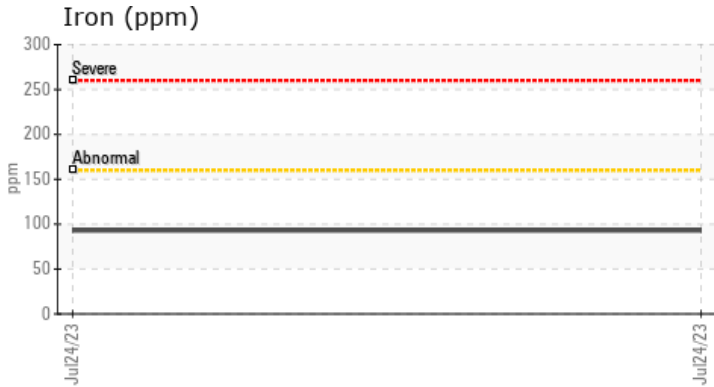
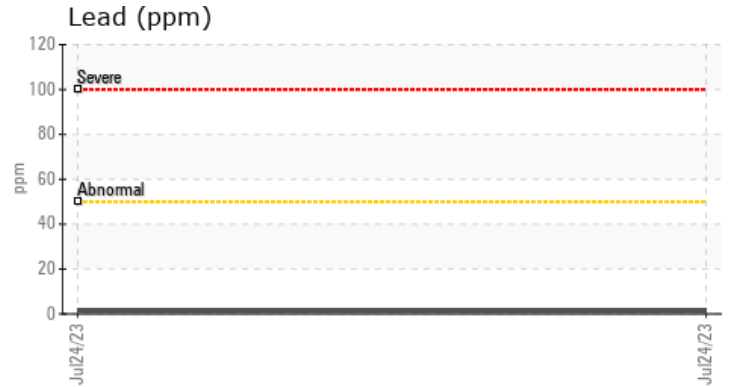
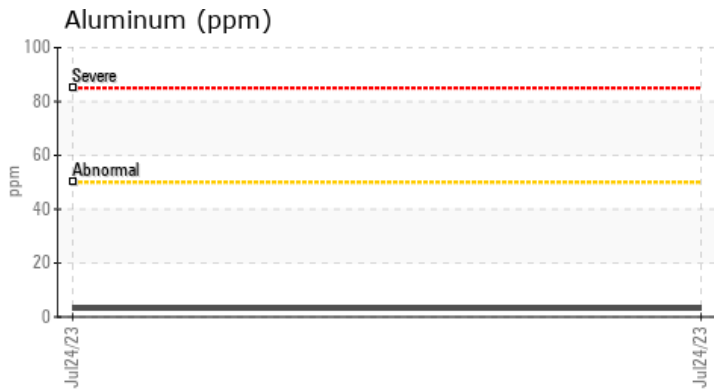
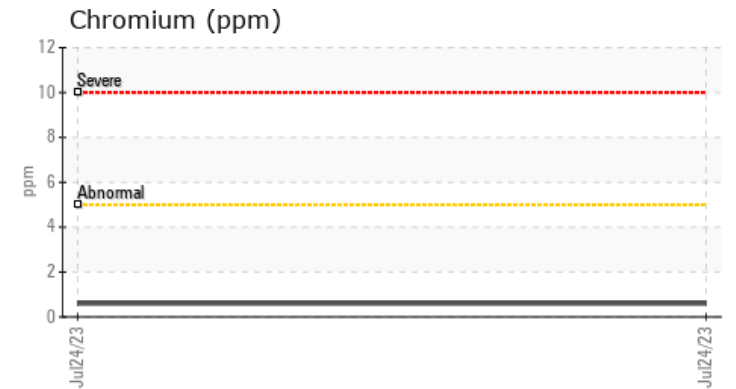
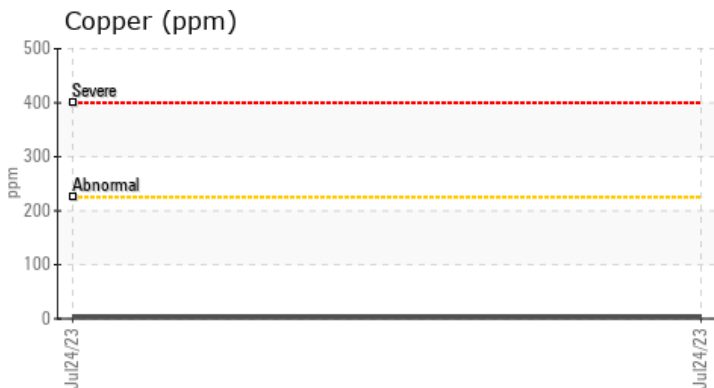
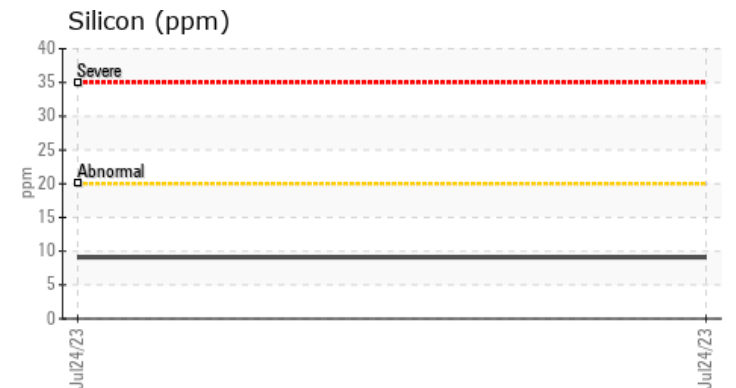
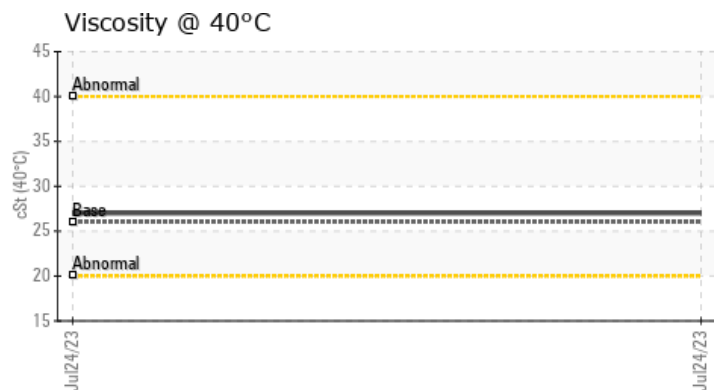
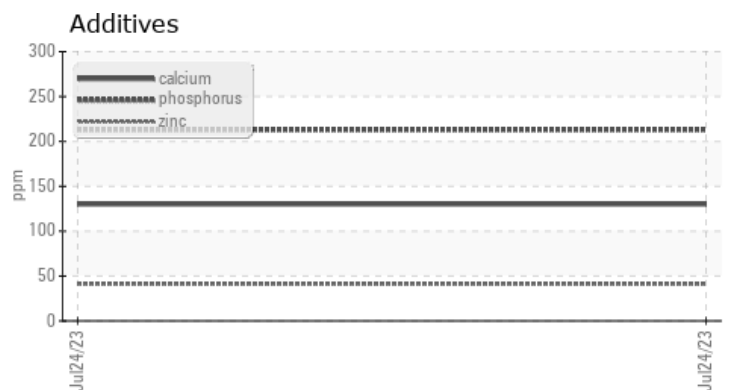
VOLVO GRAPHS

Resample at the next service interval to monitor. The fluid was not specified, however, a fluid match indicates that this fluid is (GENERIC) DEXRON III. Please confirm. All component wear rates are normal. There is no indication of any contamination in the fluid. The condition of the fluid is acceptable for the time in service.
