# CONSTRUCTION EQUIPMENT

BERGEN 8000372864 VOLVO L60H 622360 - TRANSMISSION (AUTO)

**Sample No:** VCE07567  
**Oil Type:** VOLVO EXTRA AUTOMATIC FLUID  
**Job No:** 8000372864

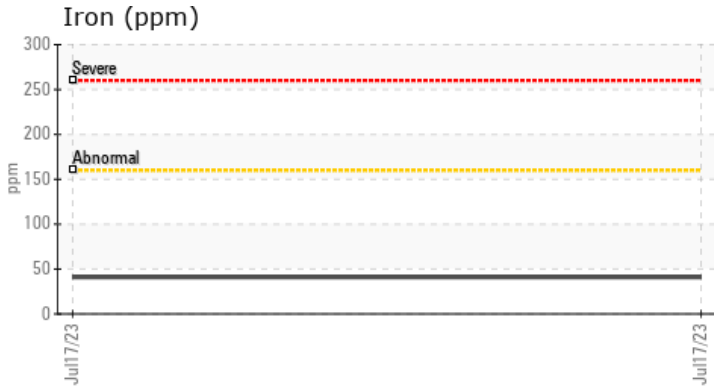
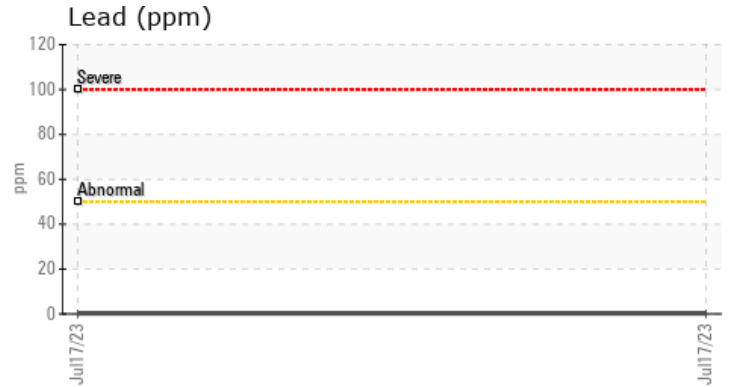
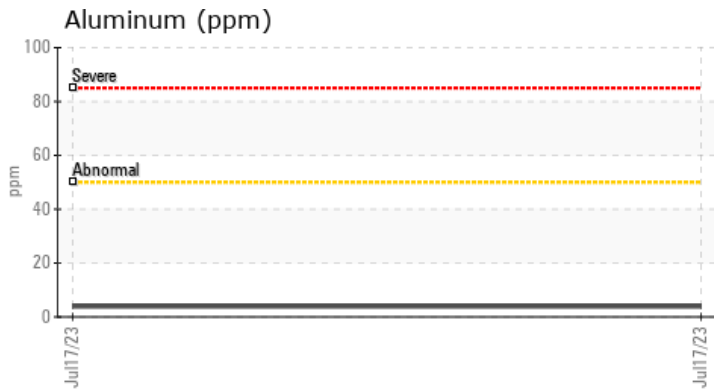
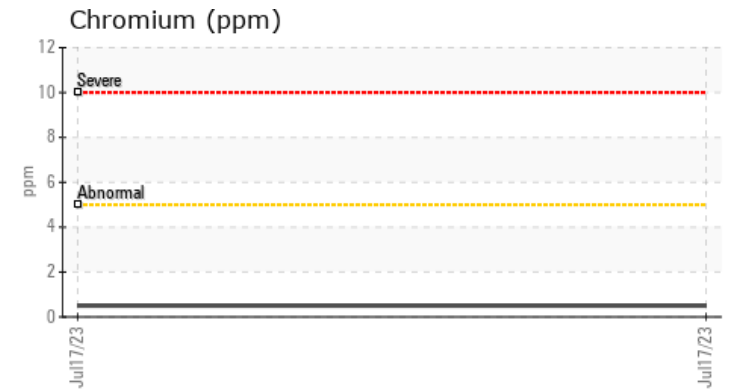
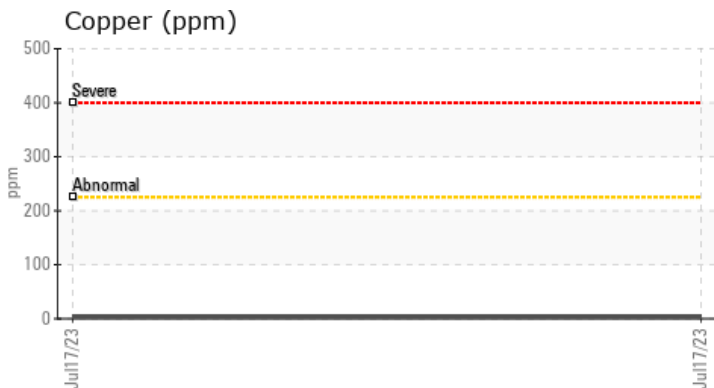
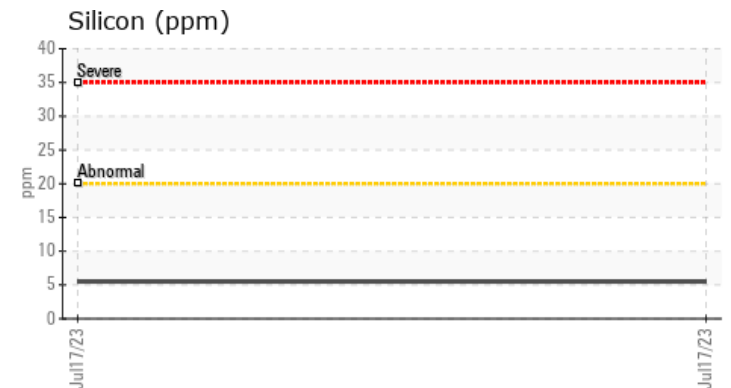
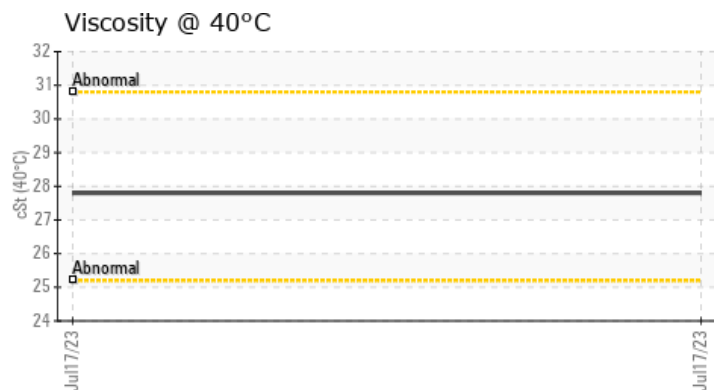
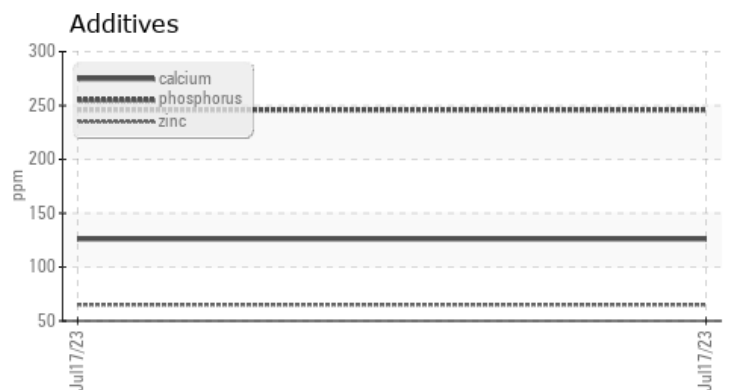
## GRAPHS

Resample at the next service interval to monitor. All component wear rates are normal. There is no indication of any contamination in the fluid. The condition of the fluid is acceptable for the time in service.
