CONSTRUCTION EQUIPMENT

372608 VOLVO L90H 625879 - TRANSMISSION (AUTO)

Sample No: VCP391526
Oil Type: VOLVO AT 102
Job No: 372608

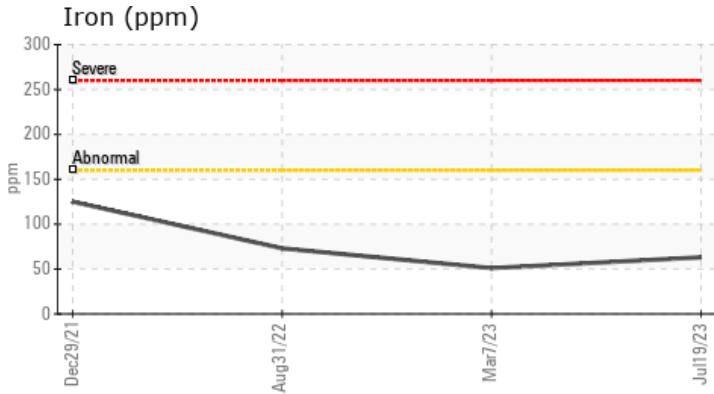
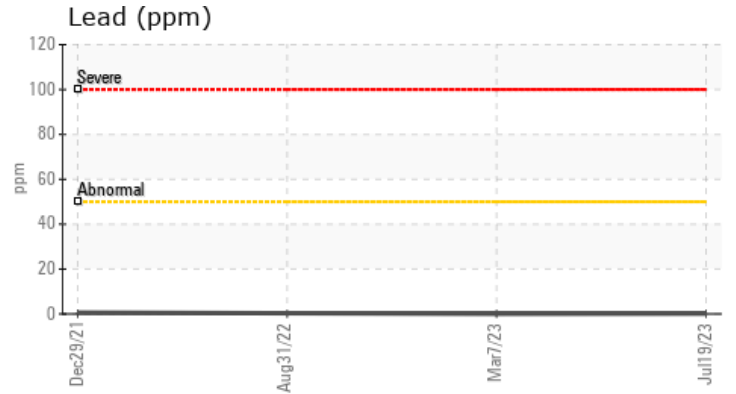
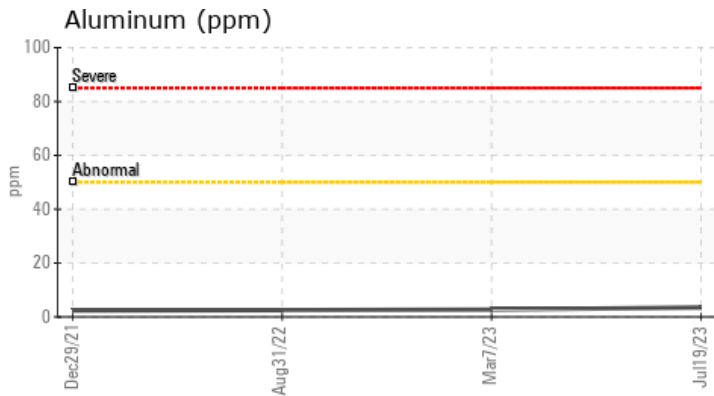
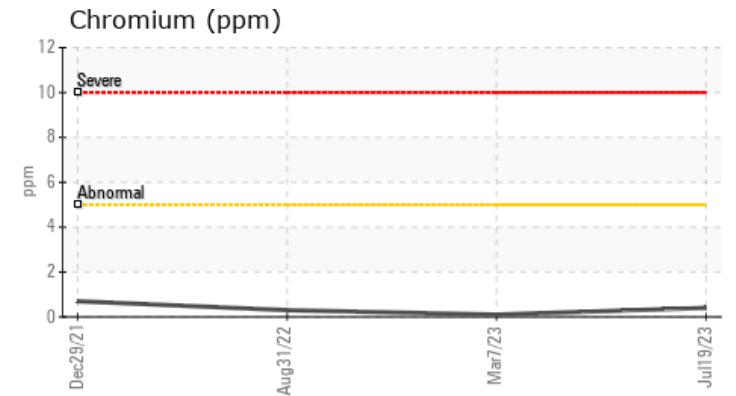
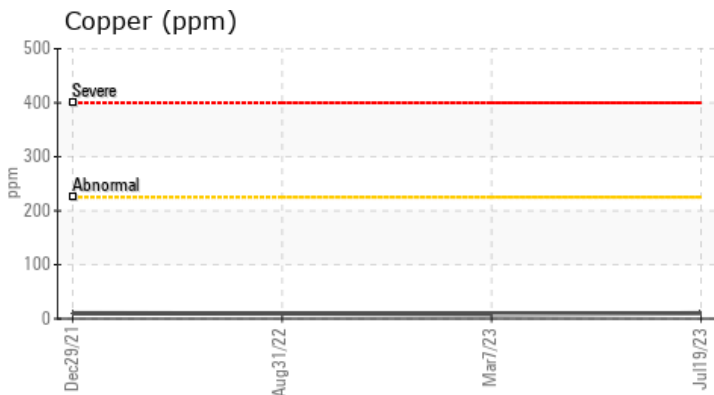
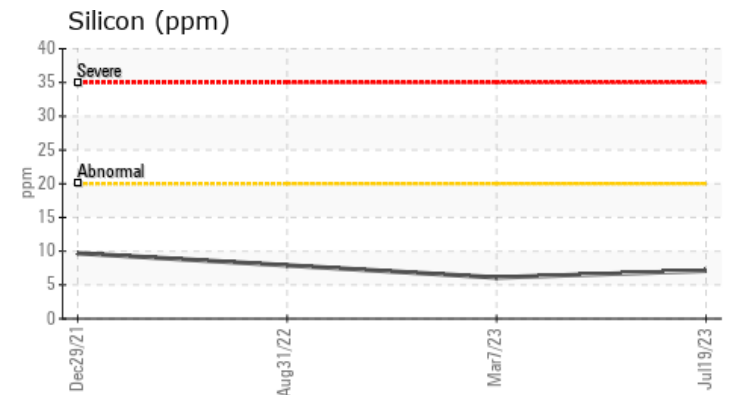
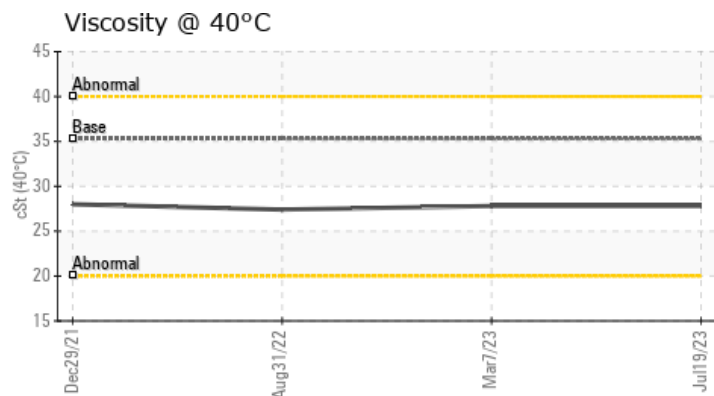
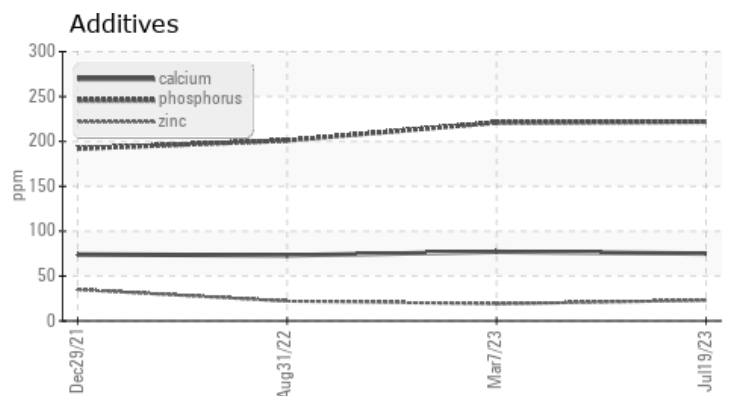
VOLVO GRAPHS

Échantillonner de nouveau l'équipement au prochain intervalle de vidange afin d'en surveiller la condition. Les taux d'usure de tous les composants sont normaux. Il n'y a aucun indice de contamination dans le fluide. L'état de le fluide est acceptable pour la durée de service.
