# CONSTRUCTION EQUIPMENT

379885 VOLVO 110H 632019 - DIESEL ENGINE

**Sample No:** VCP380403  
**Oil Type:** VOLVO ULTRA DIESEL ENGINE OIL 15W40 VDS-3  
**Job No:** 379885

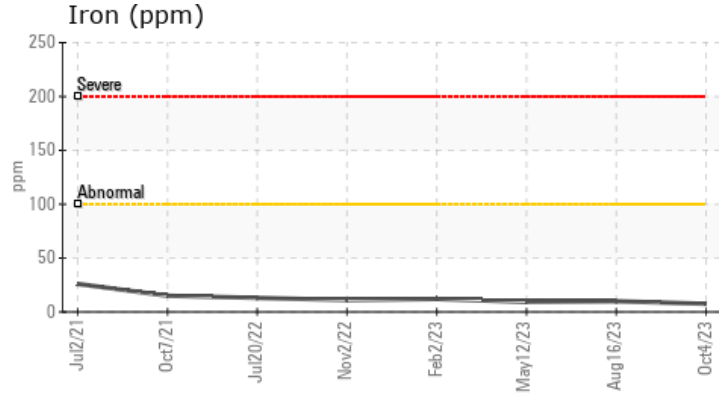
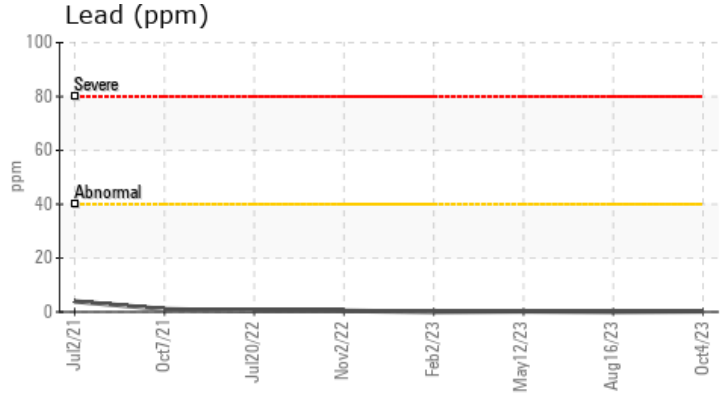
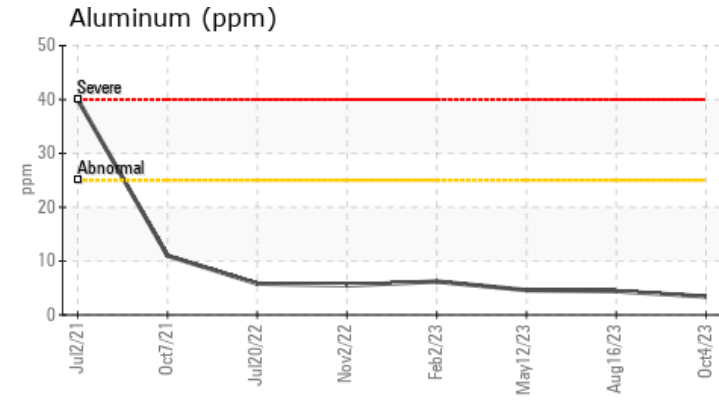
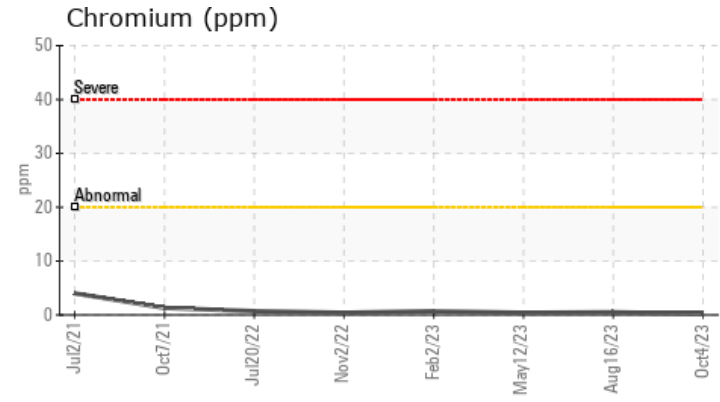
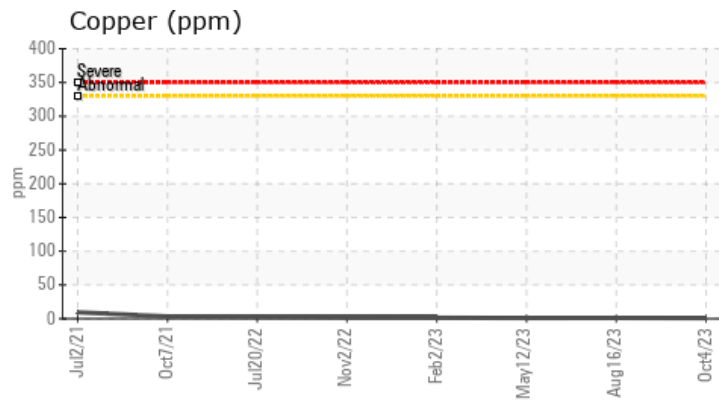
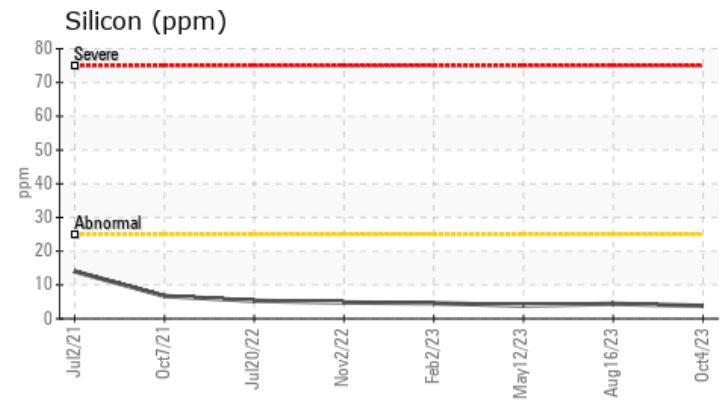
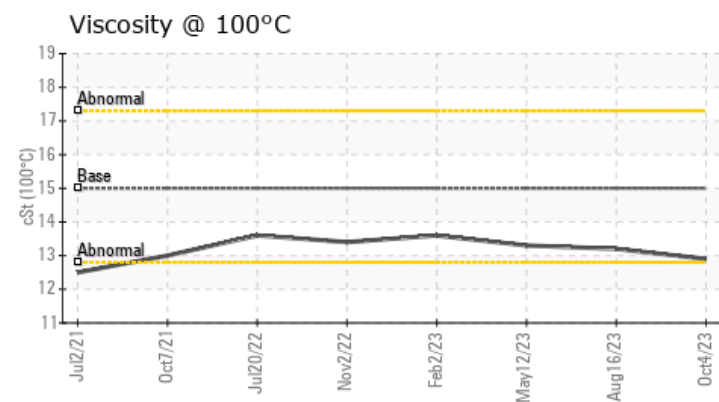
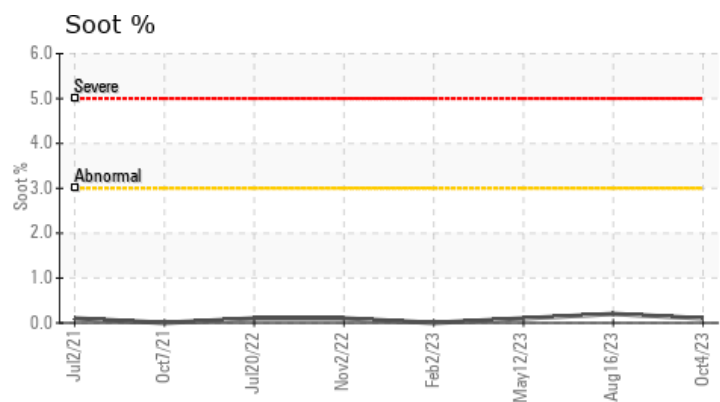
## GRAPHS

Échantillonner de nouveau l'équipement au prochain intervalle de vidange afin d'en surveiller la condition. Les taux d'usure de tous les composants sont normaux. Il n'y a aucun indice de contamination dans l'huile. L'état de l'huile est acceptable pour la durée de service.
