# CONSTRUCTION EQUIPMENT

GFL 8-384239 VOLVO L120H 632507 - DIESEL ENGINE

**Sample No:** VCP353269  
**Oil Type:** DIESEL ENGINE OIL SAE 40  
**Job No:** 8-384239

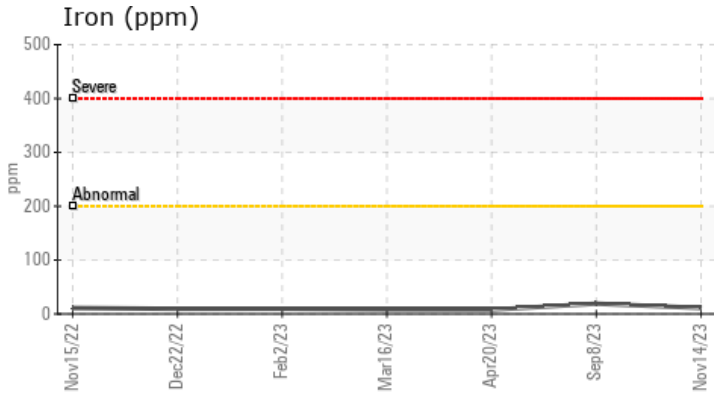
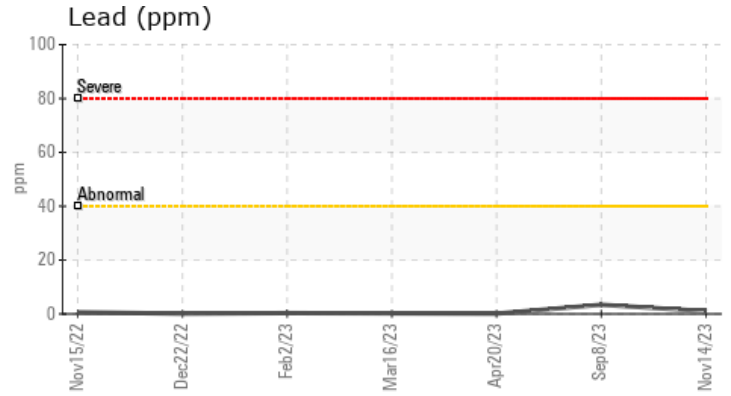
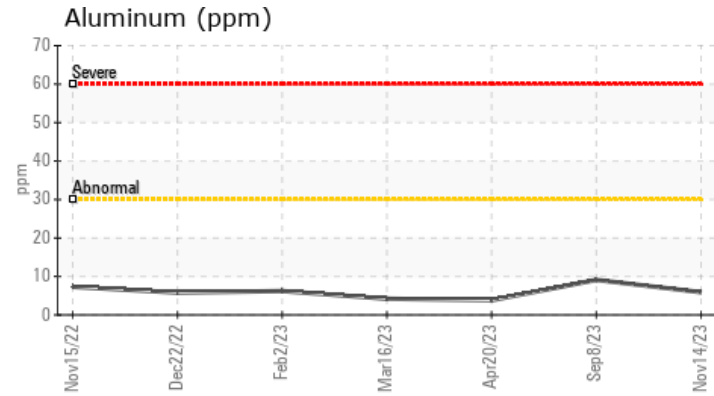
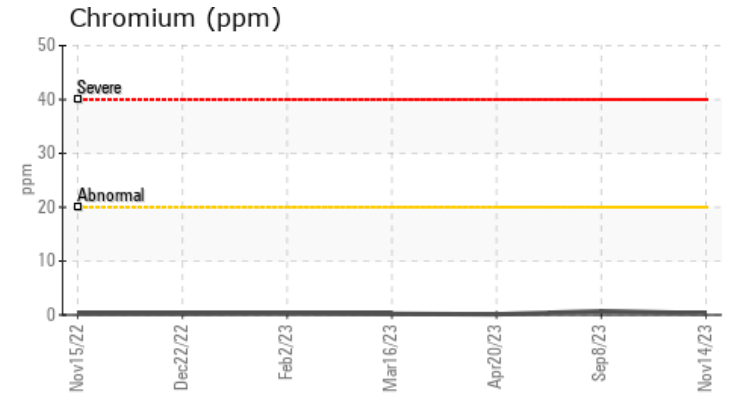
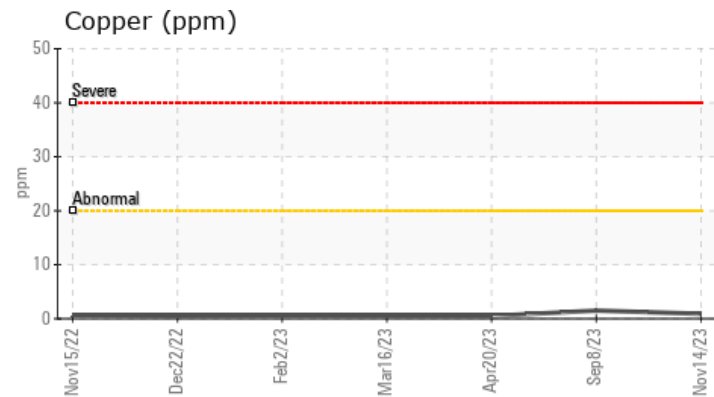
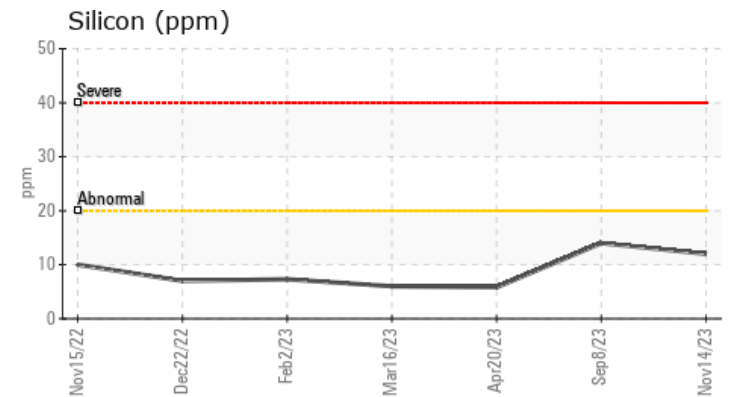
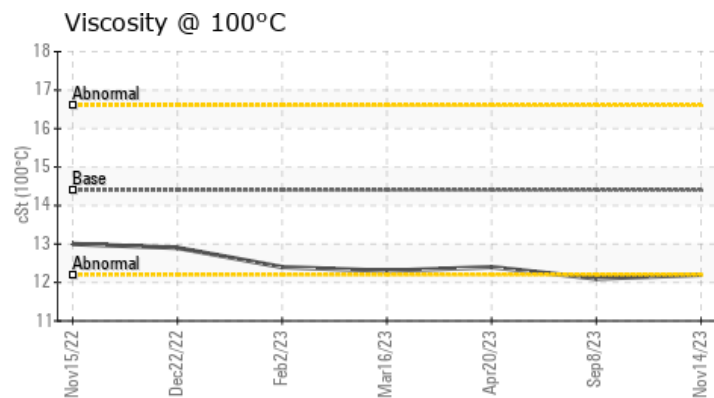
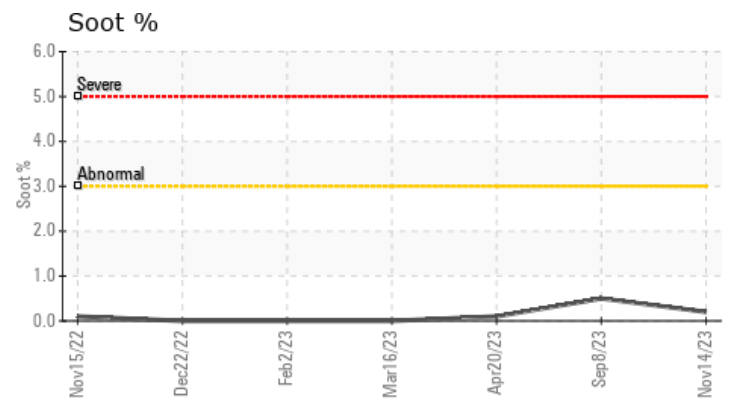
## GRAPHS

Resample at the next service interval to monitor. All component wear rates are normal. There is no indication of any contamination in the oil. The condition of the oil is acceptable for the time in service.
