CONSTRUCTION EQUIPMENT

STELLA JONES 6203 - TRANSMISSION (AUTO)

Sample No: VCP380166
Oil Type: VOLVO AUTOMATIC TRANSMISSION FLUID AT102
Job No:

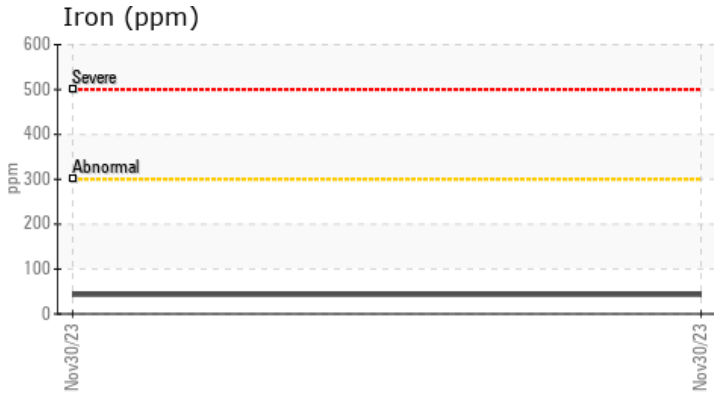
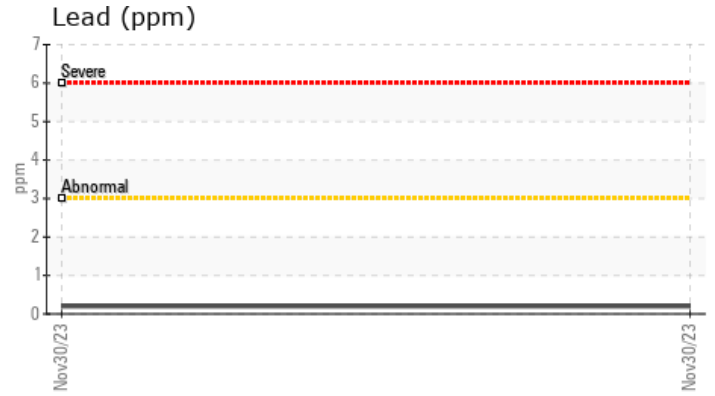
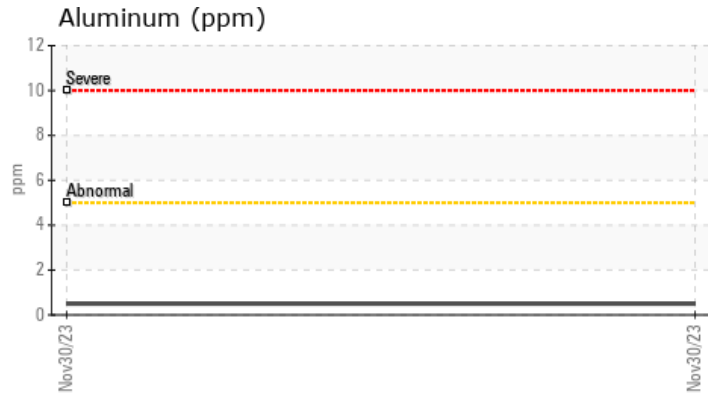
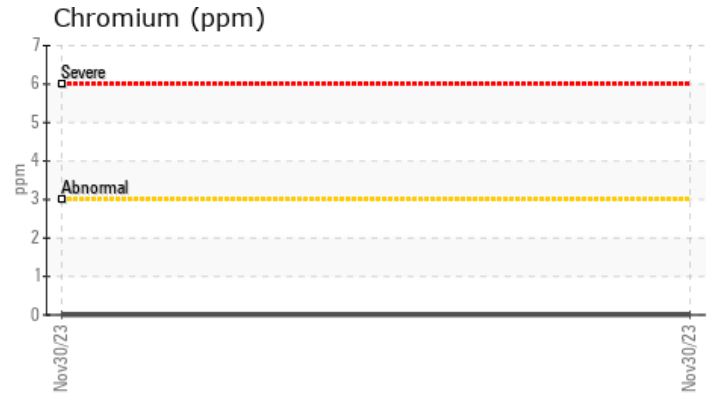
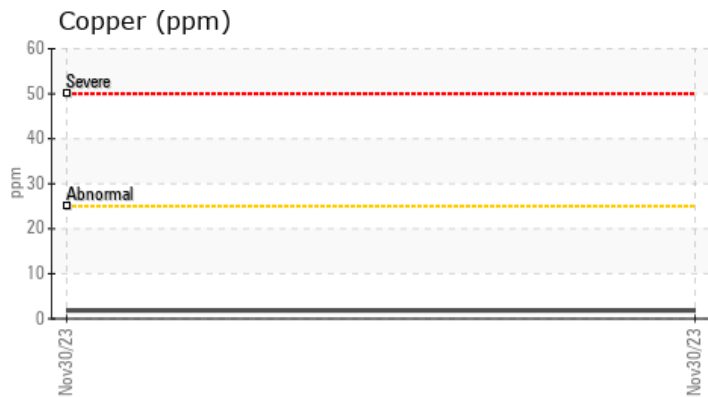
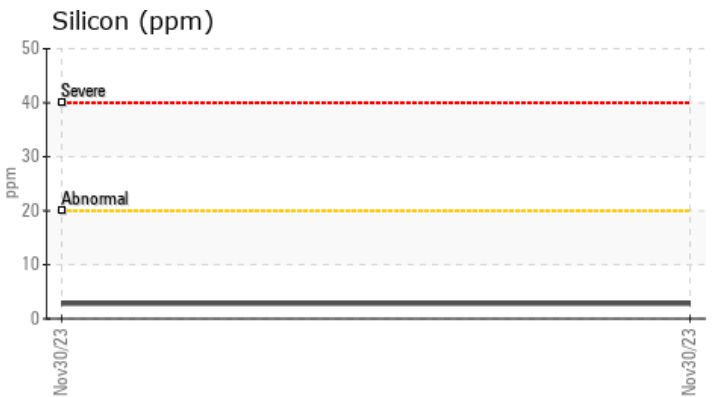
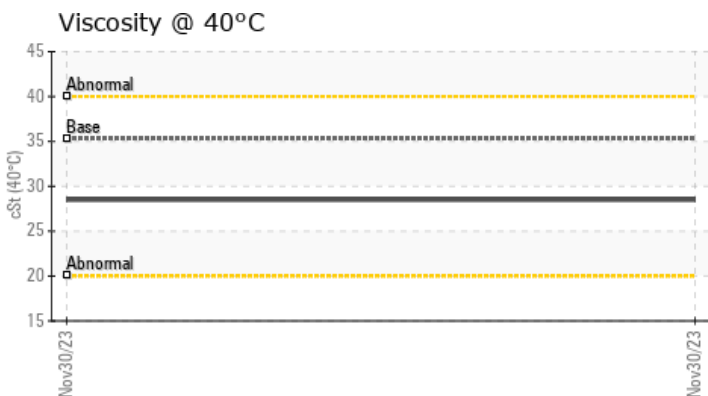
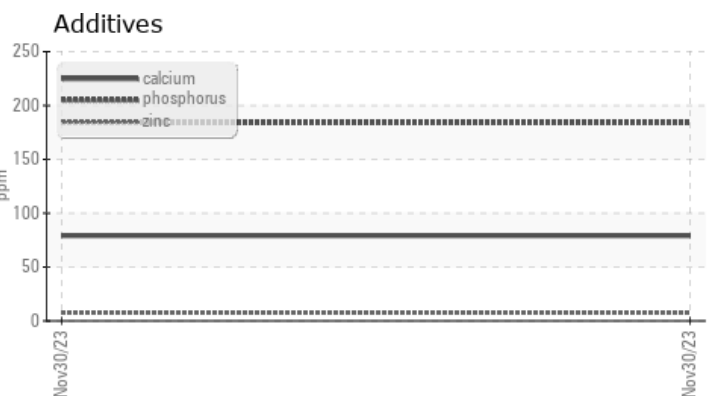
GRAPHS

Confirm the source of the lubricant being utilized for top-up/fill. Resample at the next service interval to monitor. All component wear rates are normal. There is no indication of any contamination in the fluid. Additive levels indicate the addition of a different brand, or type of fluid. The condition of the fluid is acceptable for the time in service.
