## CONSTRUCTION EQUIPMENT ABL TIMBER LTD VOLVO EC220D NOUNITVCP212691 - DIESEL ENGIN

### Sample No: VCP212691

<b>Oil Type:</b> KLONDIKE HEAVY [	OUTY 15W40
-----------------------------------	------------

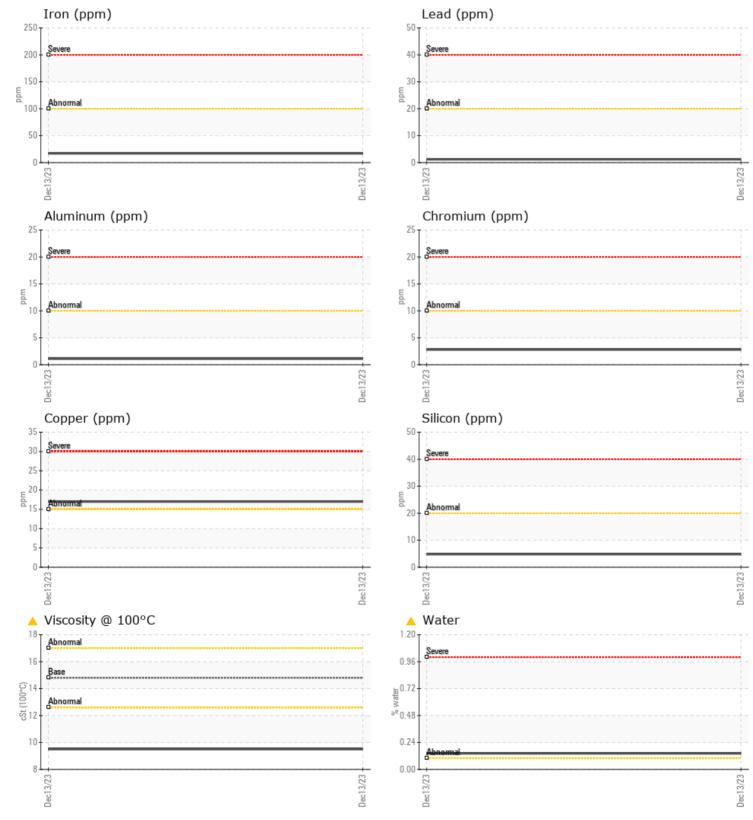
GRAPHS

We advise that you check all areas where contaminants can enter the system. The oil change at the time of sampling has been noted. We recommend an early resample to monitor this condition. No other corrective action is recommended at this time.All component wear rates are normal. Light fuel dilution occurring. There is a trace of moisture present in the oil. Test for glycol is negative. No other contaminants were detected in the oil. Viscosity of sample indicates oil is within SAE 30 range, advise investigate. The oil is no longer serviceable due to the presence of contaminants.
