CONSTRUCTION EQUIPMENT

387685 VOLVO L90H 625351 - DIESEL ENGINE

Sample No: VCP393174
Oil Type: PETRO CANADA 15W40
Job No: 387685

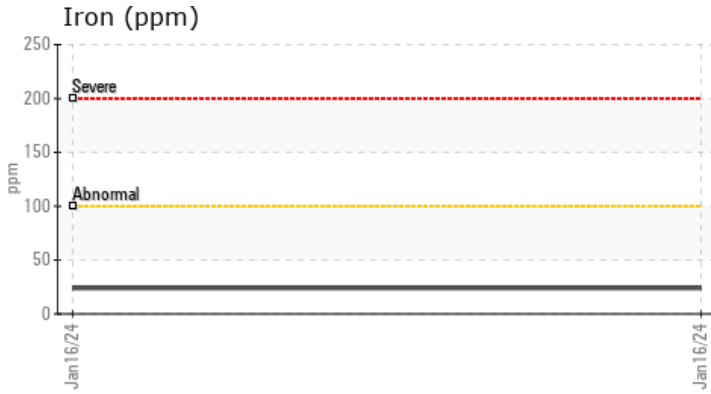
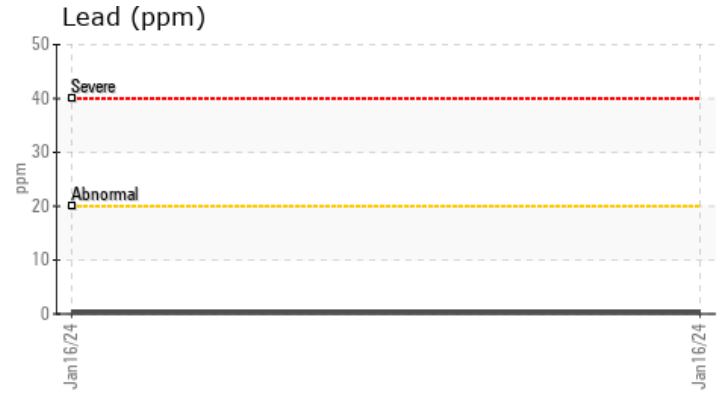
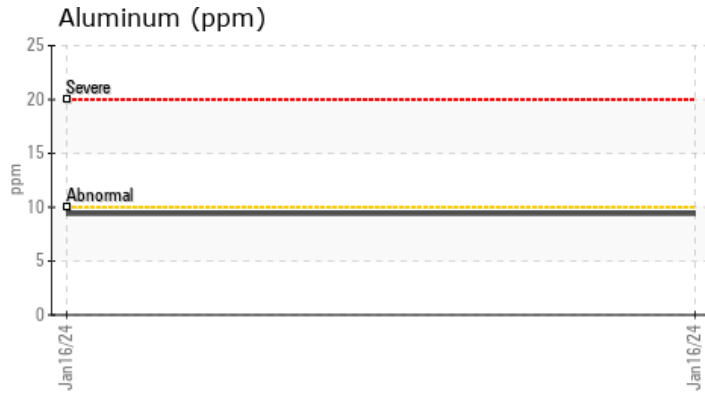
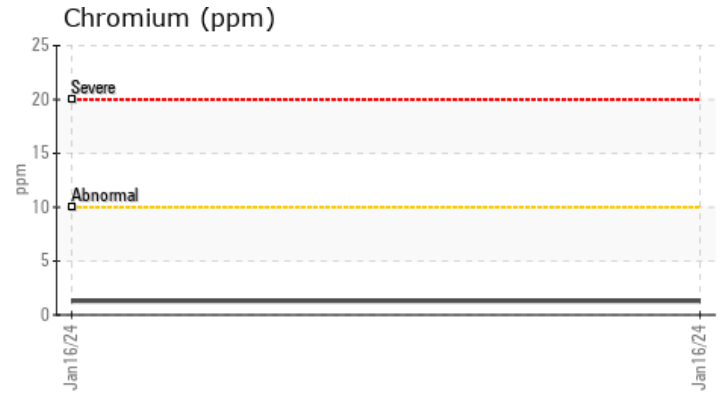
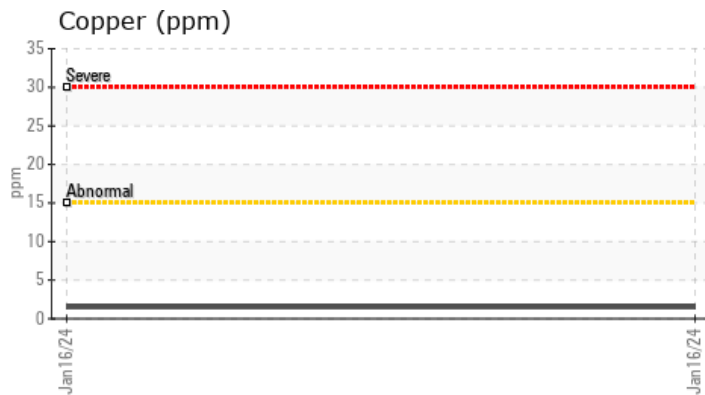
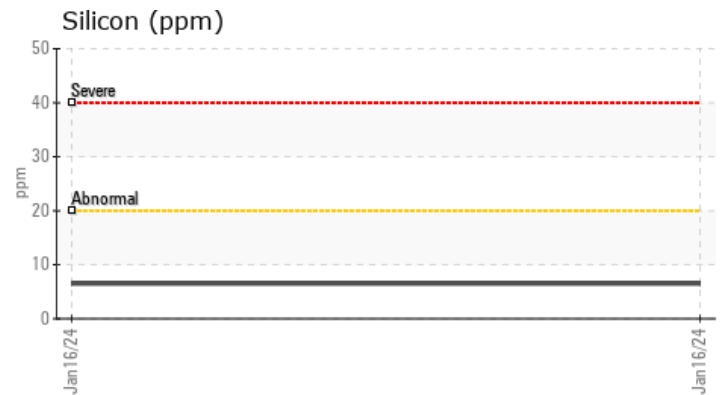
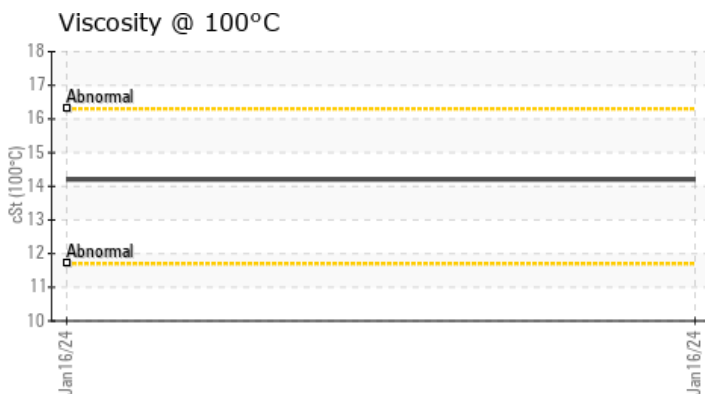
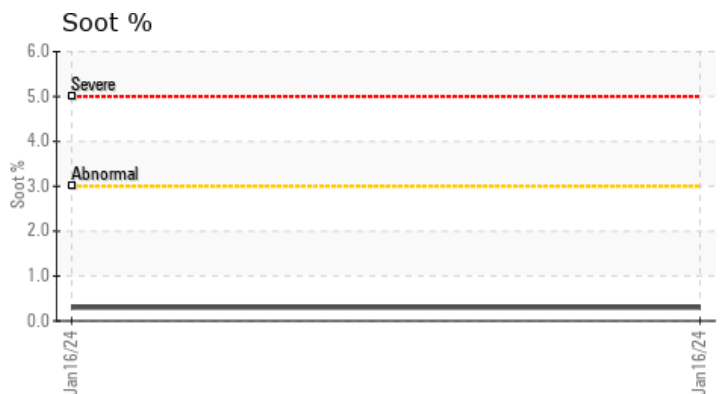
GRAPHS

Échantillonner de nouveau l'équipement au prochain intervalle de vidange afin d'en surveiller la condition. Les taux d'usure de tous les composants sont normaux. Elevated aluminum (Al) and/or lead (Pb) and potassium (K) levels in your metals analysis are likely a result of solder flux release into the lubricant and is common on new equipment/components. Il n'y a aucun indice de contamination dans l'huile. L'état de l'huile est acceptable pour la durée de service.
