# CONSTRUCTION EQUIPMENT

BETON PROVINCIAL 391592 VOLVO L260H 1053 - TRANSMISSION (AUTO)

**Sample No:** VCP392040  
**Oil Type:** VOLVO AT 102  
**Job No:** 391592

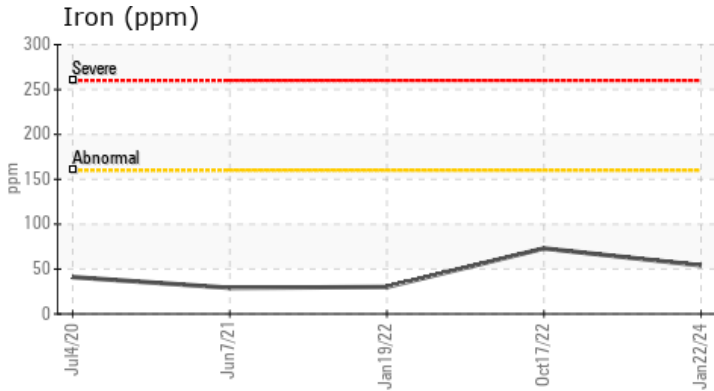
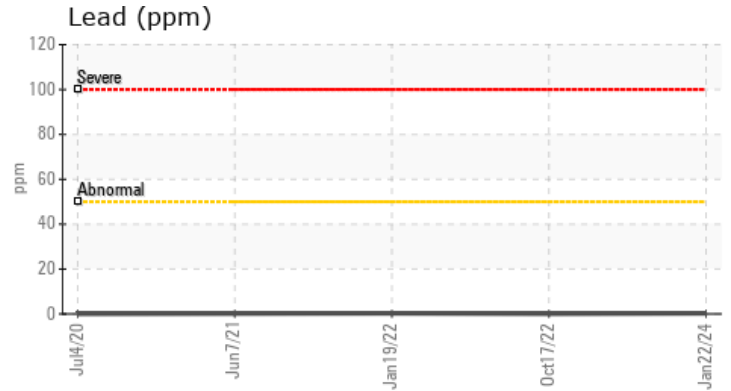
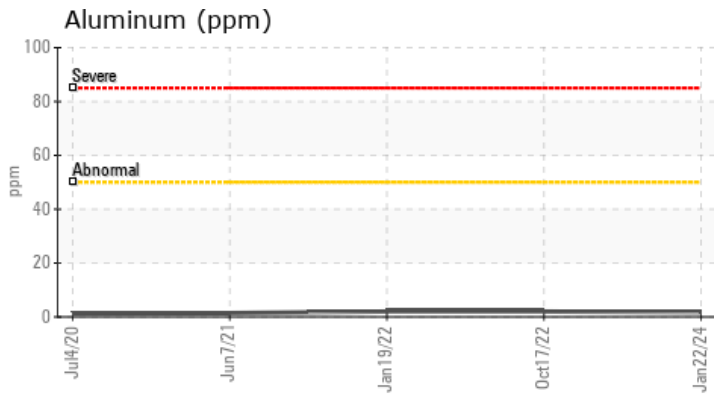
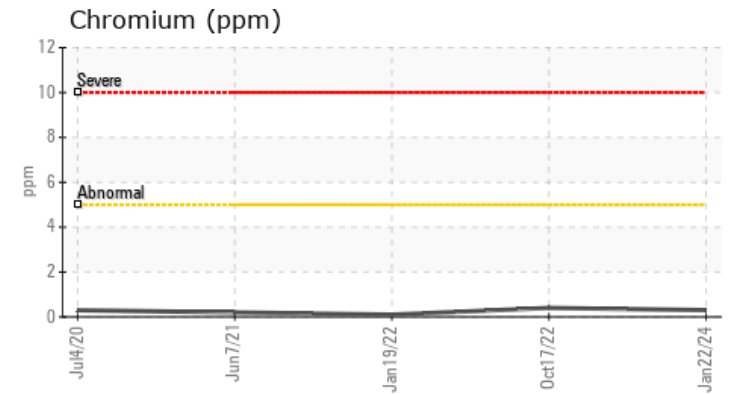
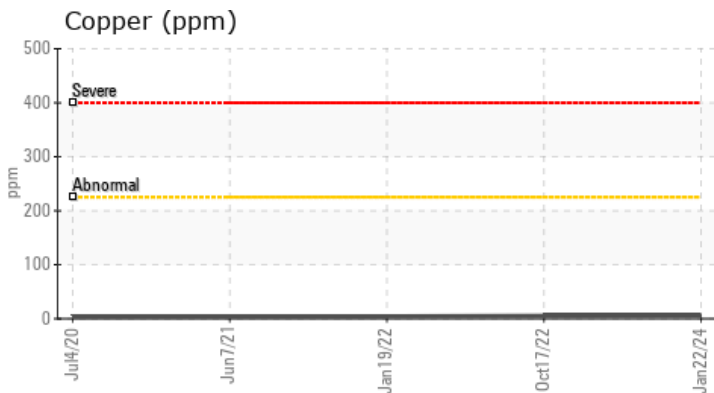
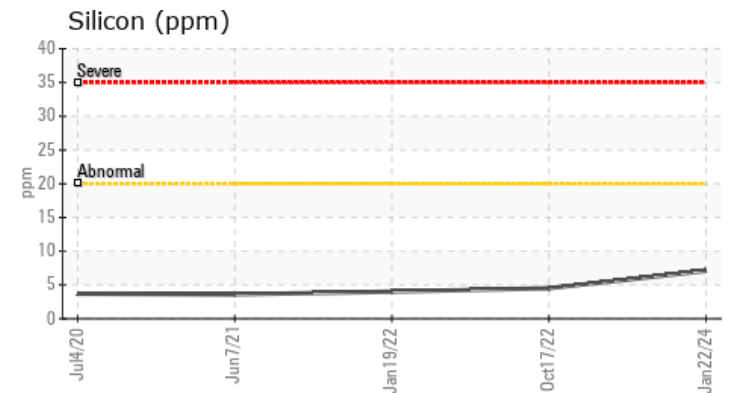
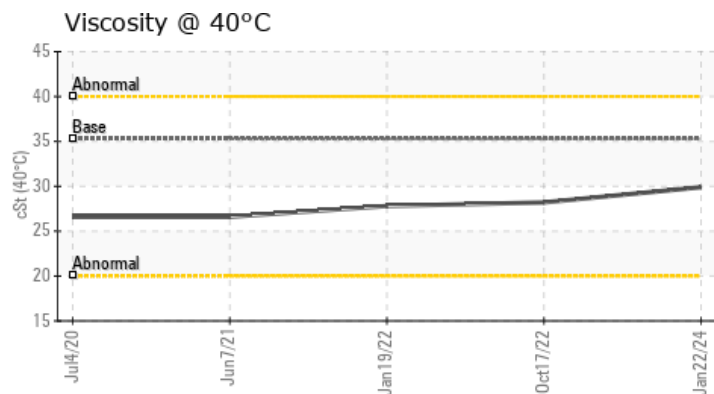
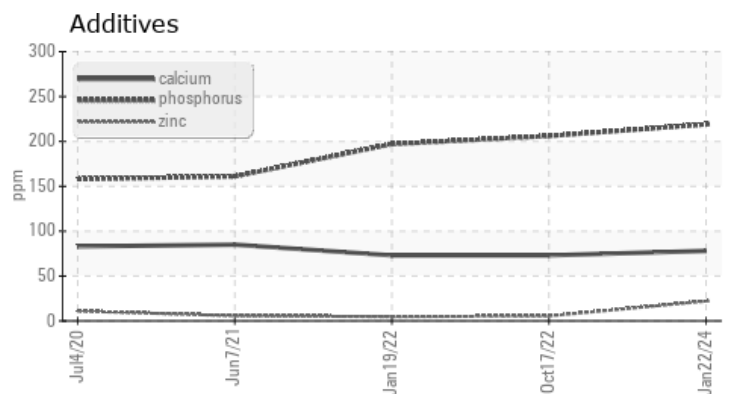
## GRAPHS

Échantillonner de nouveau l'équipement au prochain intervalle de vidange afin d'en surveiller la condition. Les taux d'usure de tous les composants sont normaux. Il n'y a aucun indice de contamination dans le fluide. L'état de le fluide est acceptable pour la durée de service.
