LAFARGE CANADA INC 392278 VOLVO L220H 003543 - TRANSMISSION (AUTO)

Sample No: VCP392079
Oil Type: VOLVO AT 102
Job No: 392278

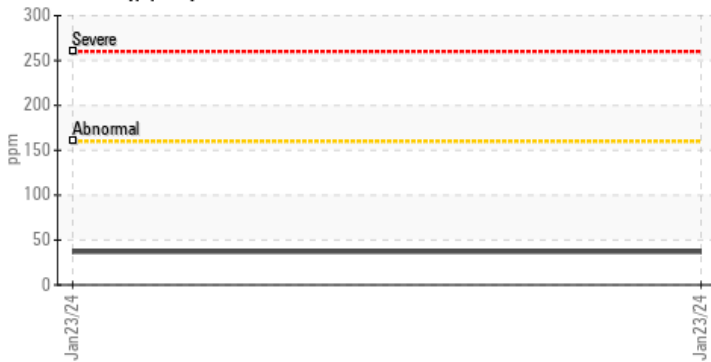
Iron (ppm)

Iron	ppm	█ 37	---	---	---
Copper	ppm	█ 4	---	---	---
Lead	ppm	█ <1	---	---	---
Tin	ppm	█ 0	---	---	---
Aluminum	ppm	█ 1	---	---	---
Chromium	ppm	█ 0	---	---	---
Molybdenum	ppm	█ 0	---	---	---
Nickel	ppm	█ <1	---	---	---
Titanium	ppm	0	---	---	---
Silver	ppm	█ 0	---	---	---
Manganese	ppm	█ 3	---	---	---
Vanadium	ppm	0	---	---	---

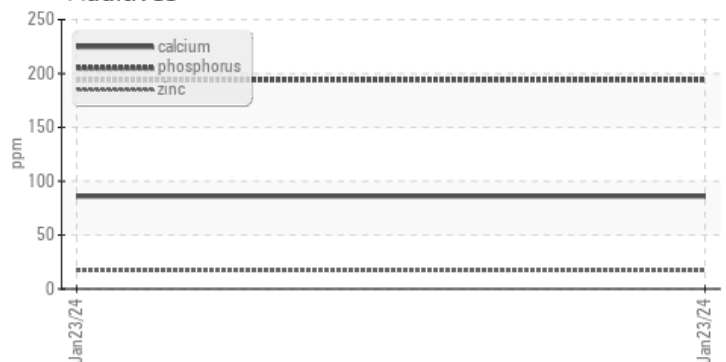
Additives

Calcium	ppm	█ 86	---	---	---
Magnesium	ppm	█ 1	---	---	---
Zinc	ppm	17	---	---	---
Phosphorus	ppm	█ 194	---	---	---
Barium	ppm	█ 4	---	---	---
Boron	ppm	█ 74	---	---	---
