# CONSTRUCTION EQUIPMENT

IMPACT AUTO 8-395951 VOLVO L-90-H 624436 - DIESEL ENGINE

**Sample No:** VCP449306  
**Oil Type:** DIESEL ENGINE OIL SAE 15W40  
**Job No:** 8-395951

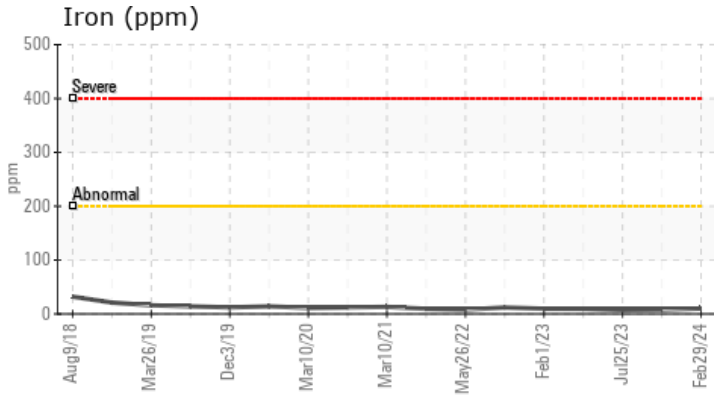
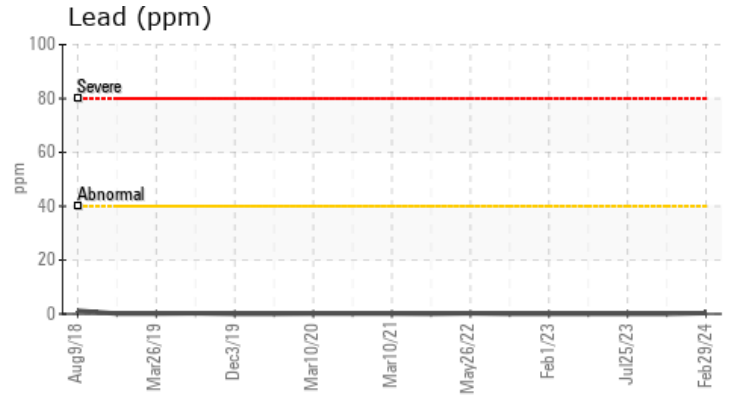
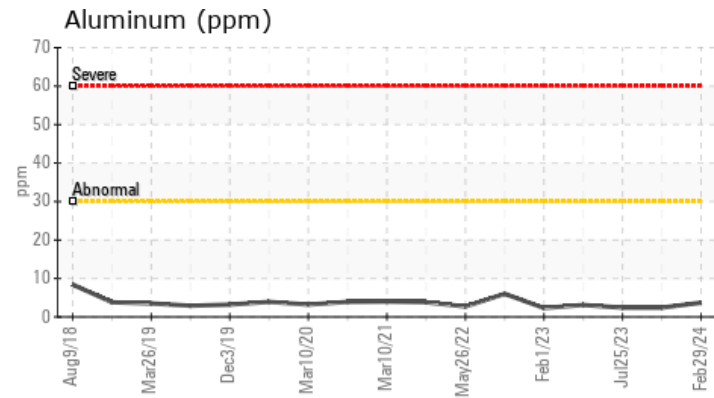
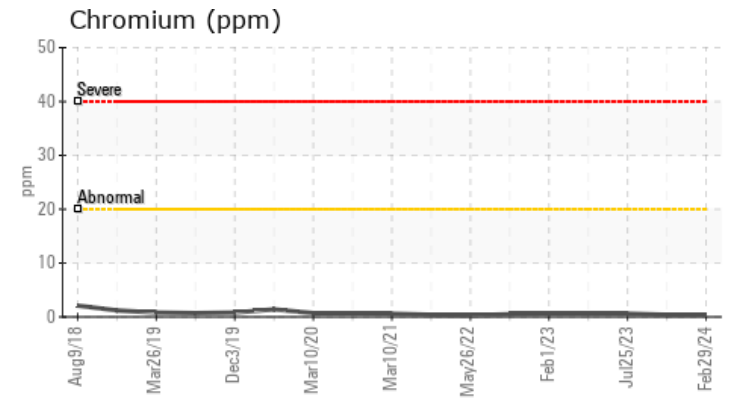
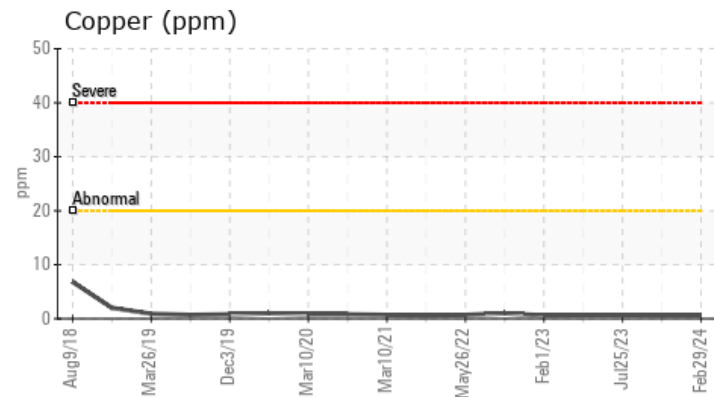
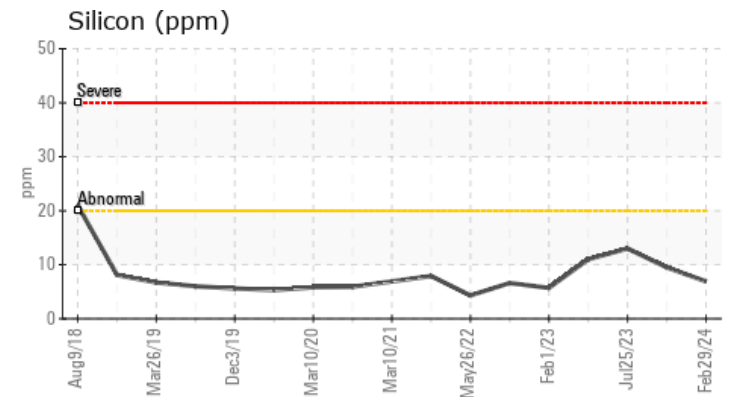
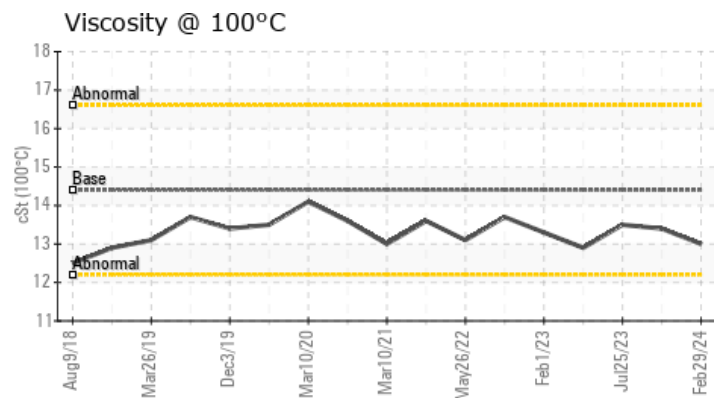
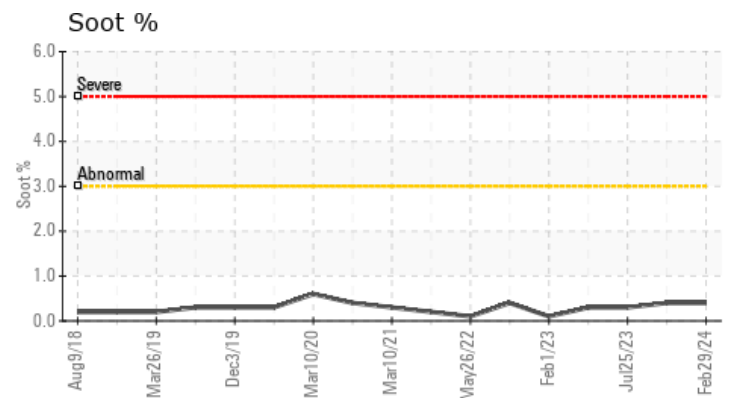
## VOLVO GRAPHS

Resample at the next service interval to monitor. All component wear rates are normal. There is no indication of any contamination in the oil. The condition of the oil is acceptable for the time in service.
