# CONSTRUCTION EQUIPMENT

8000398340 VOLVO EC220EL 310956 - HYDRAULIC SYSTEM

**Sample No:** VCP392187  
**Oil Type:** VOLVO SUPER HYDRAULIC OIL 46  
**Job No:** 8000398340

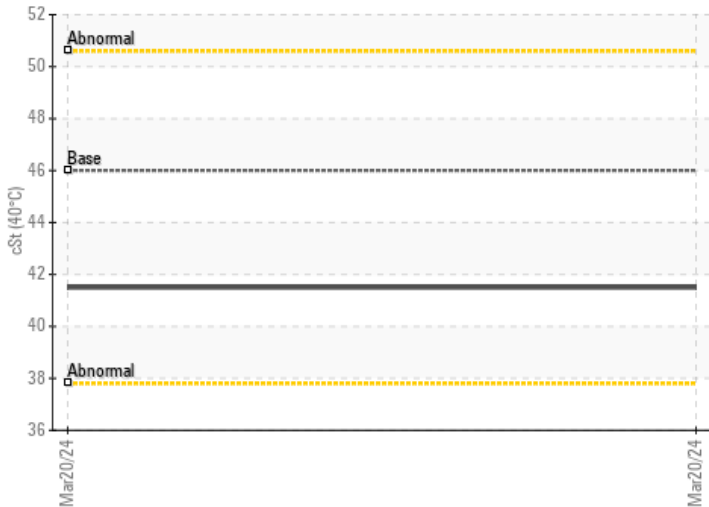
### Viscosity @ 40°C

Visc @ 40°C	cSt	█41.5	---	---	---
-------------	-----	-------	-----	-----	-----

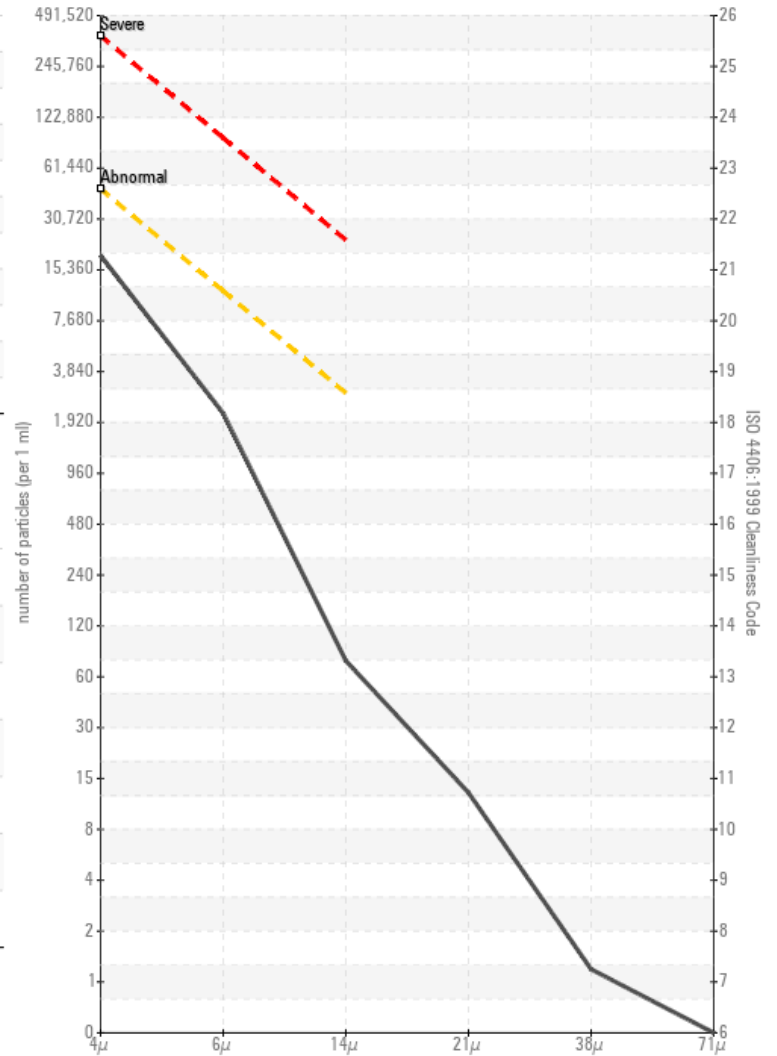
### Particle Count

Water	%	NEG	---	---	---
Particles >4µm		█16206	---	---	---
Particles >6µm		█1904	---	---	---
Particles >14µm		█66	---	---	---
ISO 4406:1999 (c)		21/18/13	---	---	---
Silicon	ppm	█4	---	---	---
Sodium	ppm	█1	---	---	---
Potassium	ppm	█<1	---	---	---

Resample at the next service interval to monitor. All component wear rates are normal. The system cleanliness is acceptable for your target ISO 4406 cleanliness code. The system and fluid cleanliness is acceptable. The condition of the oil is acceptable for the time in service.
