# CONSTRUCTION EQUIPMENT

## VOLVO A25E 73007 - REAR LEFT FINAL DRIVE

**Sample No:** VCE229274  
**Oil Type:** SAE 85W140  
**Job No:**

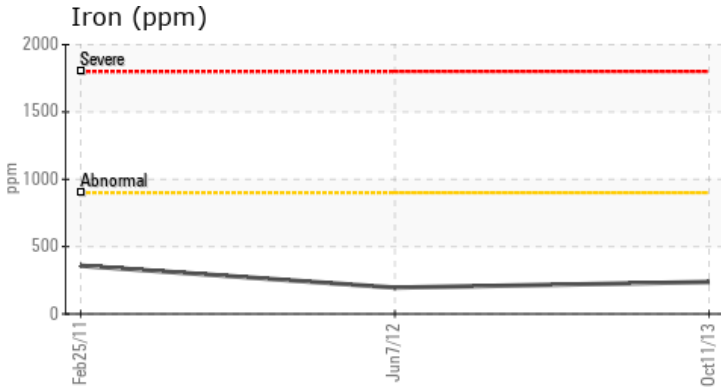
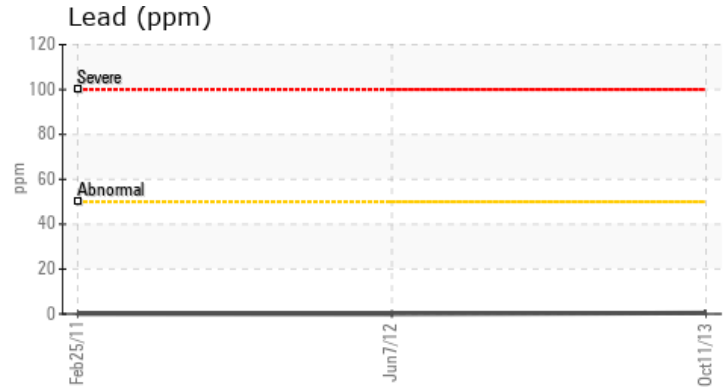
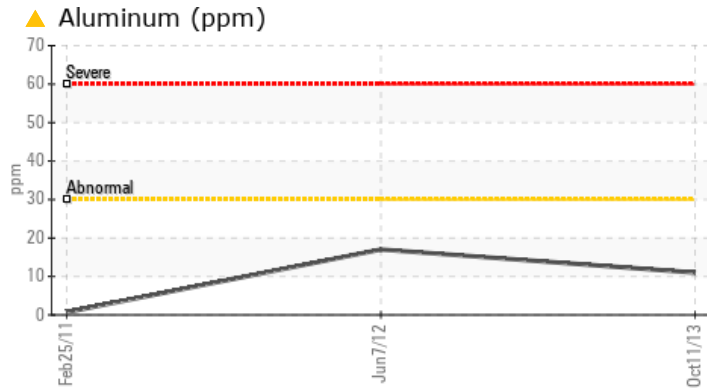
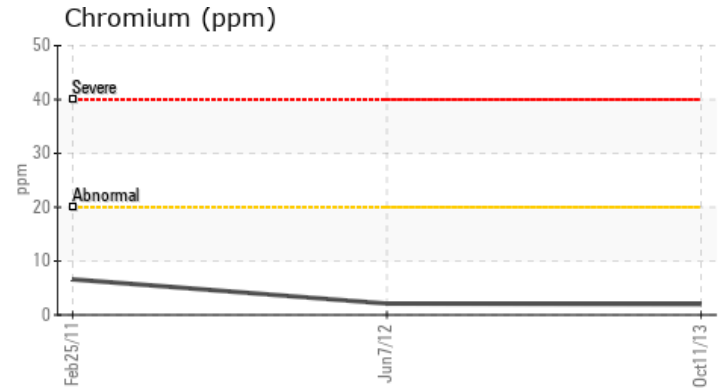
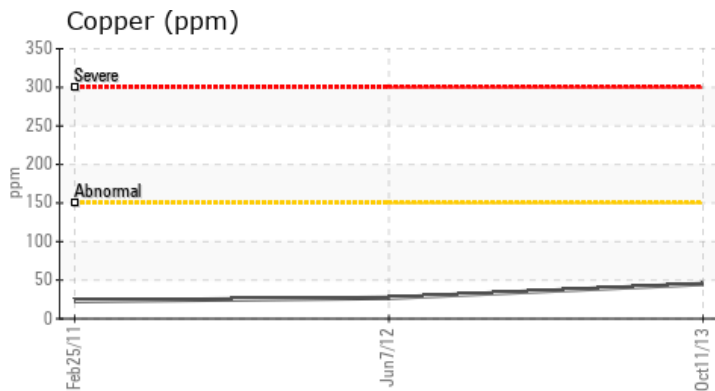
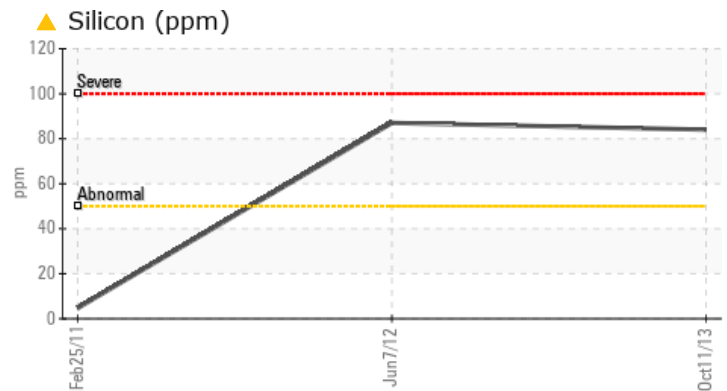
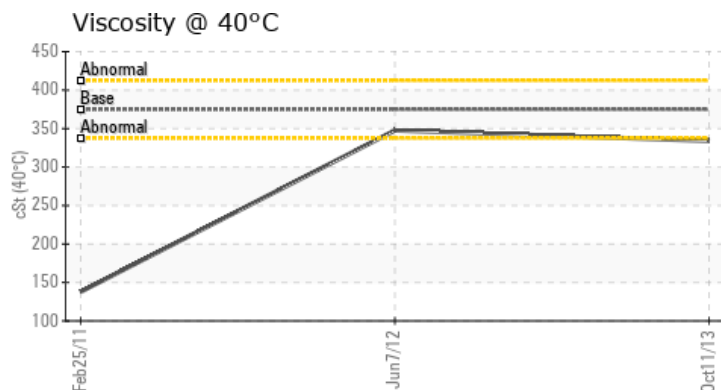
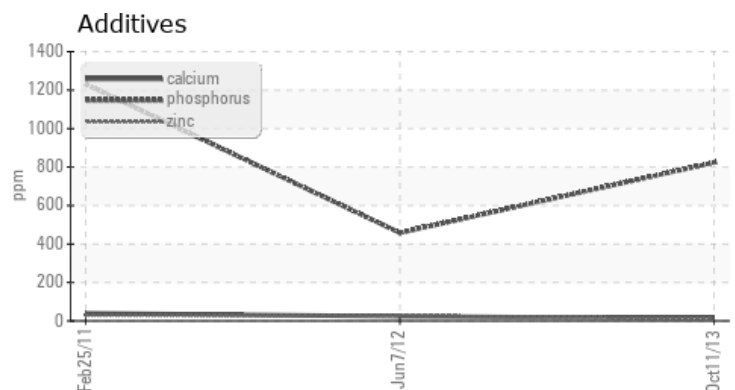
## GRAPHS

We advise that you check all areas where dirt can enter the system. The oil change at the time of sampling has been noted. Resample at the next service interval to monitor. Moderate concentration of visible metal present. All component wear rates are normal. There is a moderate amount of visible silt present in the sample. Elemental levels of silicon (Si) and aluminum (Al) indicate alumina-silicate (coarse dirt) ingress. The condition of the oil is acceptable for the time in service.
