# CONSTRUCTION EQUIPMENT

## HORST EXCAVATING VOLVO EC460CL 110503 - REAR LEFT FINAL DRIVE

**Sample No:** VCP148653  
**Oil Type:** VOLVO PREMIUM GEAR OIL 85W-140 GL-5  
**Job No:** HORST EXCAVATING

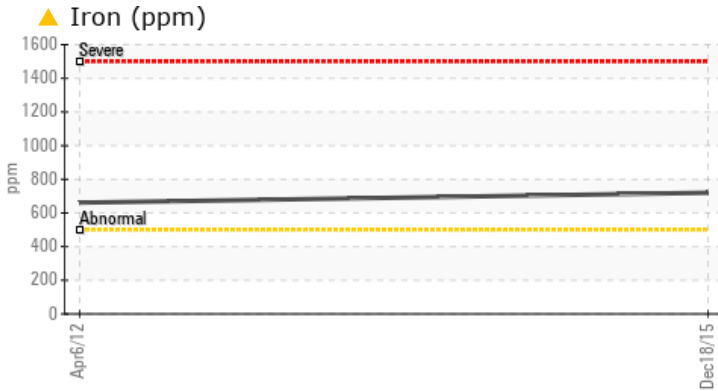
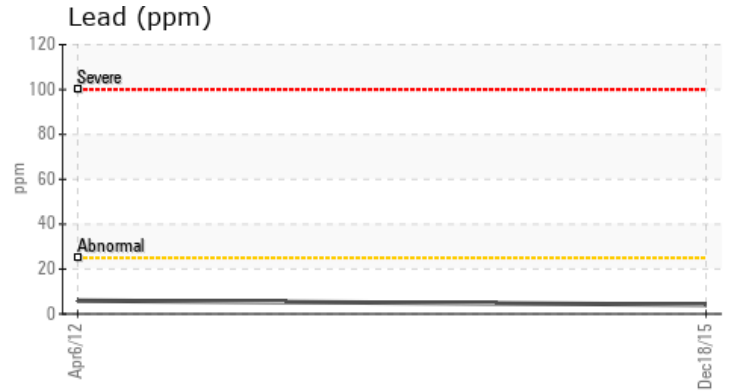
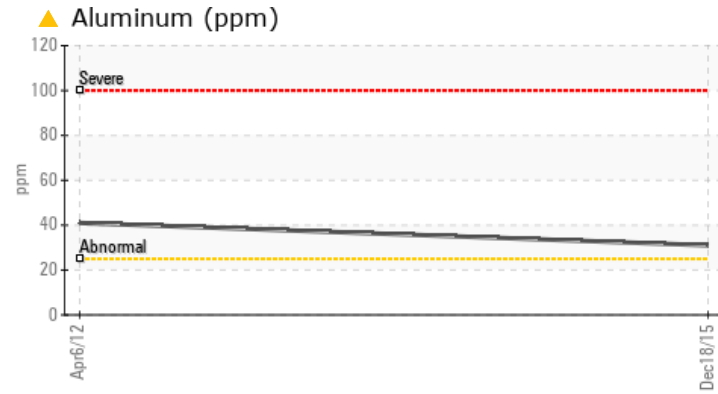
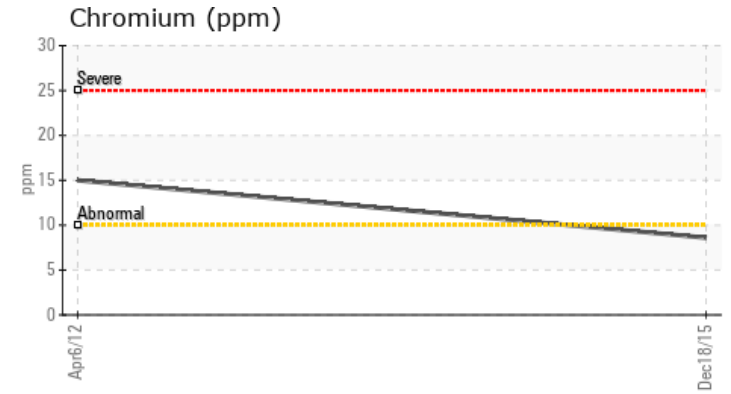
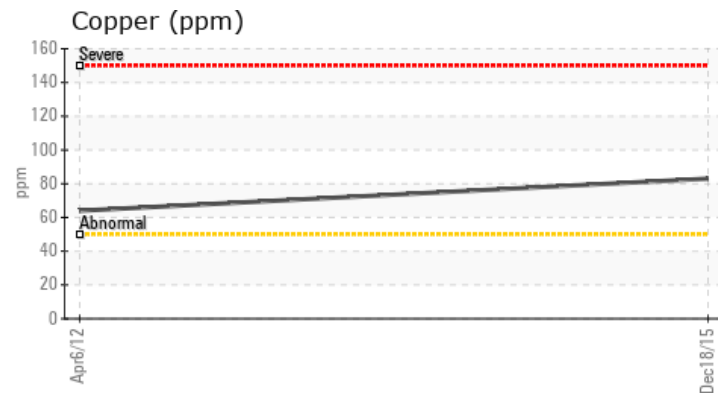
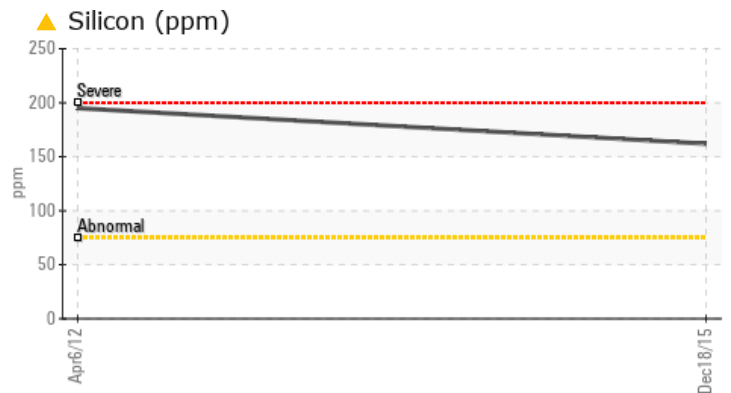
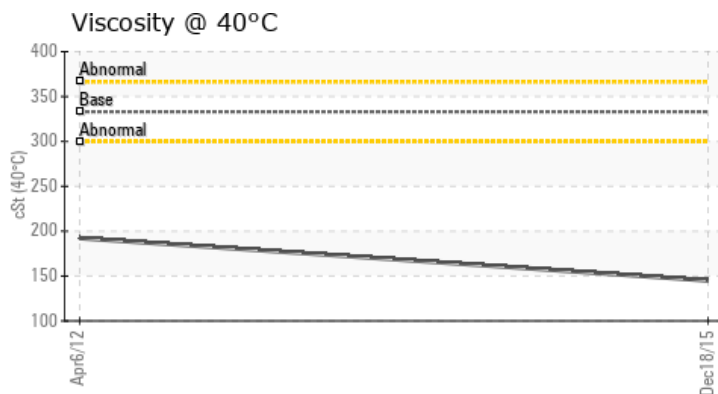
## GRAPHS

We advise that you check all areas where dirt can enter the system. Resample at the next service interval to monitor. Moderate concentration of visible metal present. Gear wear is indicated. Elemental levels of silicon (Si) and aluminum (Al) indicate alumina-silicate (coarse dirt) ingress. The condition of the oil is acceptable for the time in service.
