CONSTRUCTION EQUIPMENT 315965 VOLVO A45G 352661 - TRANSMISSION (AUTO)

Sample No: VCP312107

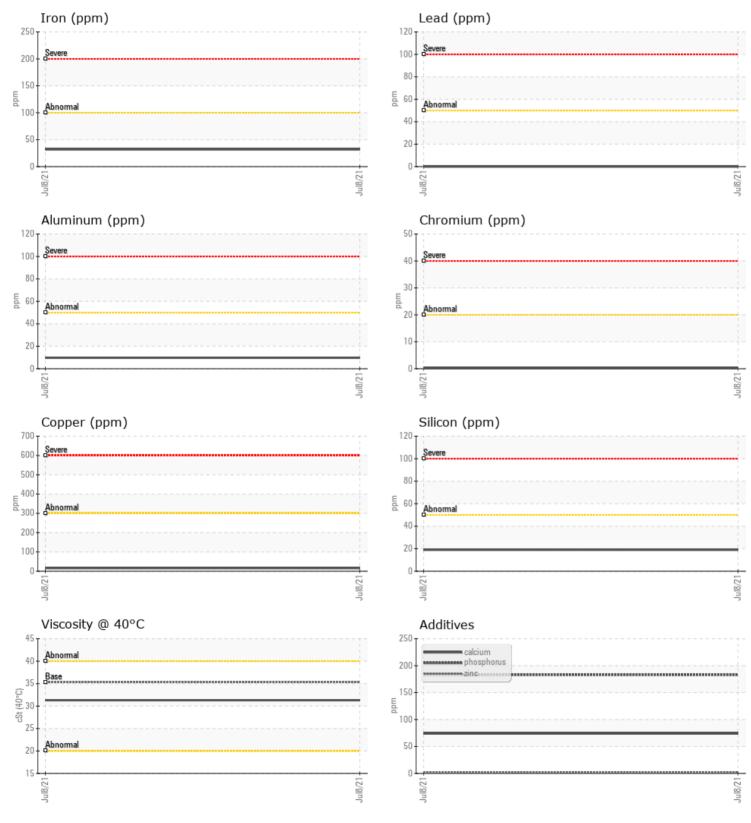
GRAPHS

E INFORMATION					
Sample Number		VCP312107				
Sample Date		08 Jul 2021				
Machine Hours		398				4030 EAST TRENT AVENUE
Oil Hours		398				SPOKANE, WA
Oil Changed		N/A				US 99202
Sample Status		NORMAL				Contact: SAM SICILIA
VOLVO						ssicilia@pacwestmachinery.com
OIL CON	IDITION					T: (509)954-5973 F: (509)534-5286
Visc @ 40°C	cSt	31.3				F: (509)534-5286
VOLVO						Diagnosis
	MINATION					Resample at the next service interval
Silicon	ppm	1 9				to monitor.All component wear rates
Sodium	ppm	4				are normal. There is no indication of
Potassium	ppm	3				any contamination in the fluid. The condition of the fluid is acceptable
WEAR I	METALS					for the time in service.
Iron	ppm	32				
Copper	ppm	16				
Lead	ppm	0				
Tin	ppm	3				
Aluminum	ppm	1 0				
Chromium	ppm					
Molybdenum	ppm	□ <1				
Nickel	ppm	2				
Titanium	ppm	0				
Silver	ppm	0				
Manganese	ppm	4				
Vanadium	ppm	0				
VOLVO	VES					
ADDITI	VE2	<u>.</u>	<u> </u>	<u>.</u>	<u>.</u>

Calcium	ppm	74				
Magnesium	ppm	2				
Zinc	ppm	2				
Phosphorus	ppm	183				
Barium	ppm	0				
Boron	ppm	95
