CONSTRUCTION EQUIPMENT554566 APTIM VOLVO A35G 340238 - COOLANT

Sample No: VCP424864

Job No: 554566 APTIM

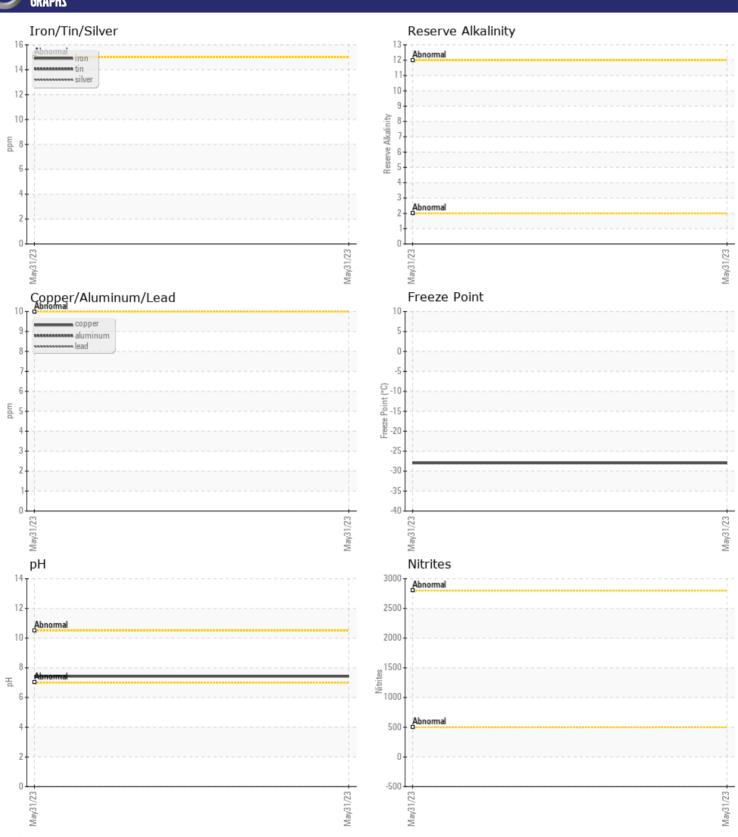
GRAPHS

SAMPLE II	NFORMATION				
Sample Number	-	VCP424864			
Sample Date		31 May 2023			
Machine Hours		8953			
Sample Status		NORMAL			
COOLANT CONDITION					
рН	Scale 0-14	7.42			
Reserve Alkalinity	Scale 0-20				
Nitrites	ppm	■ NT			
Percentage Glycol	%	47.0			
Freezing Point	°C	-28			
CONTAMIN	NATION				
Coolant Appearance		normal			
Coolant Color		Yllow

No corrective action is recommended at this time. The fluid is suitable for further service. There is no indication of any contamination in the coolant. Carboxylate test failed. The glycol level is acceptable. The pH level of this fluid is within the acceptable limits.
