# CONSTRUCTION EQUIPMENT

## VOLVO IPS 1 3194008190 - TRANSMISSION (MANUAL)

**Sample No:** VCP405470  
**Oil Type:** VOLVO API GL-5 SAE 75W90  
**Job No:**

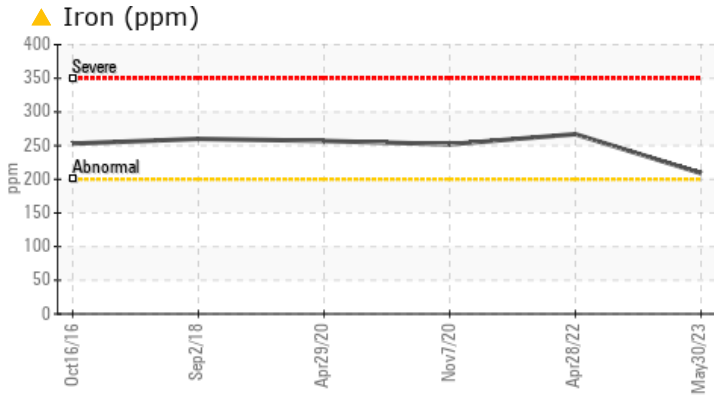
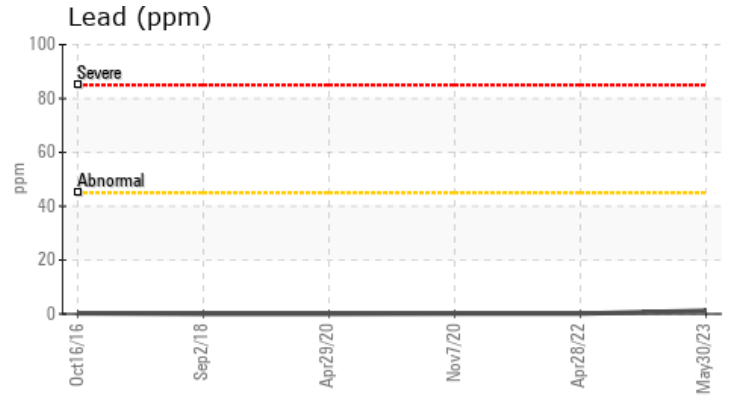
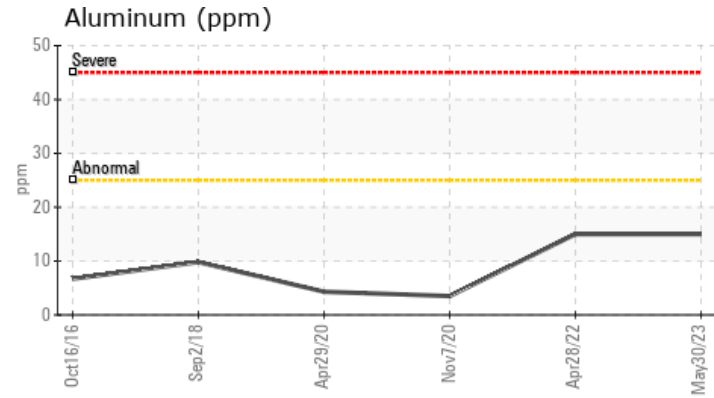
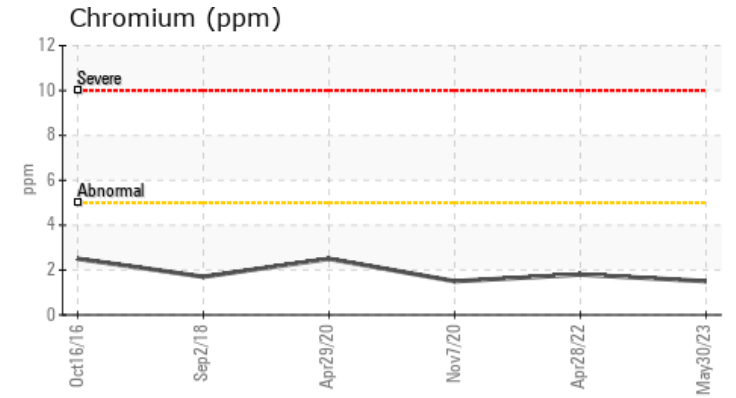
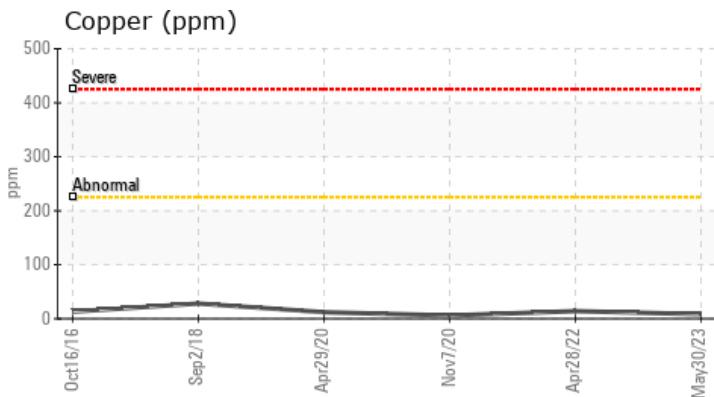
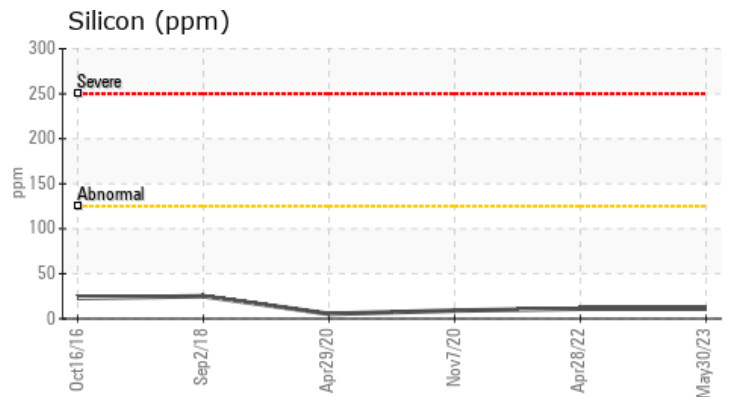
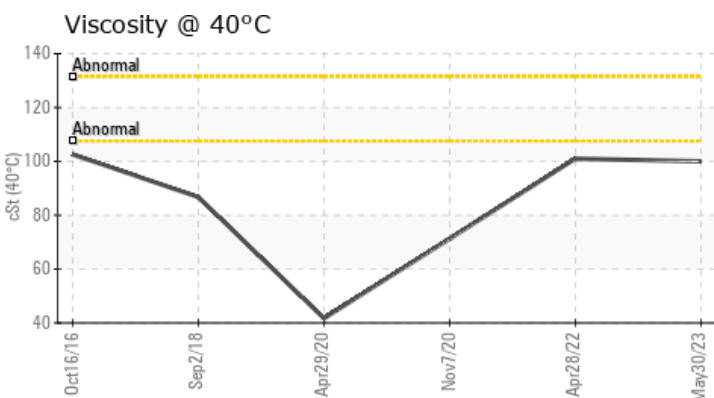
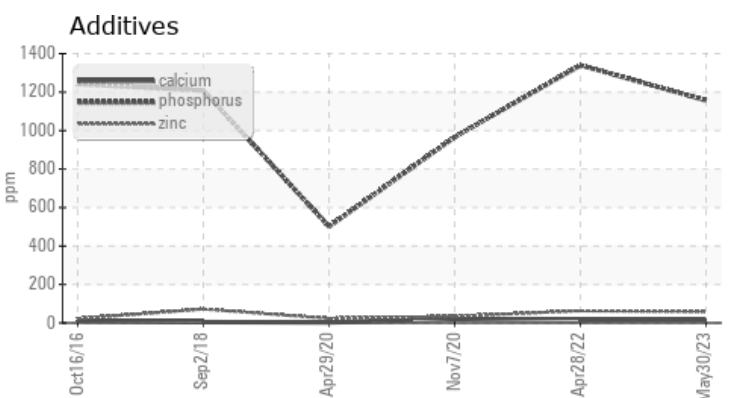
## VOLVO GRAPHS

The fluid change at the time of sampling has been noted. Resample at the next service interval to monitor. Gear wear is indicated. There is no indication of any contamination in the fluid. The condition of the fluid is acceptable for the time in service.
