# CONSTRUCTION EQUIPMENT

## VOLVO L70H 62421 - TRANSMISSION

**Sample No:** VCP416570

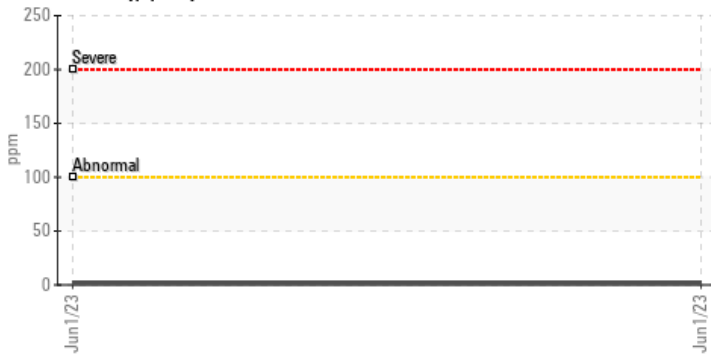
### Iron (ppm)

Iron	ppm	█ 2	---	---	---
Copper	ppm	█ 0	---	---	---
Lead	ppm	█ 0	---	---	---
Tin	ppm	█ 0	---	---	---
Aluminum	ppm	█ 0	---	---	---
Chromium	ppm	█ 0	---	---	---
Molybdenum	ppm	<1	---	---	---
Nickel	ppm	█ <1	---	---	---
Titanium	ppm	0	---	---	---
Silver	ppm	0	---	---	---
Manganese	ppm	<1	---	---	---
Vanadium	ppm	0	---	---	---

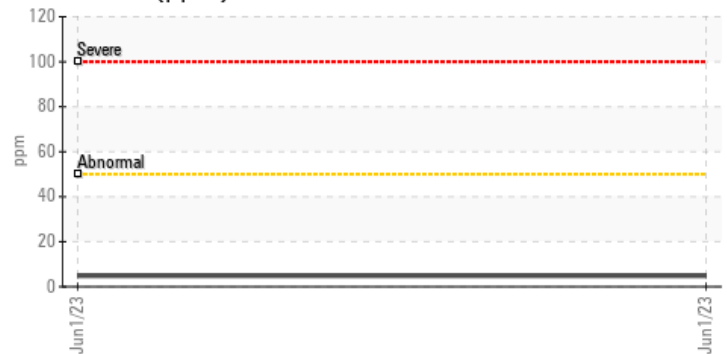
### Silicon (ppm)

Silicon	ppm	█ 5	---	---	---
Sodium	ppm	█ <1	---	---	---
Potassium	ppm	█ <1	---	---	---

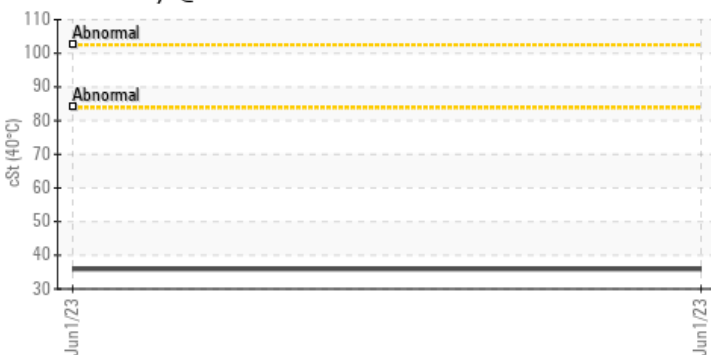
### Viscosity @ 40°C

Visc @ 40°C	cSt	█ 35.9	---	---	---
-------------	-----	--------	-----	-----	-----

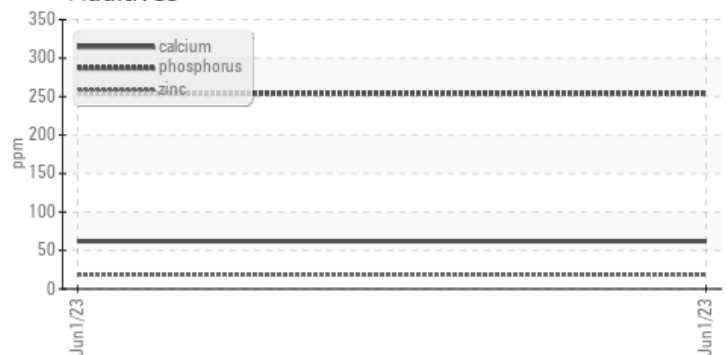
### Additives

Calcium	ppm	62	---	---	---
Magnesium	ppm	2	---	---	---
Zinc	ppm	18	---	---	---
Phosphorus	ppm	254	---	---	---
Barium	ppm	0	---	---	---
Boron	ppm	118	---	---	---
