CONSTRUCTION EQUIPMENT

A10574 VOLVO A30D 74083 - REAR AXLE

Sample No: VCP425512
Oil Type: MOBIL MOBILUBE HD 80W90
Job No: A10574

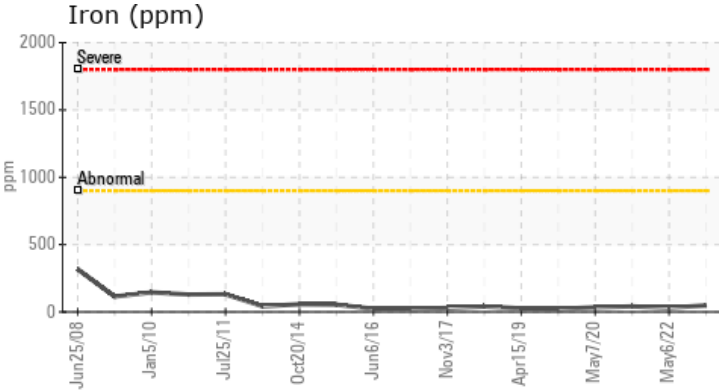
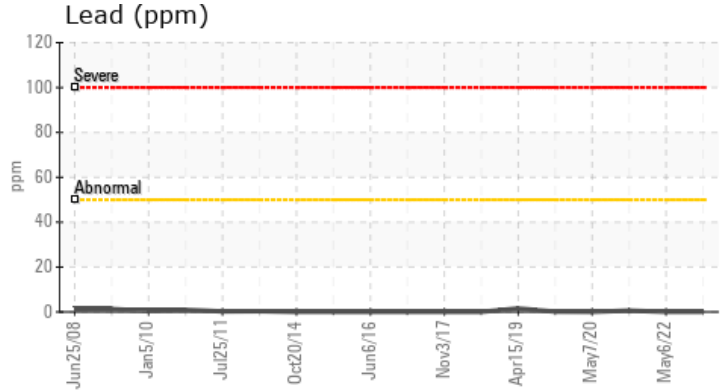
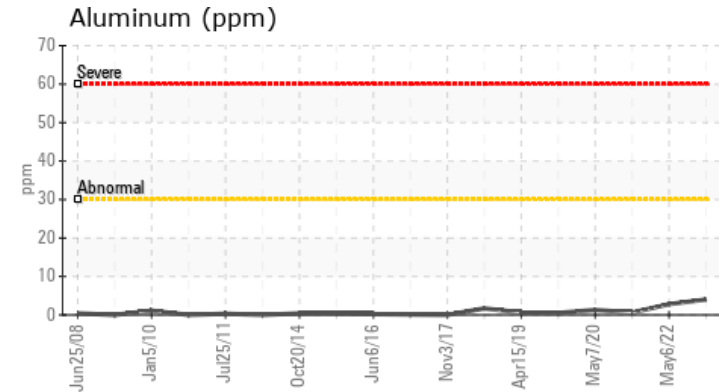
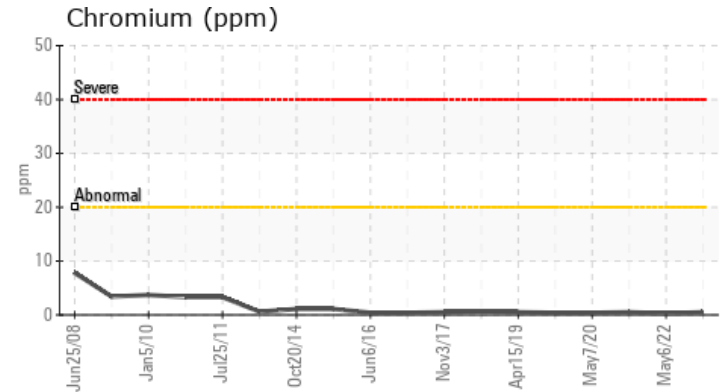
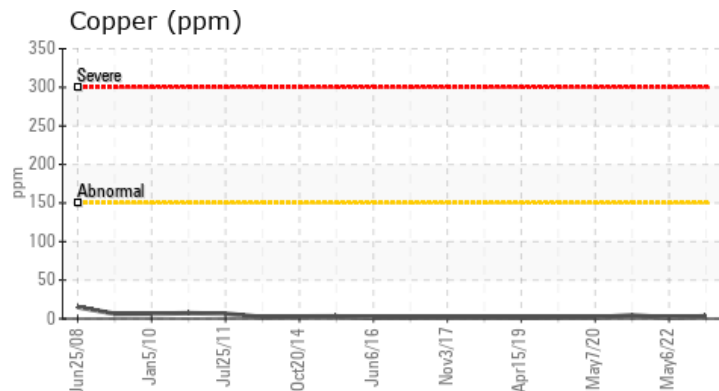
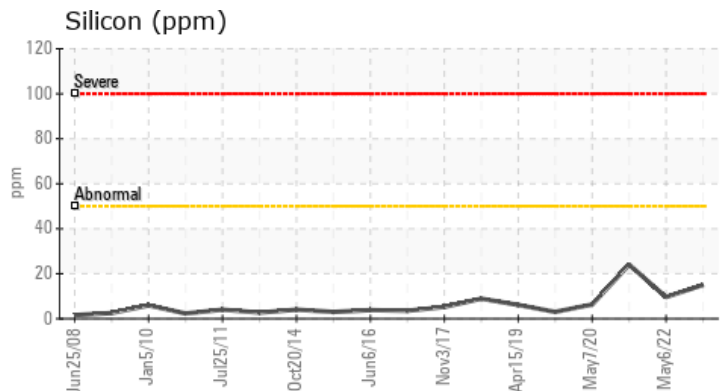
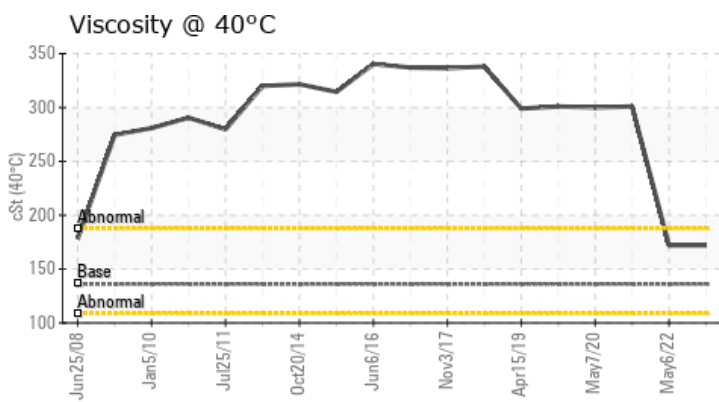
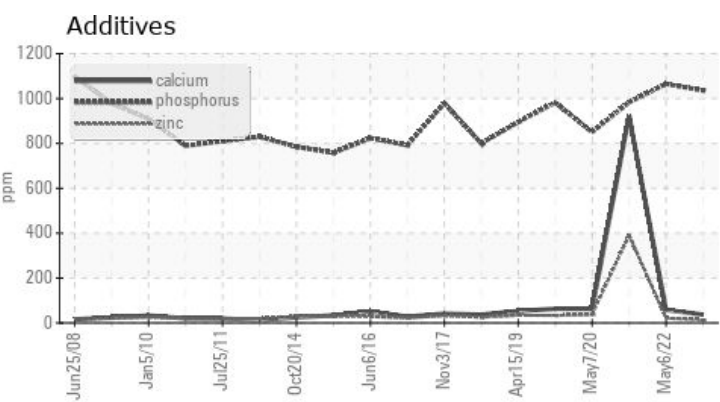
GRAPHS

Resample at the next service interval to monitor. All component wear rates are normal. There is no indication of any contamination in the oil. The condition of the oil is acceptable for the time in service.
