CONSTRUCTION EQUIPMENT

A10573 VOLVO A35D 72130 - TRANSMISSION (AUTO)

Sample No: VCP408976
Oil Type: MOBIL AT 102
Job No: A10573

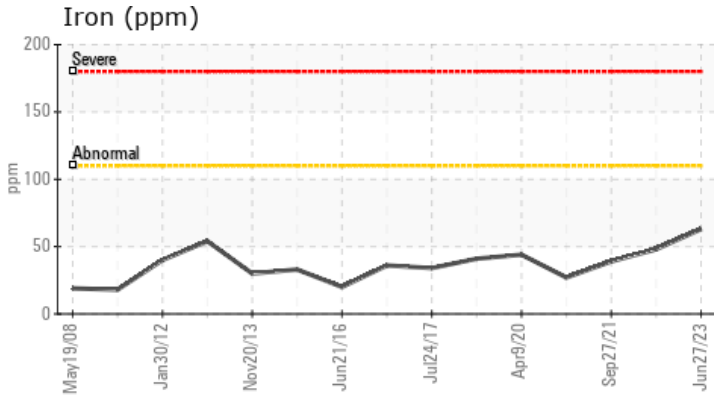
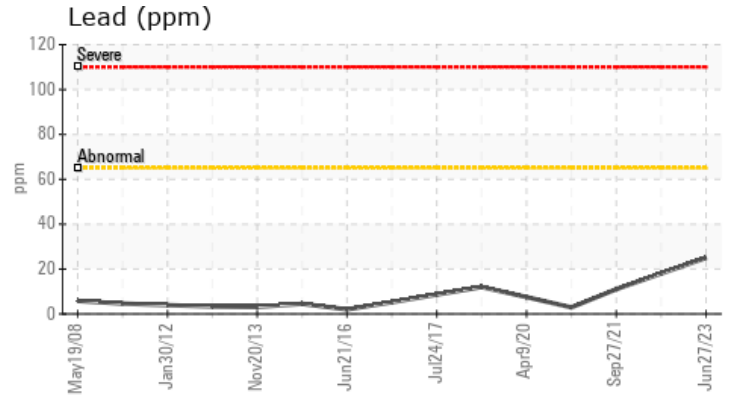
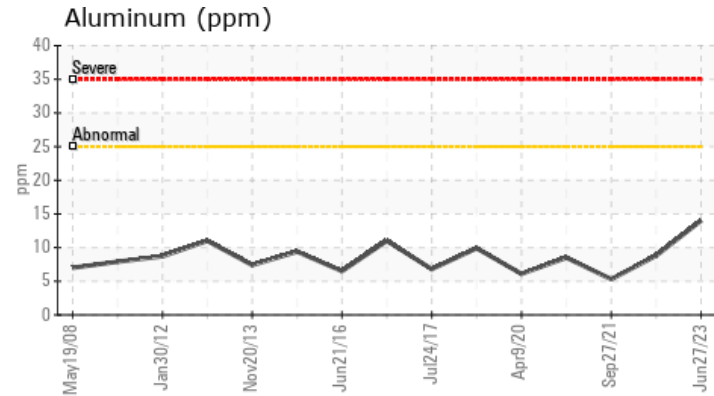
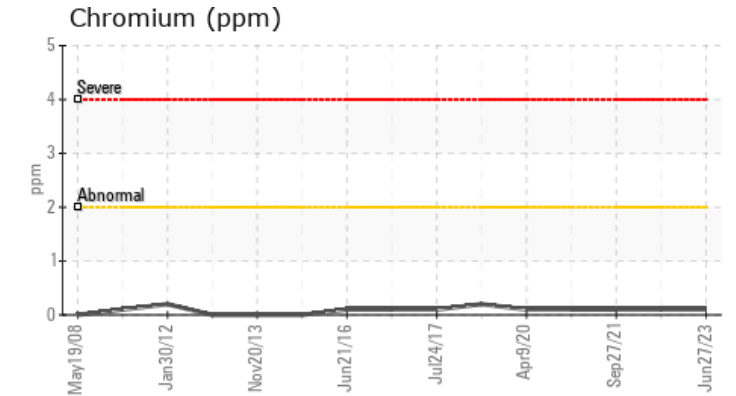
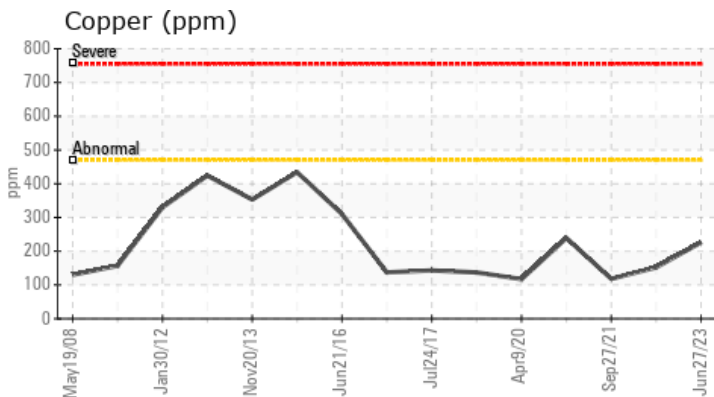
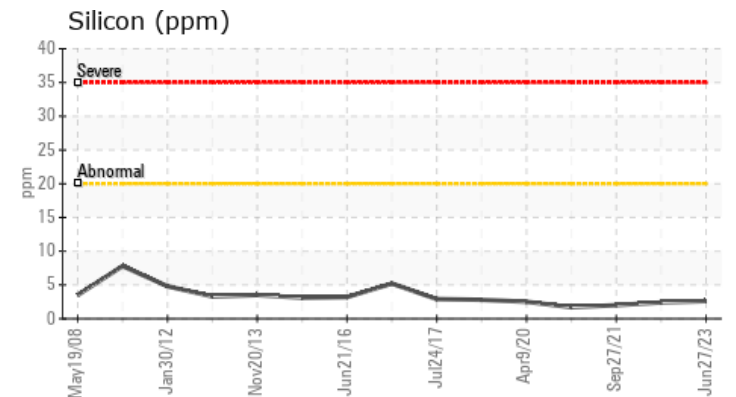
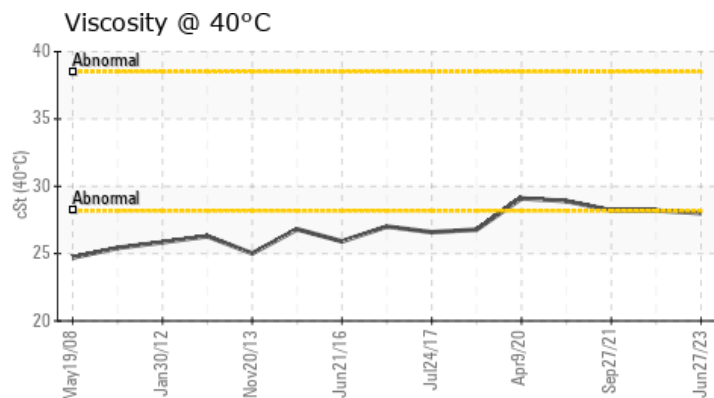
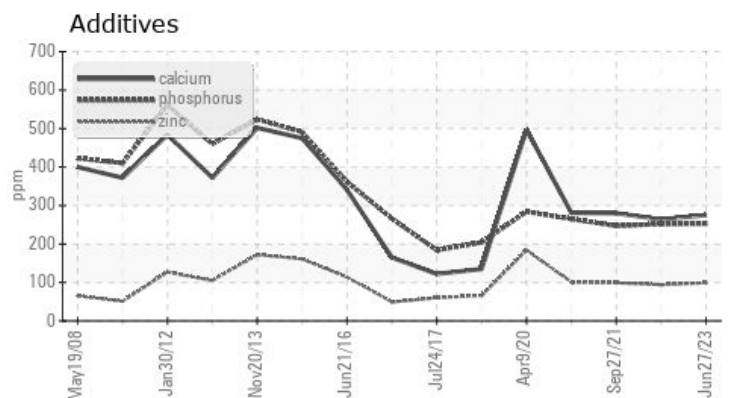
VOLVO GRAPHS

Diagnosis
Resample at the next service interval to monitor. All component wear rates are normal. There is no indication of any contamination in the fluid. The condition of the fluid is acceptable for the time in service.
