CONSTRUCTION EQUIPMENT

VOLVO L90H 624818 - DIESEL ENGINE

Sample No: VCP415939
Oil Type: VOLVO ULTRA DIESEL ENGINE OIL 15W40 VDS-3
Job No:

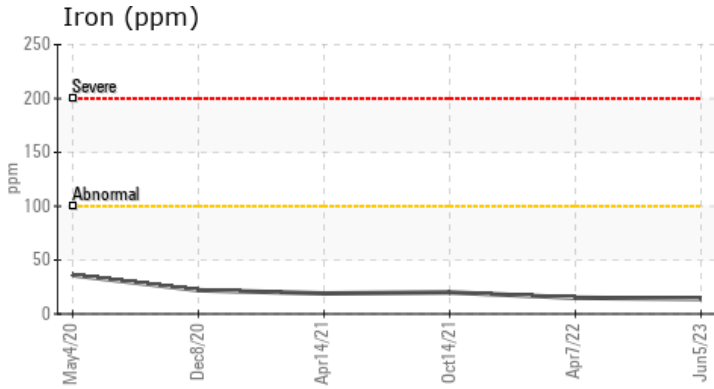
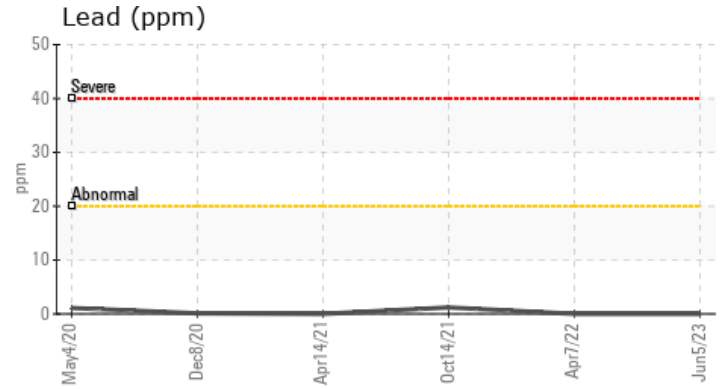
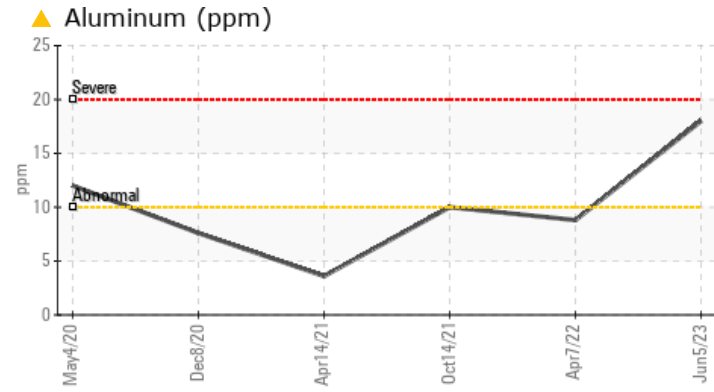
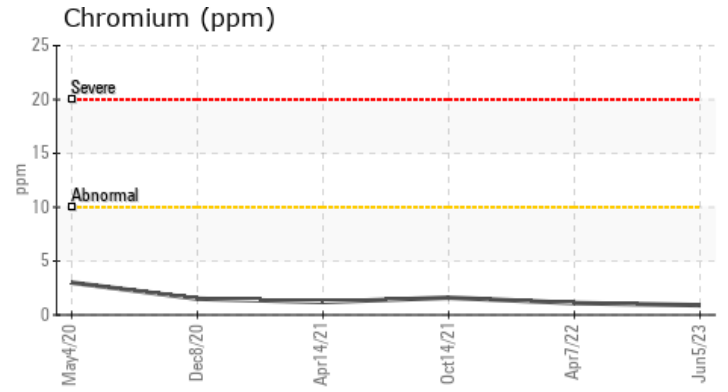
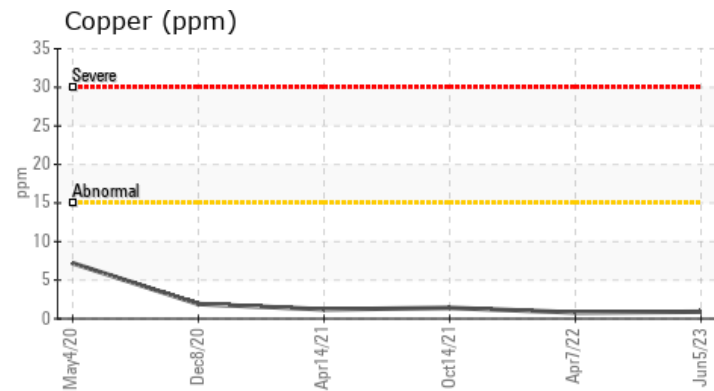
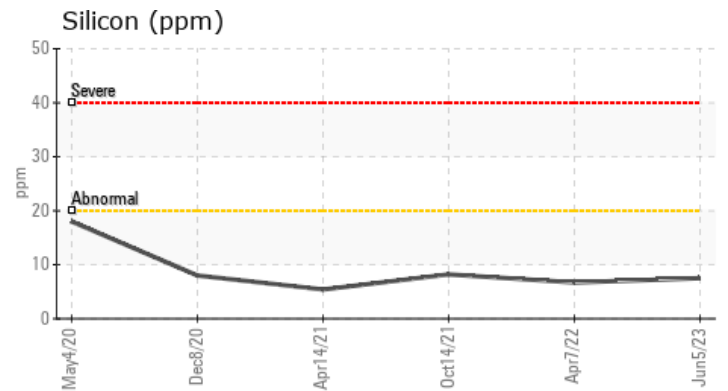
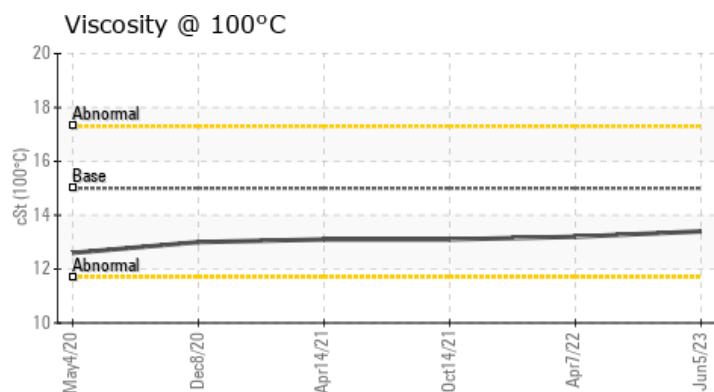
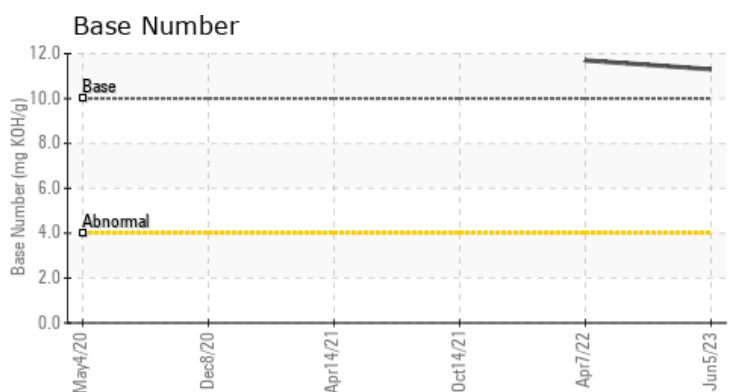
GRAPHS

Oil and filter change at the time of sampling has been noted. No corrective action is recommended at this time. Resample at the next service interval to monitor. The aluminum level is abnormal. All other component wear rates are normal. There is no indication of any contamination in the oil. The BN result indicates that there is suitable alkalinity remaining in the oil. The condition of the oil is suitable for further service.
