# CONSTRUCTION EQUIPMENT

19069 OMNISOURCE SENNEBOGEN 830E 83003546 - FRONT AXLE

**Sample No:** VCP417562  
**Oil Type:** NOT GIVEN  
**Job No:** 19069 OMNISOURCE

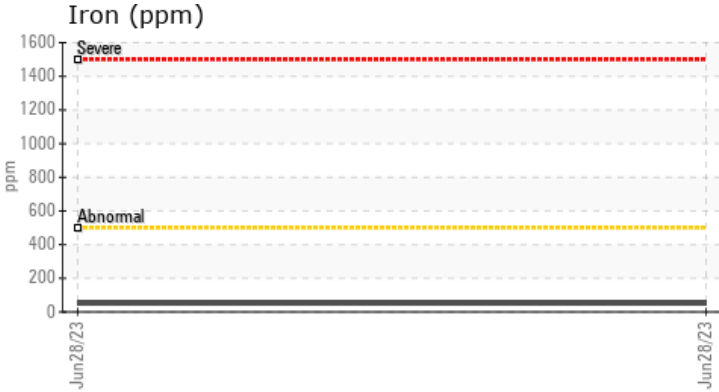
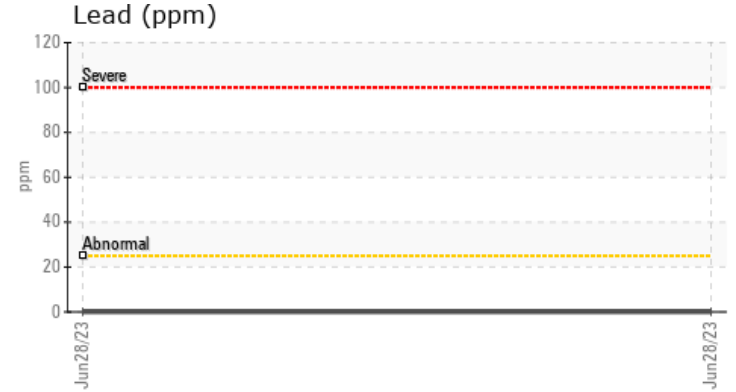
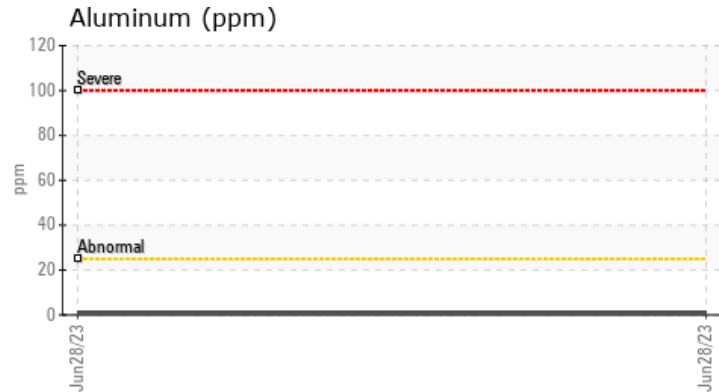
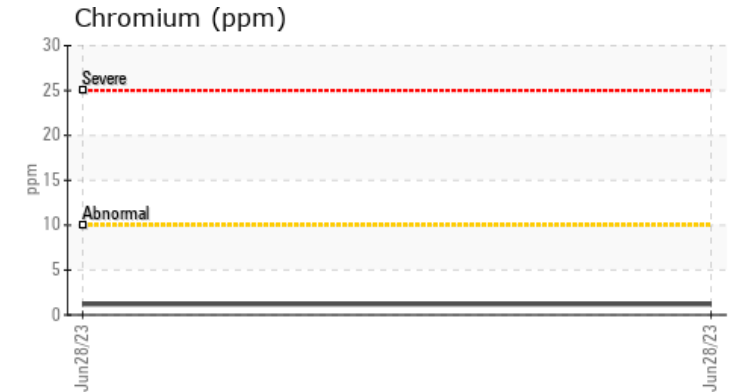
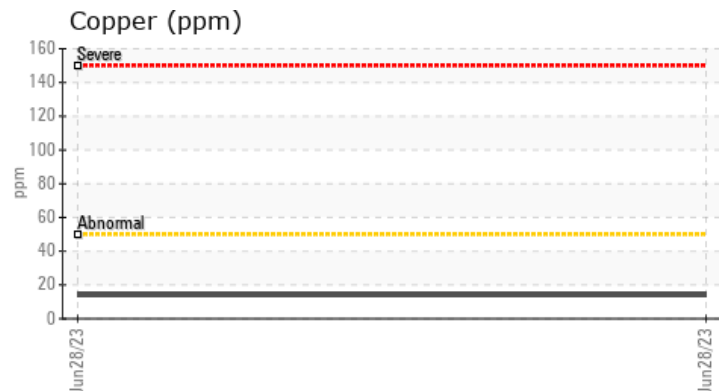
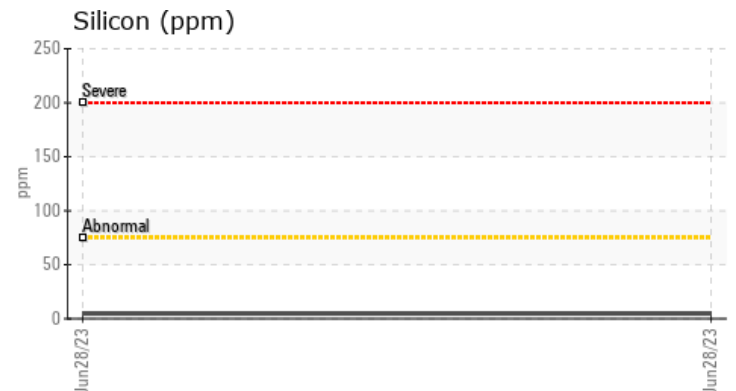
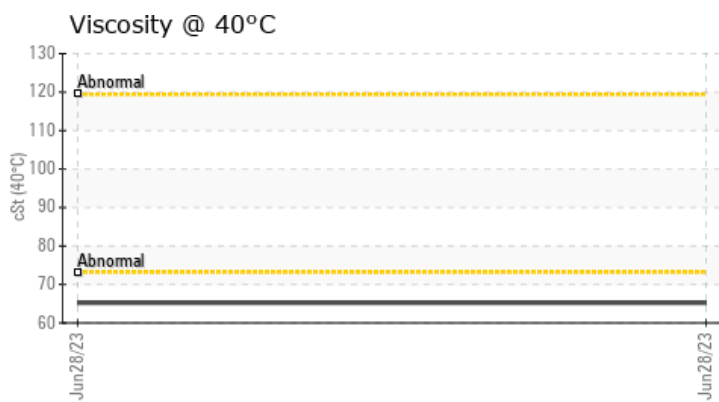
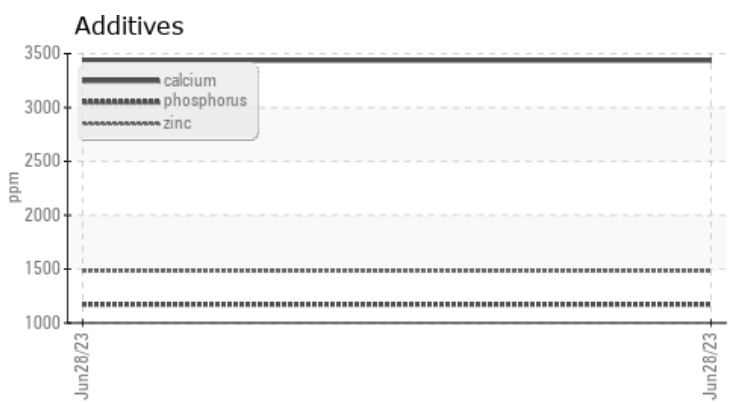
## VOLVO GRAPHS

Resample at the next service interval to monitor. All component wear rates are normal. There is no indication of any contamination in the component. The condition of the oil is acceptable for the time in service.
