# CONSTRUCTION EQUIPMENT

## A10652 VOLVO EC160E 3 10440 - DIESEL ENGINE

**Sample No:** VCP411859  
**Oil Type:** MOBIL 15W40  
**Job No:** A10652

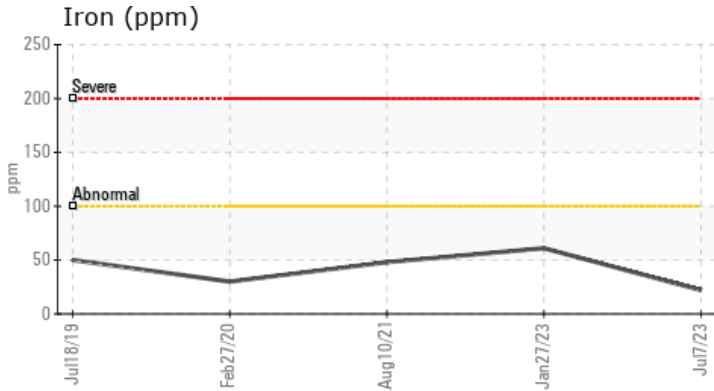
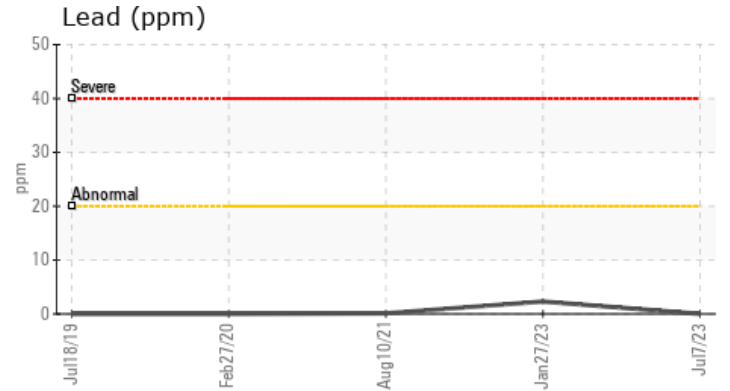
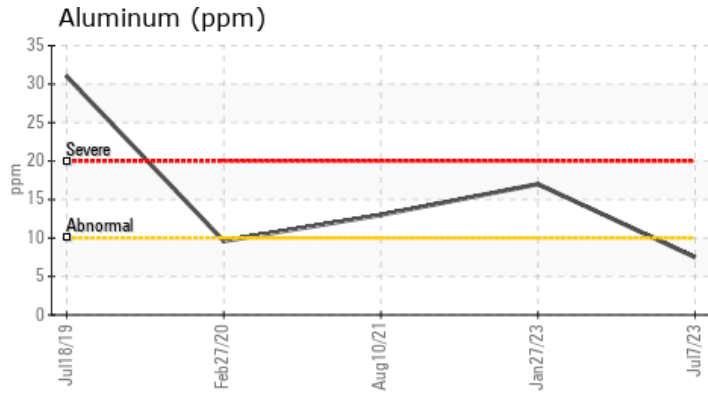
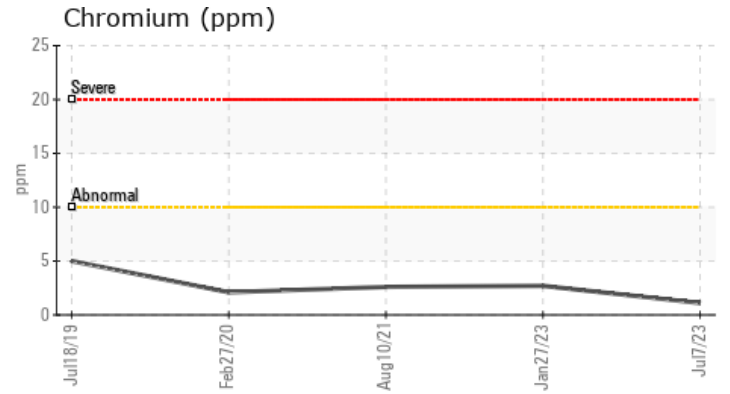
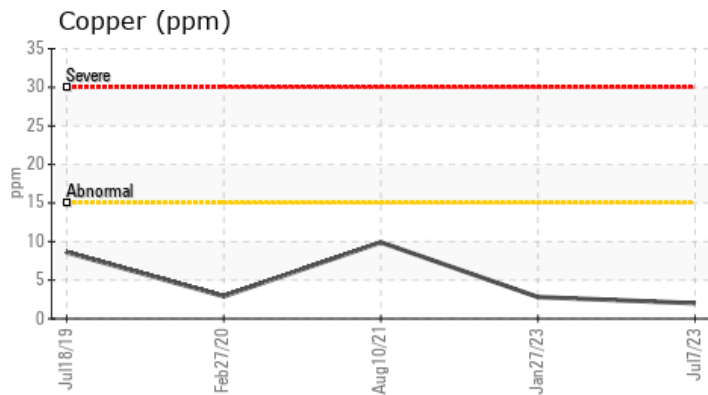
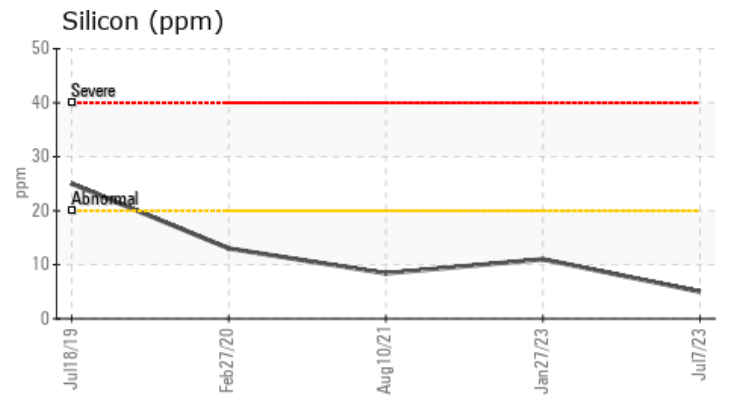
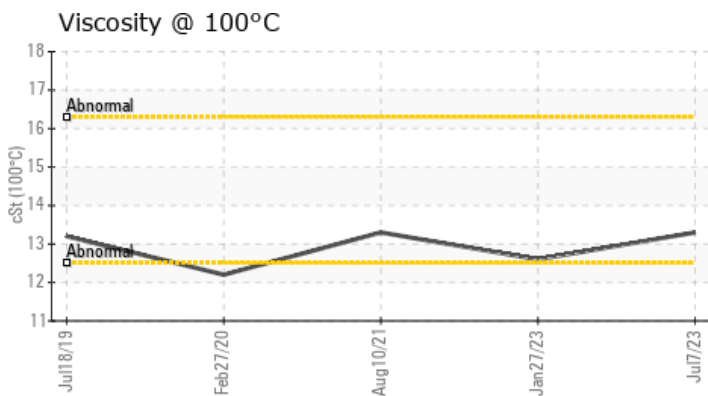
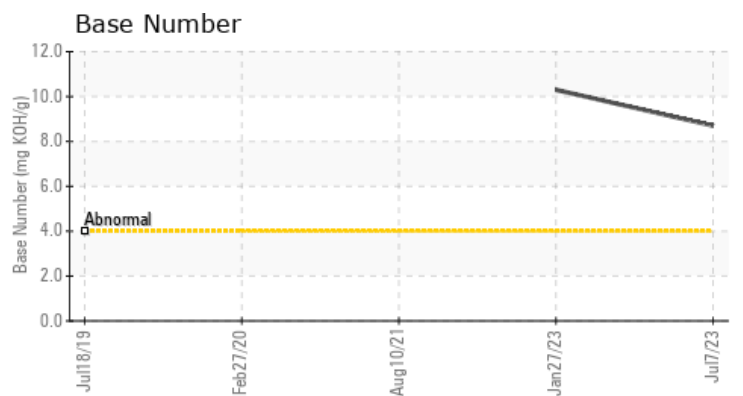
## GRAPHS

Resample at the next service interval to monitor. All component wear rates are normal. There is no indication of any contamination in the oil. The BN result indicates that there is suitable alkalinity remaining in the oil. The condition of the oil is suitable for further service.
