SPM579946 VOLVO A25G 752572 - TRANSMISSION (AUTO)

Sample No: VCP418354
Oil Type: VOLVO AUTOMATIC TRANSMISSION FLUID AT102
Job No: SPM579946

SAMPLE INFORMATION

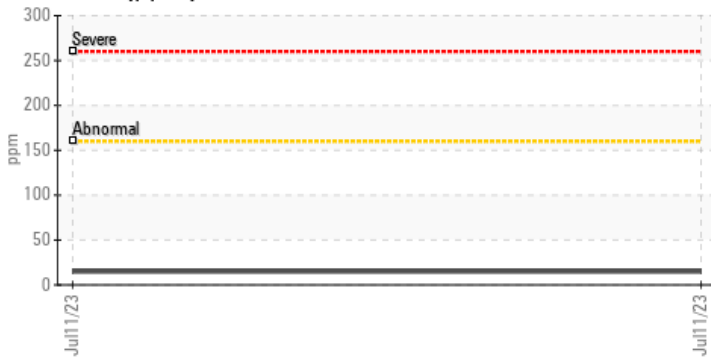
Iron (ppm)

Iron	ppm	█ 15	---	---	---
Copper	ppm	█ 14	---	---	---
Lead	ppm	█ <1	---	---	---
Tin	ppm	█ 2	---	---	---
Aluminum	ppm	█ 11	---	---	---
Chromium	ppm	█ <1	---	---	---
Molybdenum	ppm	█ 0	---	---	---
Nickel	ppm	█ <1	---	---	---
Titanium	ppm	█ 0	---	---	---
Silver	ppm	█ 0	---	---	---
Manganese	ppm	█ 3	---	---	---
Vanadium	ppm	█ 0	---	---	---

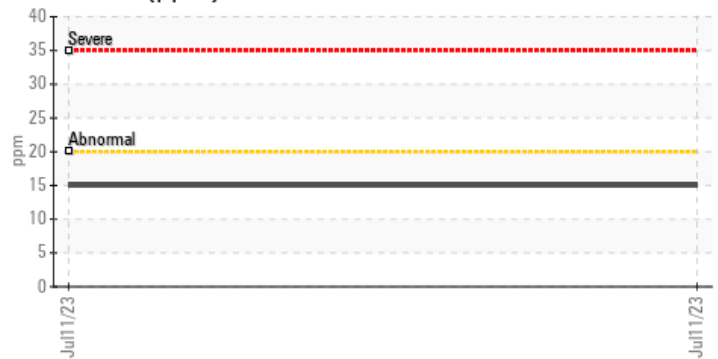
Silicon (ppm)

Silicon	ppm	█ 15	---	---	---
Sodium	ppm	█ 4	---	---	---
Potassium	ppm	█ 5	---	---	---

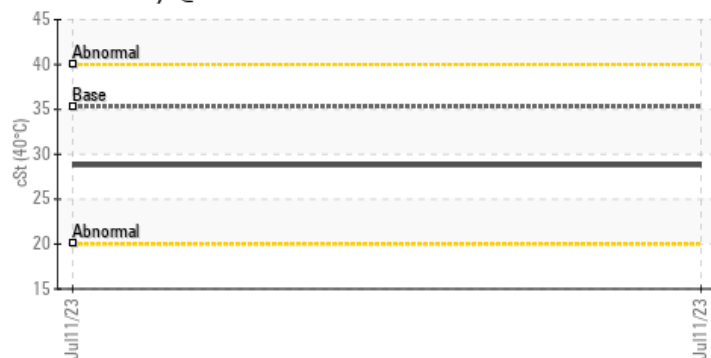
Viscosity @ 40°C

Visc @ 40°C	cSt	█ 28.8	---	---	---
-------------	-----	--------	-----	-----	-----

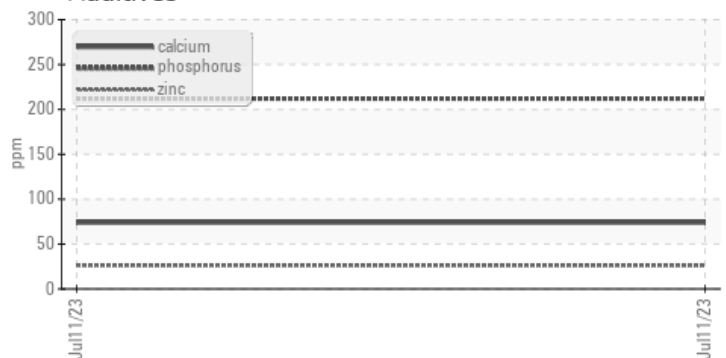
Additives

Calcium	ppm	█ 74	---	---	---
Magnesium	ppm	█ 0	---	---	---
Zinc	ppm	█ 26	---	---	---
Phosphorus	ppm	█ 212	---	---	---
Barium	ppm	█ 0	---	---	---
Boron	ppm	█ 90	---	---	---
