# CONSTRUCTION EQUIPMENT

## 23740 VOLVO L60H 1123 - TRANSMISSION (AUTO)

**Sample No:** VCP425744  
**Oil Type:** VOLVO AUTOMATIC TRANSMISSION FLUID AT102  
**Job No:** 23740

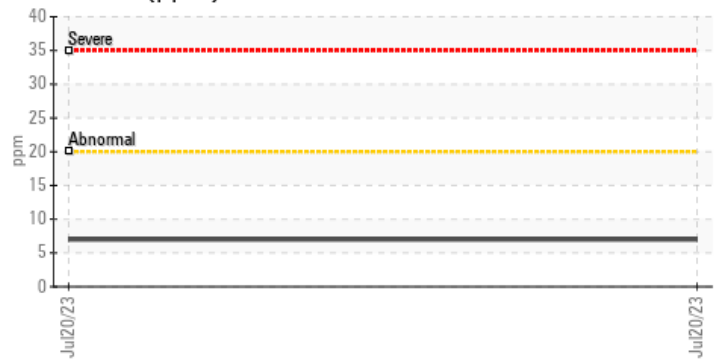
### Silicon (ppm)

Silicon	ppm	█ 7	---	---	---
Sodium	ppm	█ 5	---	---	---
Potassium	ppm	█ 0	---	---	---

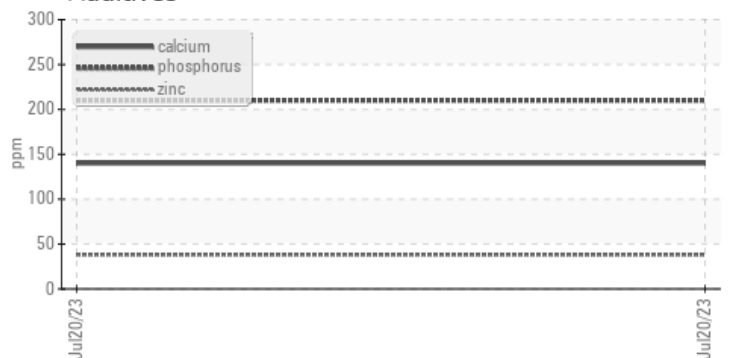
### Additives

Calcium	ppm	█ 140	---	---	---
Magnesium	ppm	█ 2	---	---	---
Zinc	ppm	█ 38	---	---	---
Phosphorus	ppm	█ 210	---	---	---
Barium	ppm	█ 0	---	---	---
Boron	ppm	█ 67	---	---	---
