CONSTRUCTION EQUIPMENT

23754 VOLVO A25 80275 - TRANSMISSION (AUTO)

Sample No: VCP408107
Oil Type: VOLVO AUTOMATIC TRANSMISSION FLUID AT102
Job No: 23754

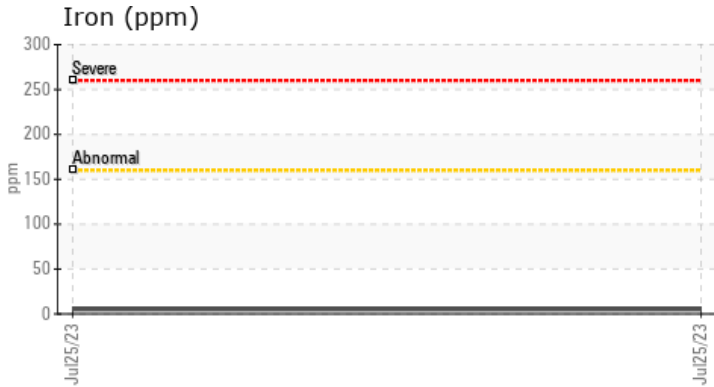
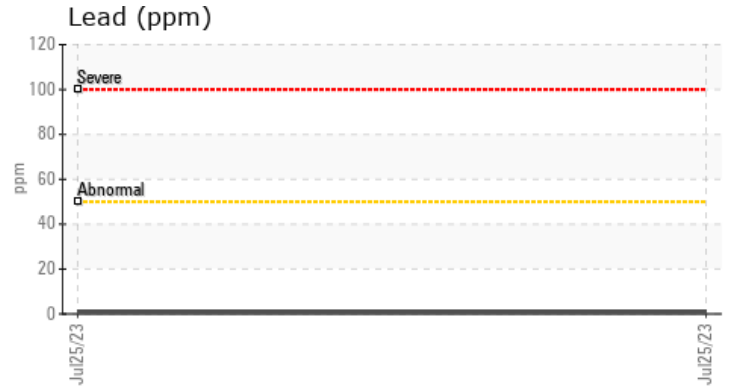
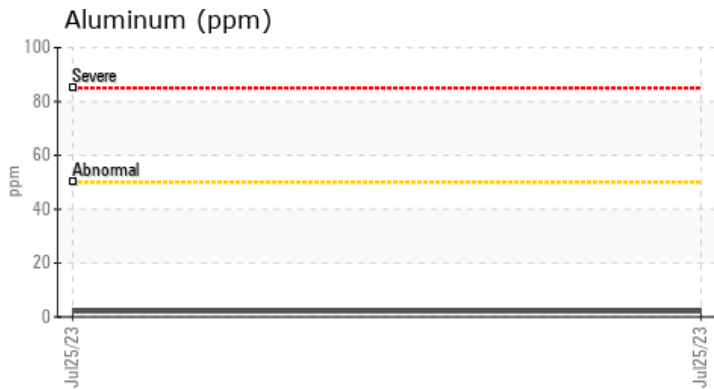
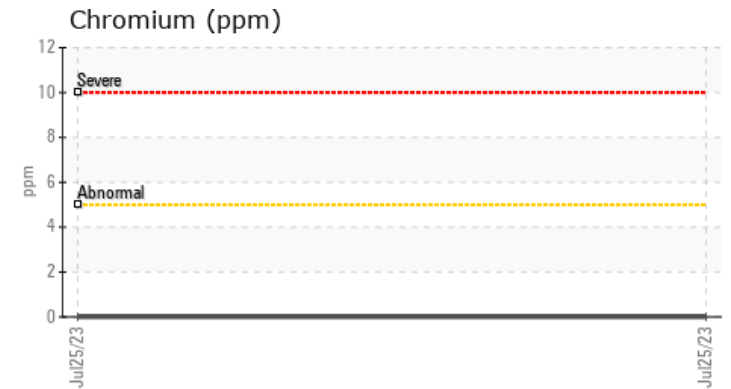
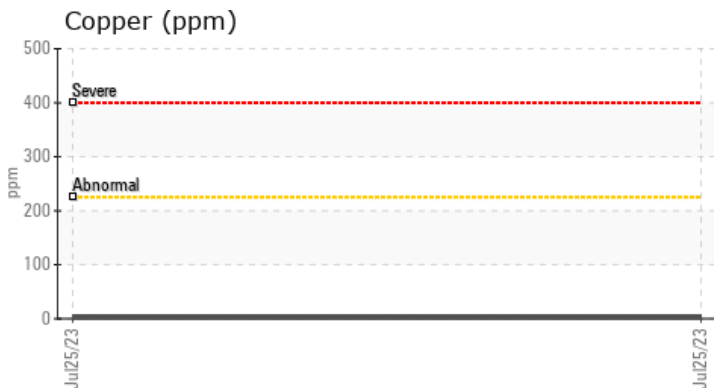
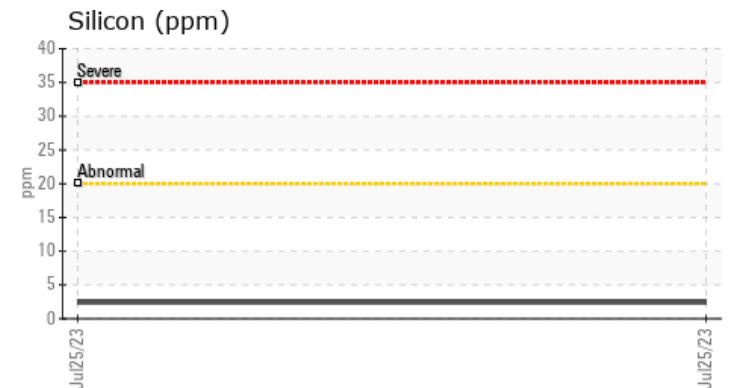
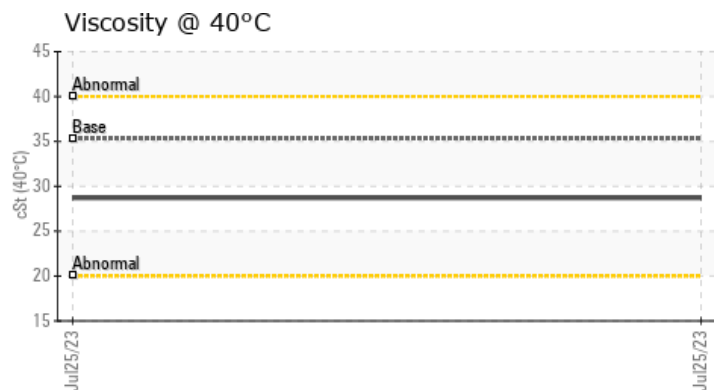
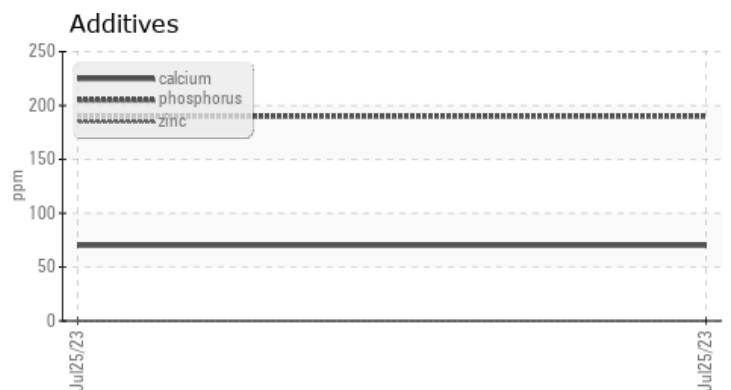
GRAPHS

Oil and filter change at the time of sampling has been noted. Resample at the next service interval to monitor. All component wear rates are normal. Moderate concentration of visible dirt/debris present in the fluid. The condition of the fluid is acceptable for the time in service.
