CONSTRUCTION EQUIPMENT

224972 WM VOLVO L220G 12593 - TRANSMISSION (AUTO)

Sample No: VCP426762
Oil Type: DEXRON III
Job No: 224972 WM

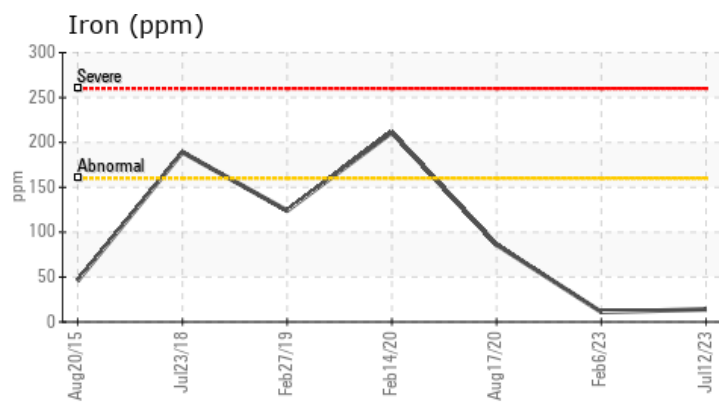
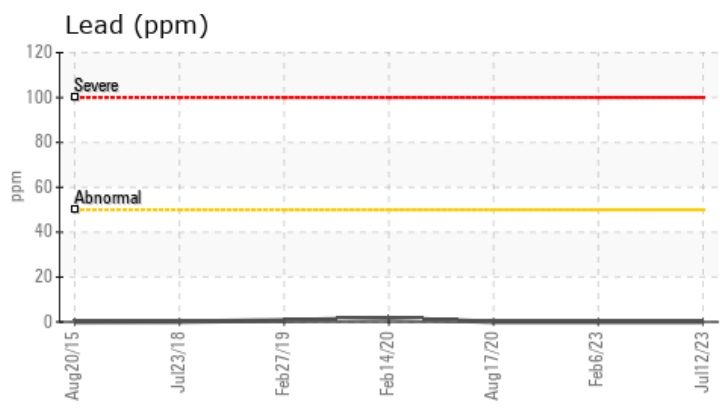
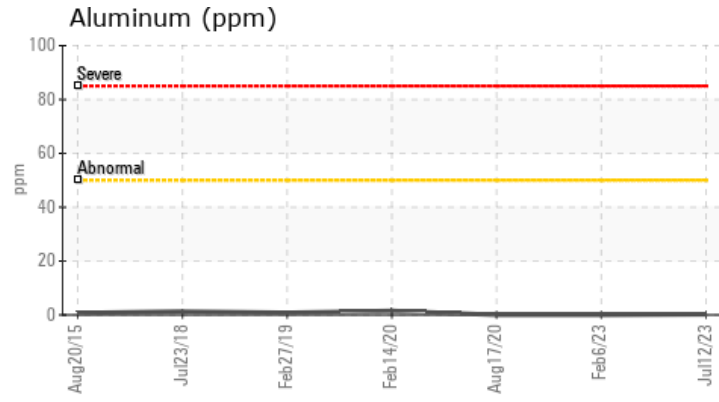
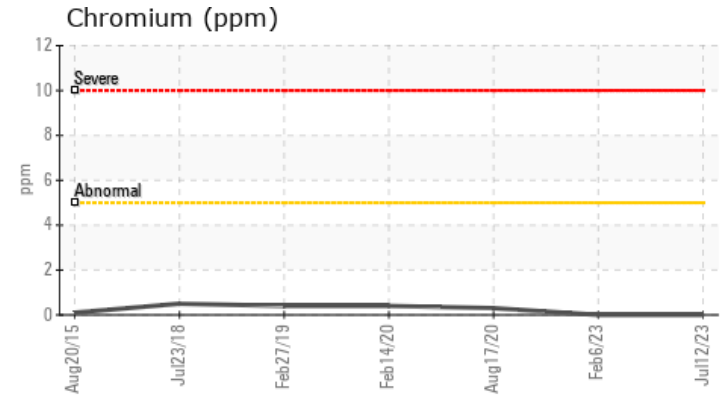
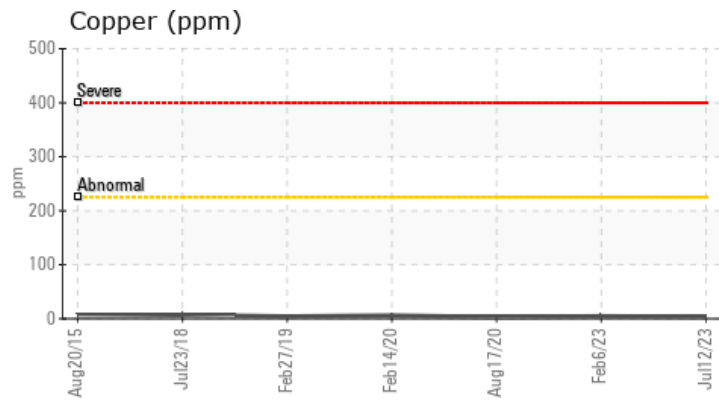
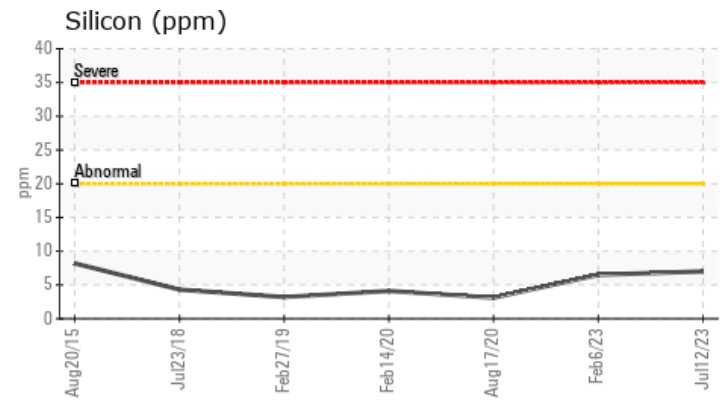
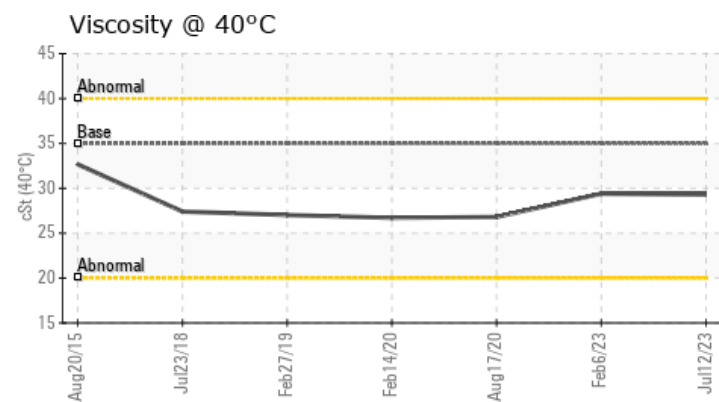
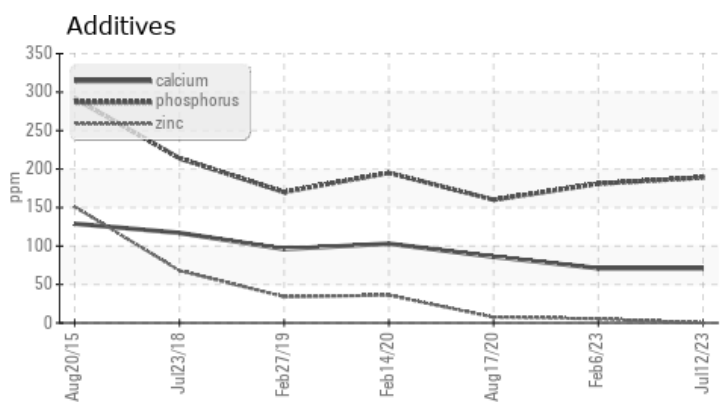
VOLVO **GRAPHS**

Iron	ppm	14	11	86	▲ 211
Copper	ppm	3	4	3	6
Lead	ppm	0	0	0	2
Tin	ppm	0	0	0	0
Aluminum	ppm	<1	0	0	2
Chromium	ppm	0	0	<1	<1
Molybdenum	ppm	0	0	<1	<1
Nickel	ppm	0	0	<1	<1
Titanium	ppm	0	0	0	0
Silver	ppm	0	0	<1	0
Manganese	ppm	3	3	<1	2
Vanadium	ppm	0	0	0	0

Resample at the next service interval to monitor. The fluid was not specified, however, a fluid match indicates that this fluid is (GENERIC) DEXRON III. Please confirm. All component wear rates are normal. There is no indication of any contamination in the fluid. The condition of the fluid is acceptable for the time in service.
