CONSTRUCTION EQUIPMENT

SCOTT HASLAM ELTEC E7 108 - DIESEL ENGINE

Sample No: VCP315284
Oil Type: VOLVO ULTRA DIESEL ENGINE OIL 15W40 VDS-3
Job No: SCOTT HASLAM

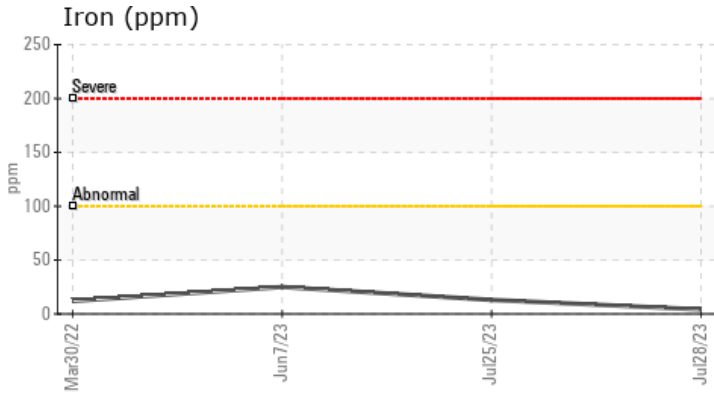
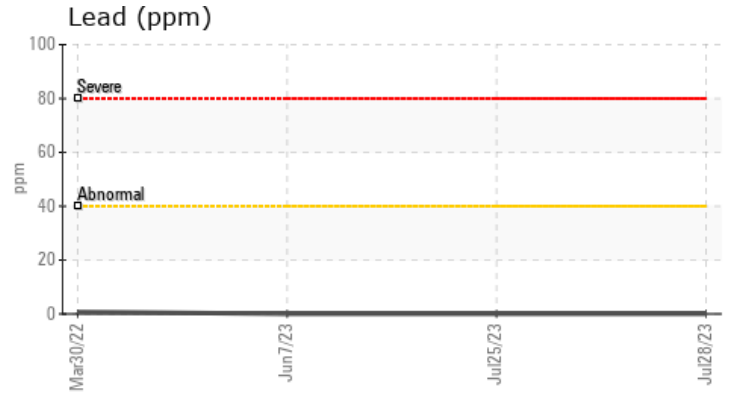
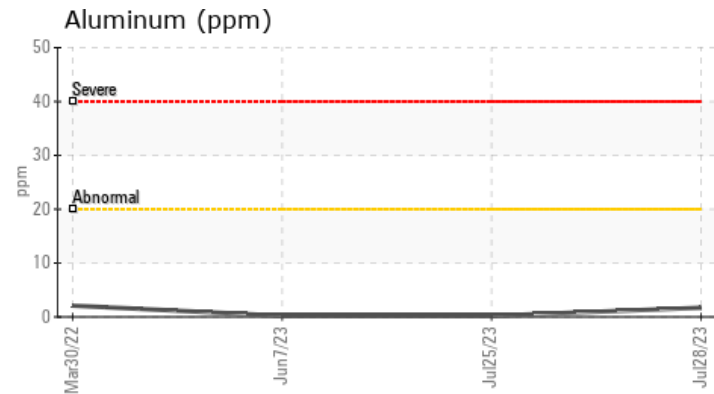
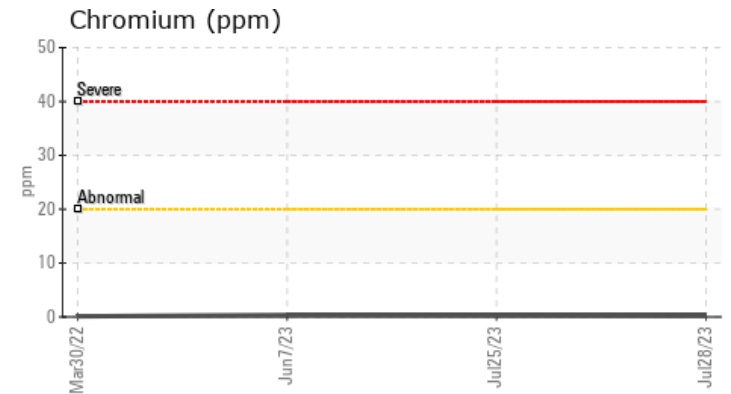
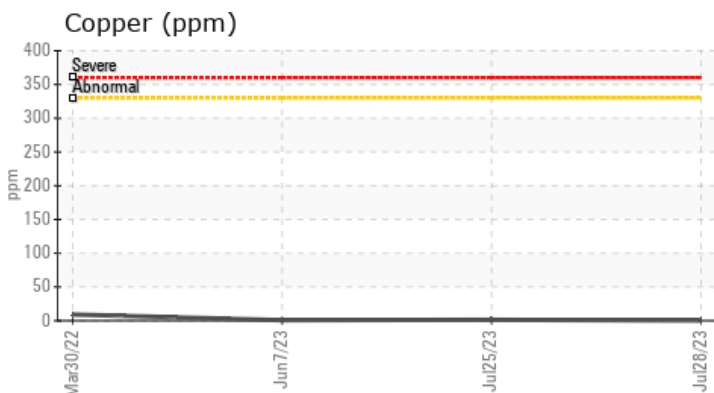
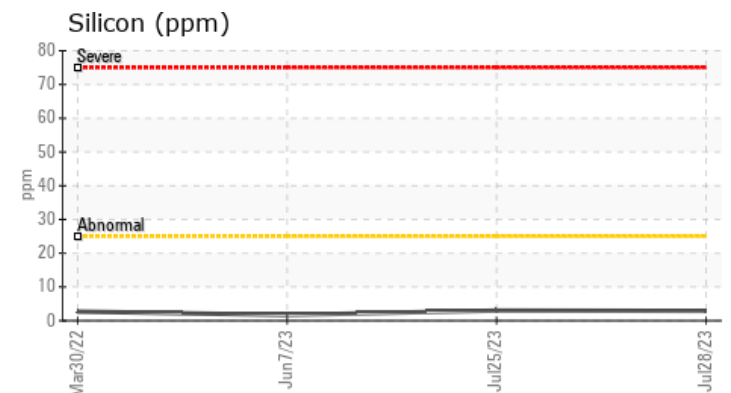
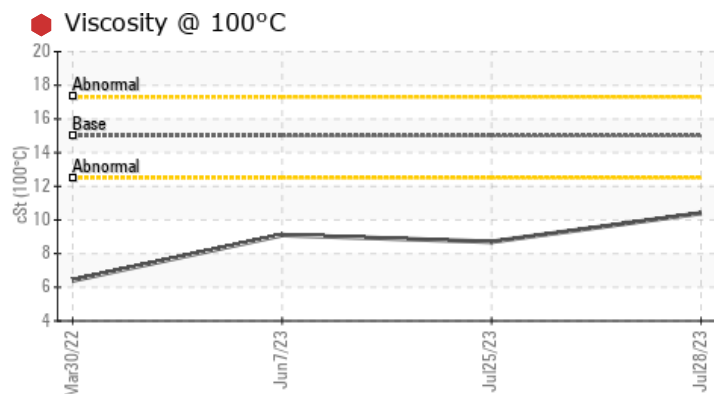
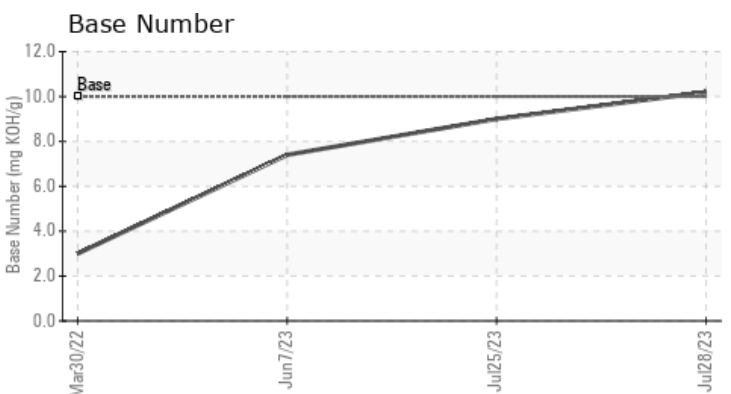
GRAPHS

We advise that you check the fuel injection system. We recommend that you drain the oil from the component if this has not already been done. We recommend an early resample to monitor this condition. All component wear rates are normal. There is a high amount of fuel present in the oil. Tests confirm the presence of fuel in the oil. The BN result indicates that there is suitable alkalinity remaining in the oil. Fuel is present in the oil and is lowering the viscosity. The oil is no longer serviceable due to the presence of contaminants.
