# CONSTRUCTION EQUIPMENT

580677 APTIM VOLVO A35G 340041 - COOLANT

**Sample No:** VCP417003  
**Oil Type:** VOLVO COOLANT VCS (YELLOW)  
**Job No:** 580677 APTIM

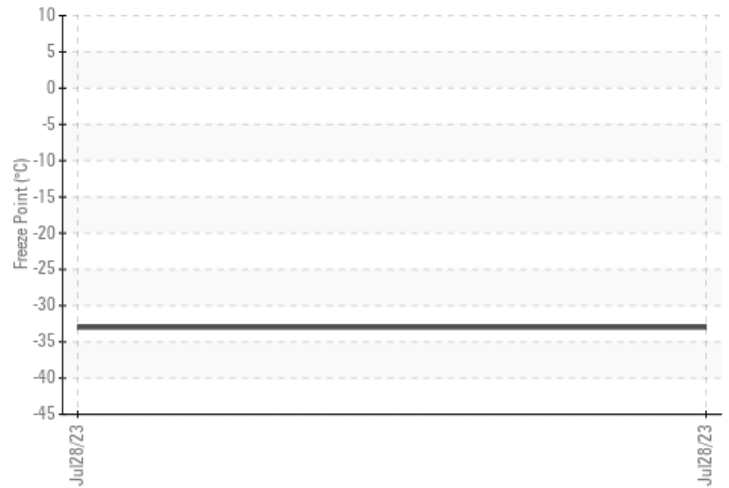
### Freeze Point

pH	Scale 0-14	■ 7.56	---	---	---
Reserve Alkalinity	Scale 0-20	---	---	---	---
Nitrites	ppm	■ NT	---	---	---
Percentage Glycol	%	■ 49.5	---	---	---
Freezing Point	°C	■ -33	---	---	---

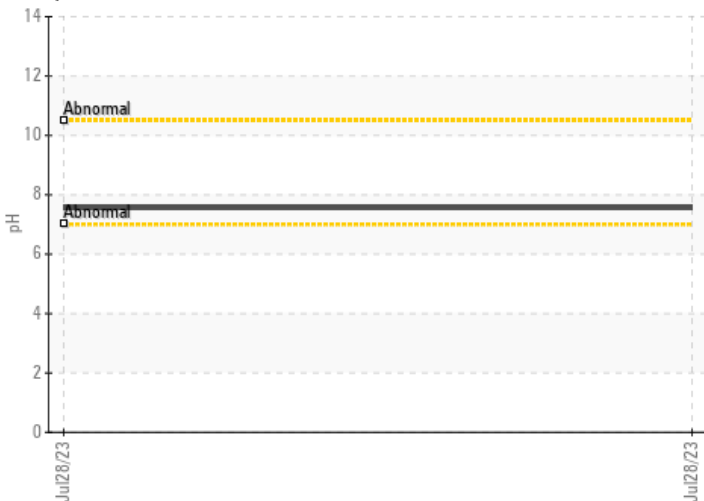
### pH

No corrective action is recommended at this time. The fluid is suitable for further service. There is no indication of any contamination in the coolant. Carboxylate test failed. The glycol level is acceptable. The pH level of this fluid is within the acceptable limits.
