## A10814 STELLA JONES VOLVO L110G 8543 - TRANSMISSION (AUTO)

**Sample No:** VCP408934  
**Oil Type:** MOBIL ATF  
**Job No:** A10814 STELLA JONES

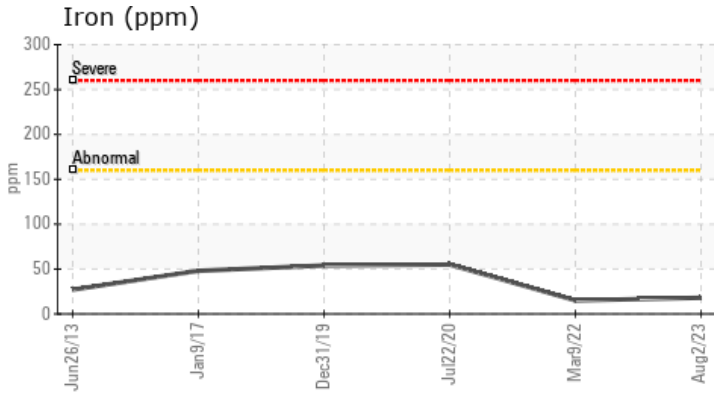
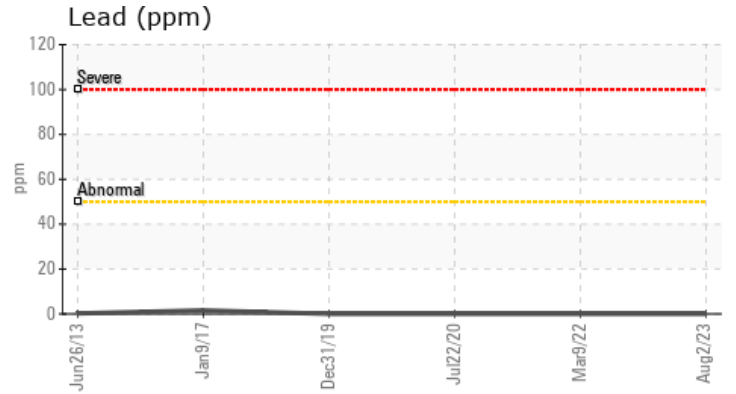
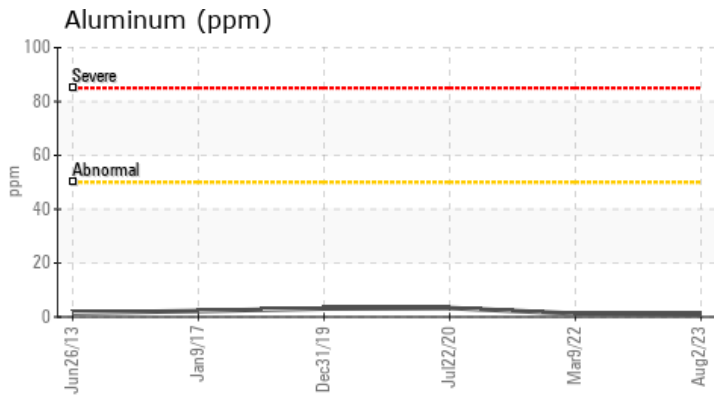
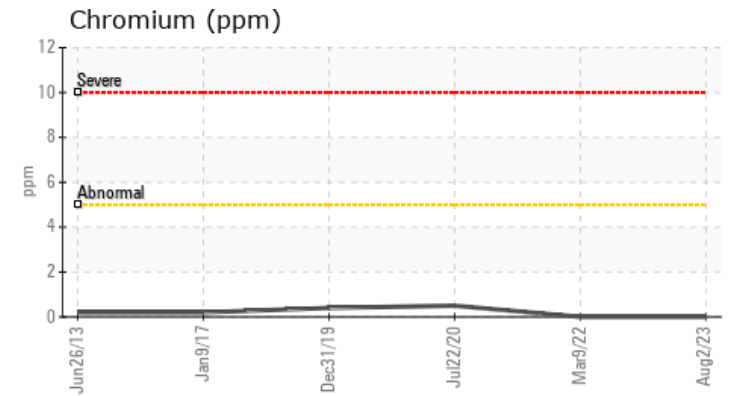
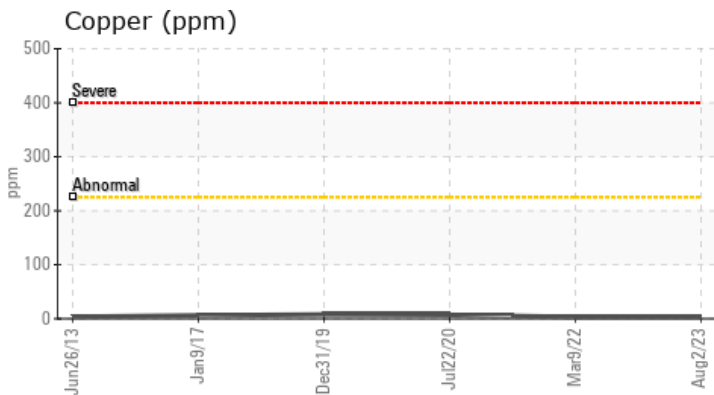
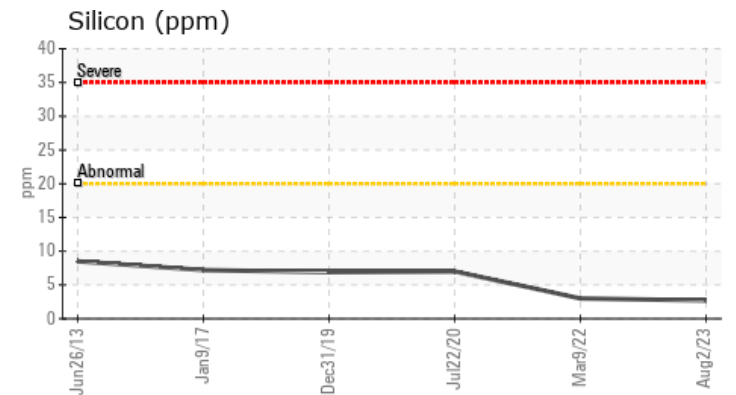
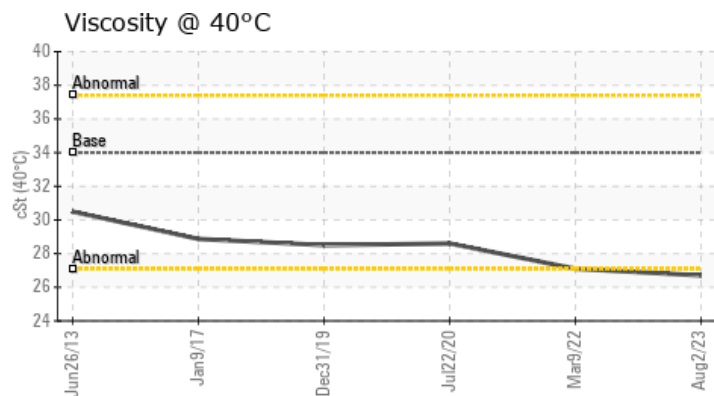
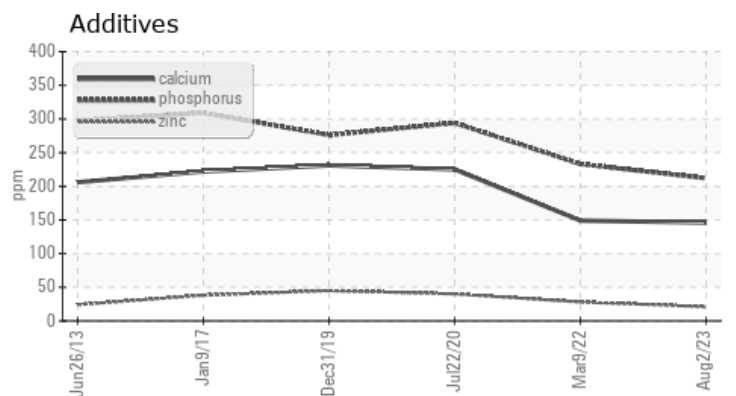
## VOLVO GRAPHS

Resample at the next service interval to monitor. All component wear rates are normal. There is no indication of any contamination in the fluid. The condition of the fluid is acceptable for the time in service.
