# CONSTRUCTION EQUIPMENT

## 580547 VOLVO A40G 3525 13 - DIESEL ENGINE

**Sample No:** VCP420925  
**Oil Type:** VOLVO ULTRA DIESEL ENGINE OIL 15W40 VDS-3  
**Job No:** 580547

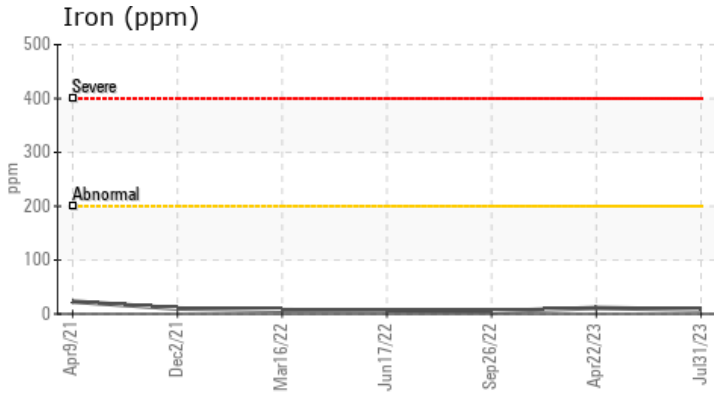
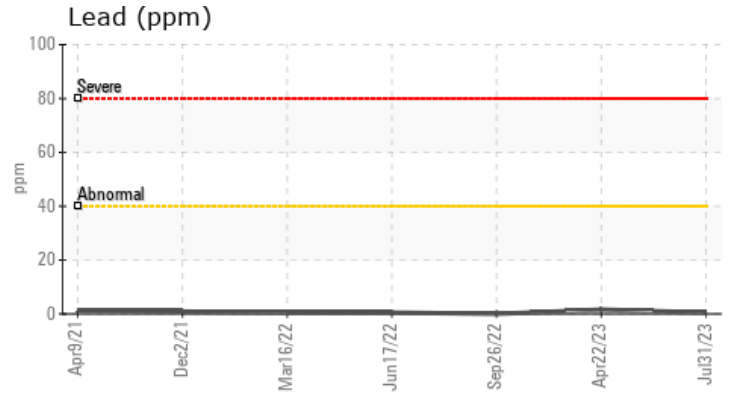
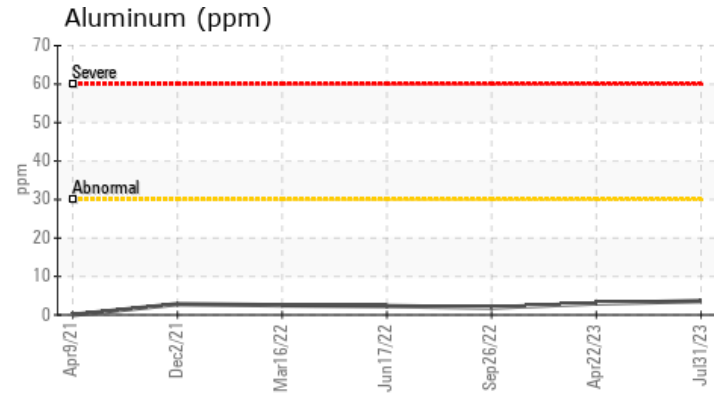
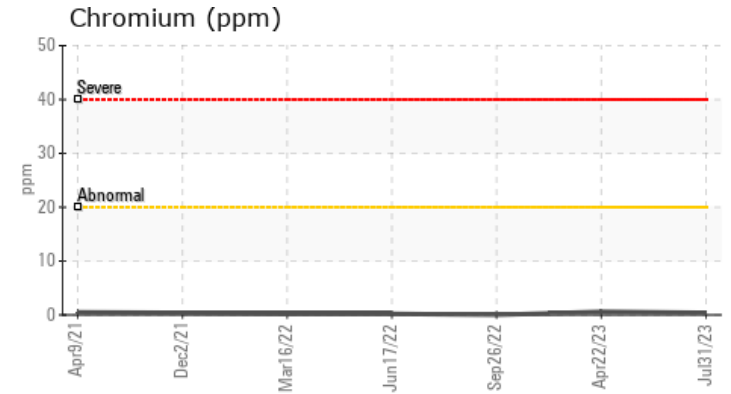
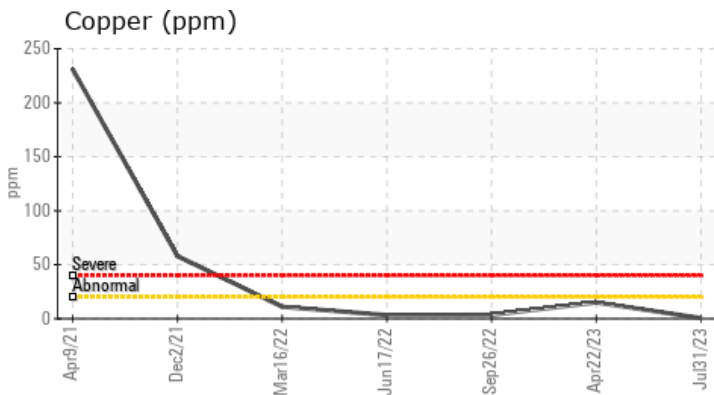
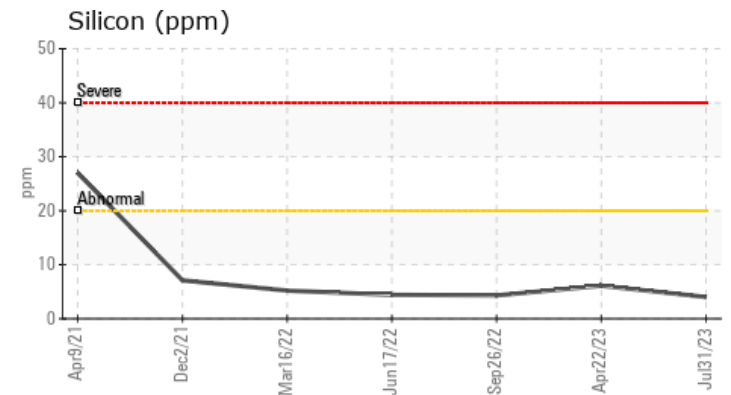
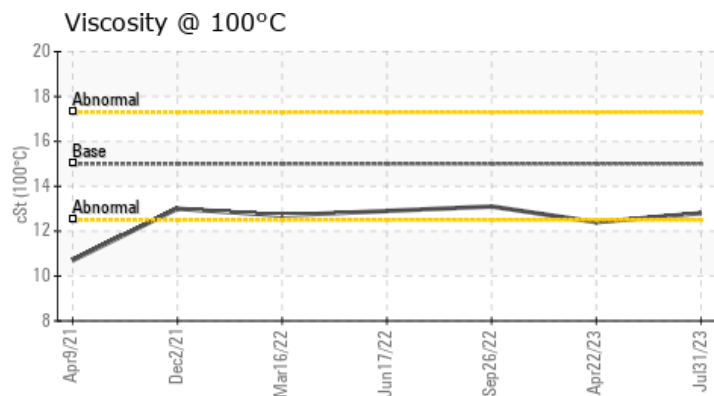
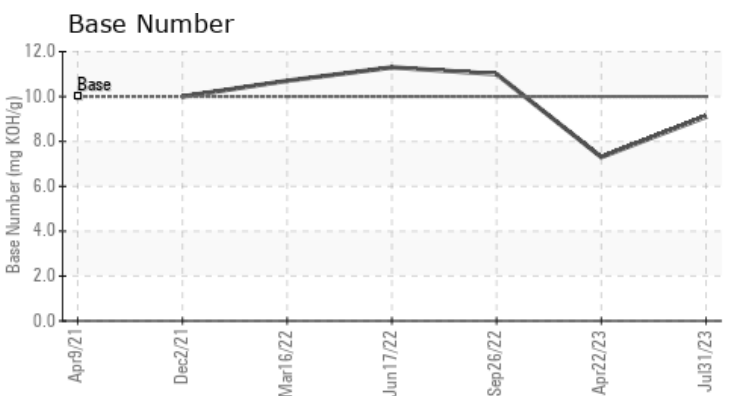
## GRAPHS

Resample at the next service interval to monitor. All component wear rates are normal. There is no indication of any contamination in the oil. The BN result indicates that there is suitable alkalinity remaining in the oil. The condition of the oil is suitable for further service.
