# CONSTRUCTION EQUIPMENT

580404 VOLVO L110H 631298 - DIESEL ENGINE

**Sample No:** VCP414216  
**Oil Type:** VOLVO ULTRA DIESEL ENGINE OIL 15W40 VDS-3  
**Job No:** 580404

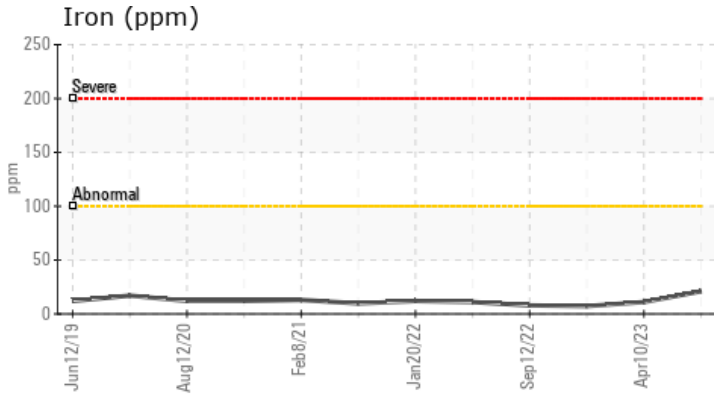
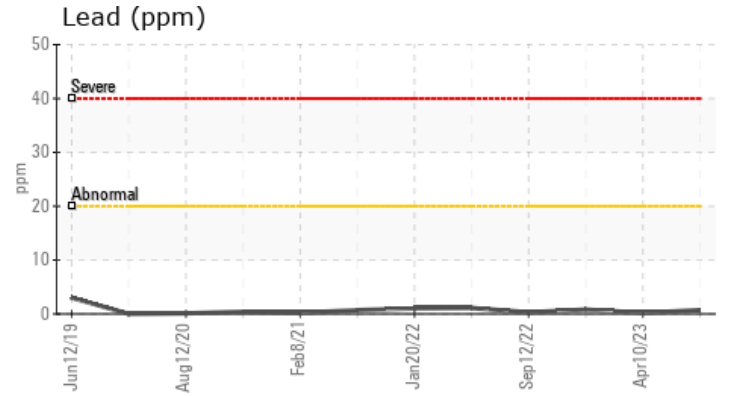
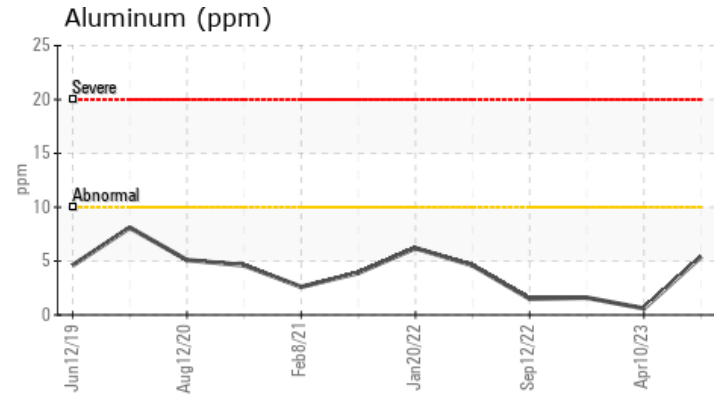
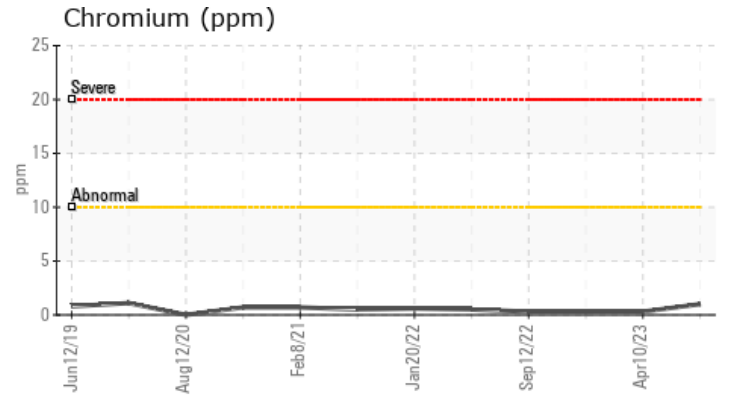
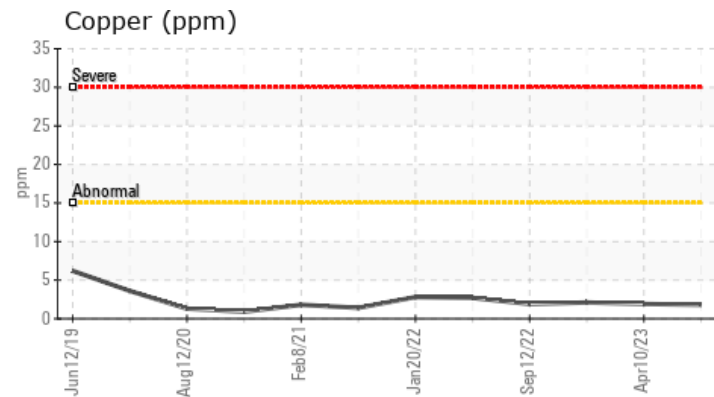
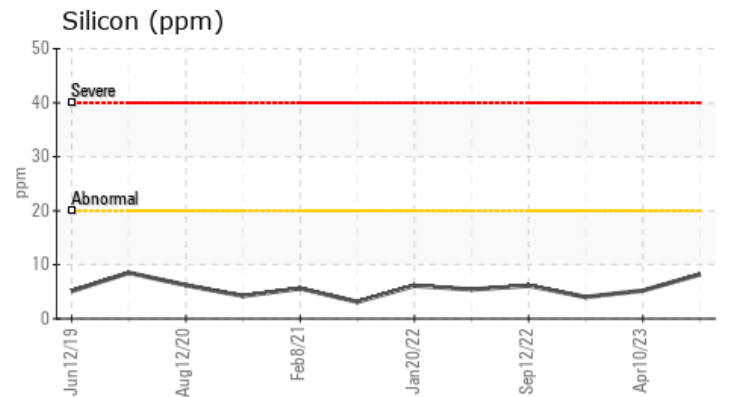
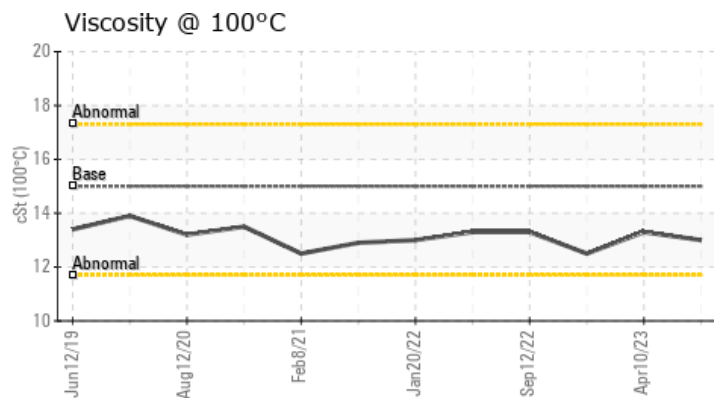
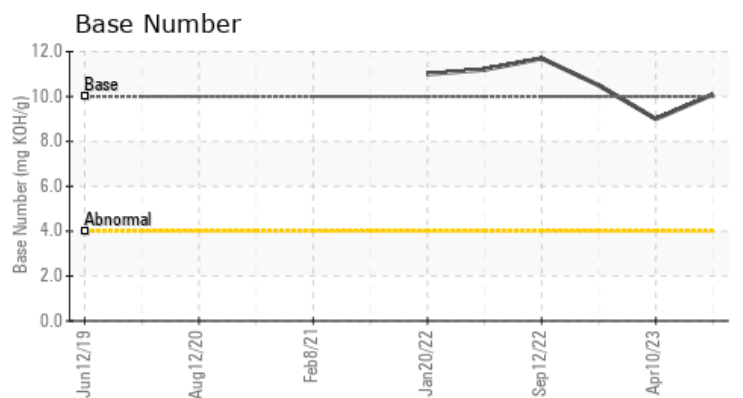
## VOLVO GRAPHS

Resample at the next service interval to monitor. All component wear rates are normal. There is no indication of any contamination in the oil. The BN result indicates that there is suitable alkalinity remaining in the oil. The condition of the oil is suitable for further service.
