580521 CITRUS VOLVO L110H 632392 - TRANSMISSION (AUTO)

Sample No: VCP396850
Oil Type: VOLVO AT 102
Job No: 580521 citrus

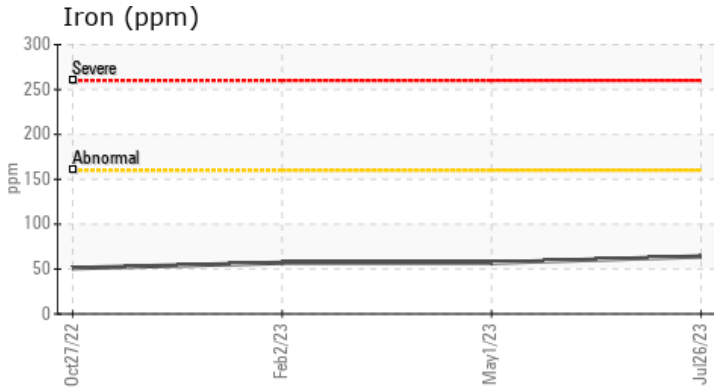
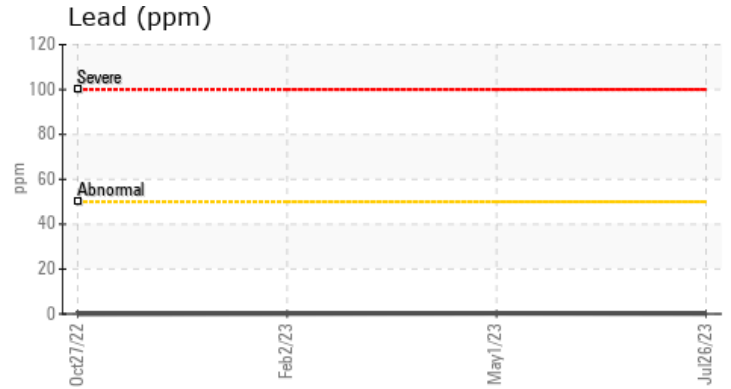
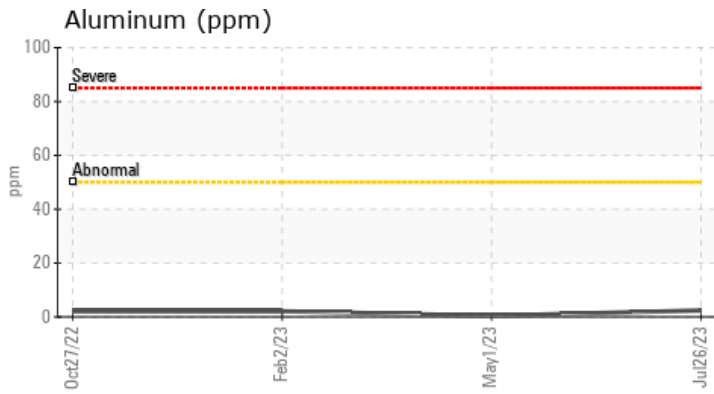
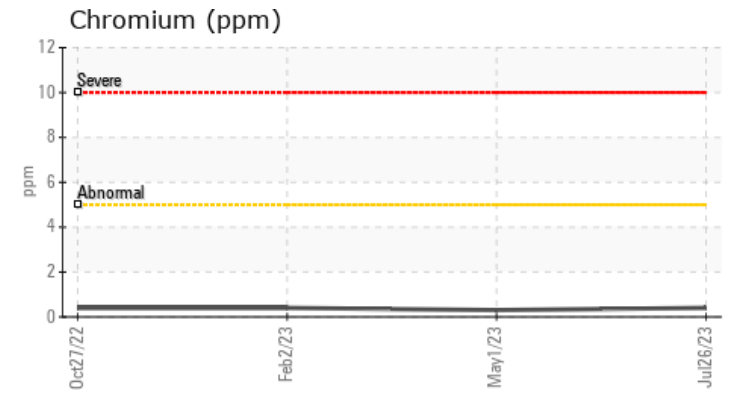
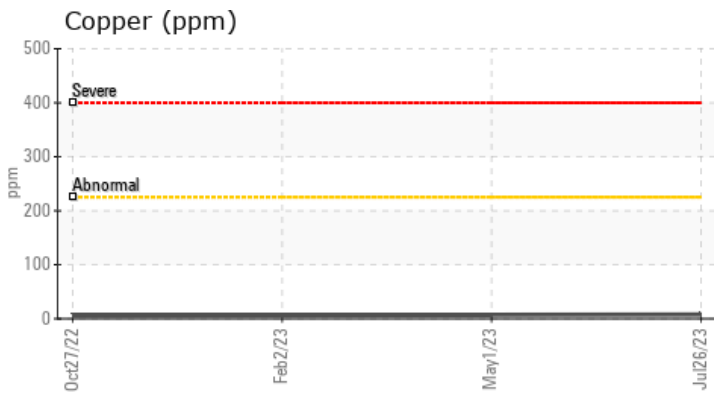
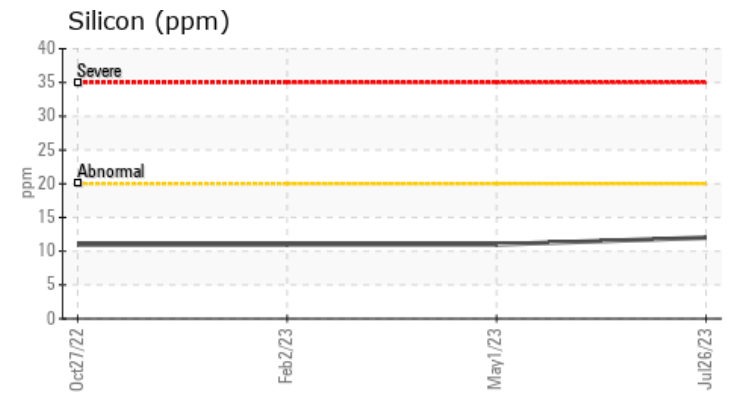
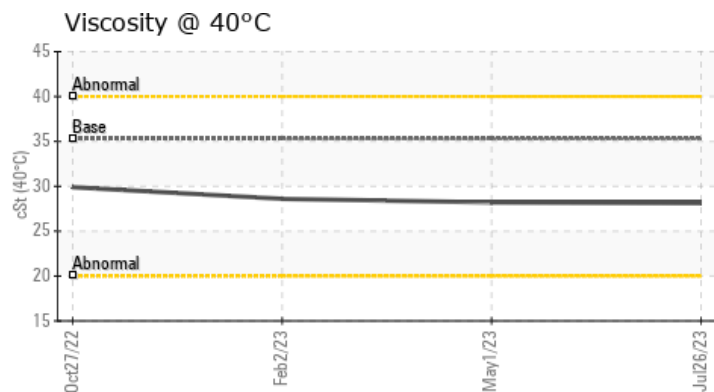
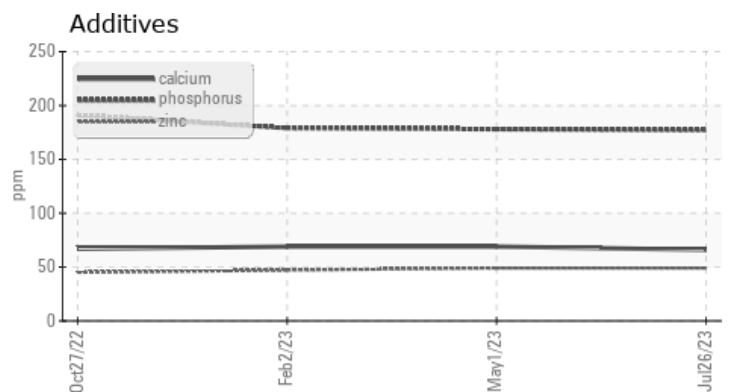
GRAPHS

Resample at the next service interval to monitor. All component wear rates are normal. There is no indication of any contamination in the fluid. The condition of the fluid is acceptable for the time in service.
