# CONSTRUCTION EQUIPMENT

M0700016 FORD F750 38399 - DIESEL ENGINE

**Sample No:** VCP407789  
**Oil Type:** MOBIL 15W40  
**Job No:** M0700016

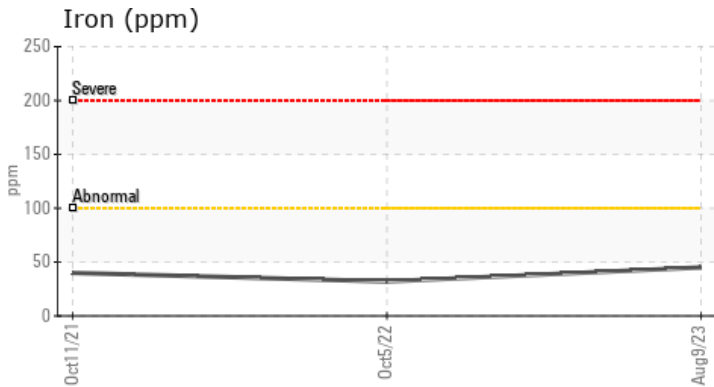
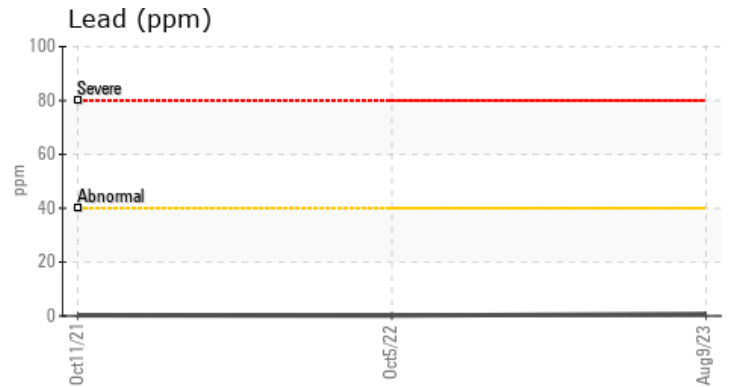
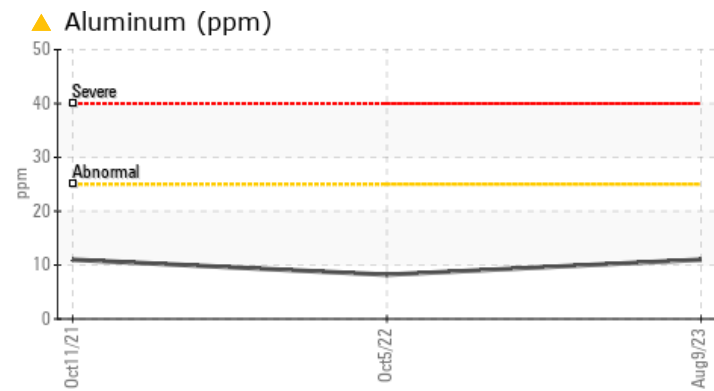
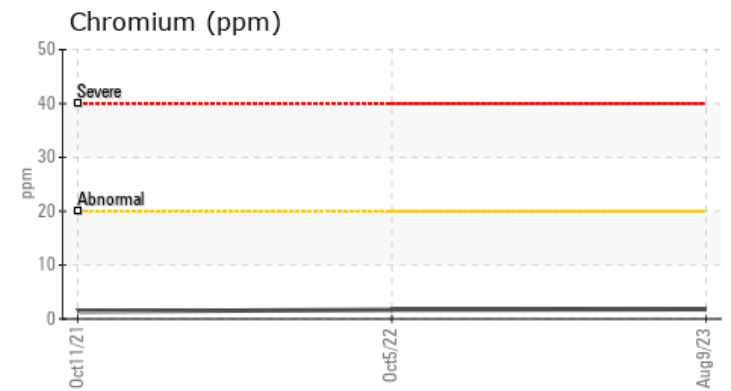
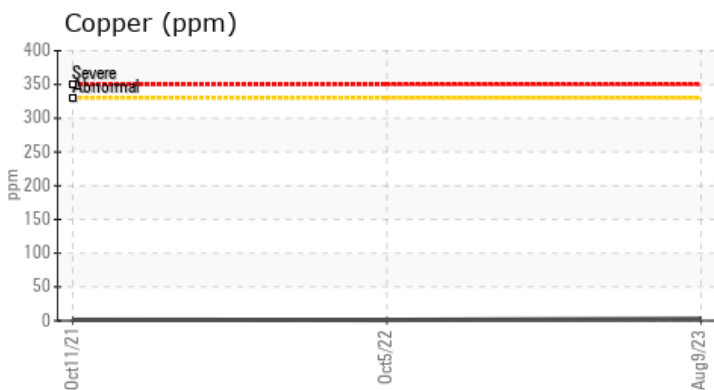
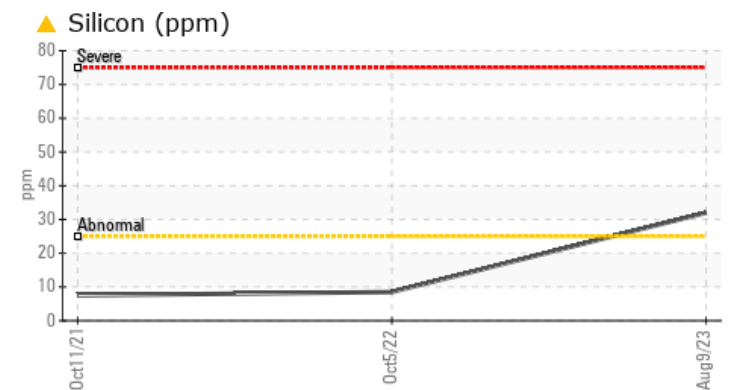
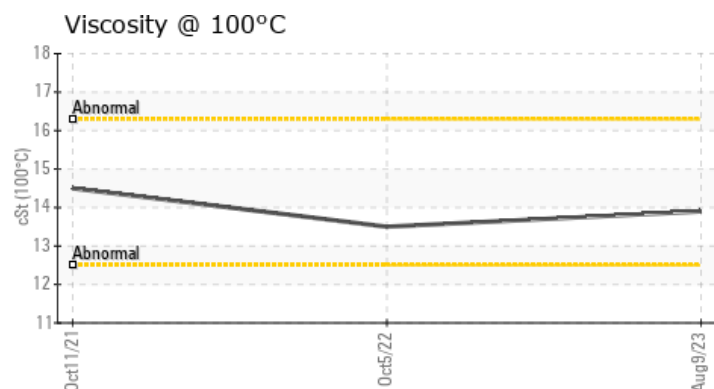
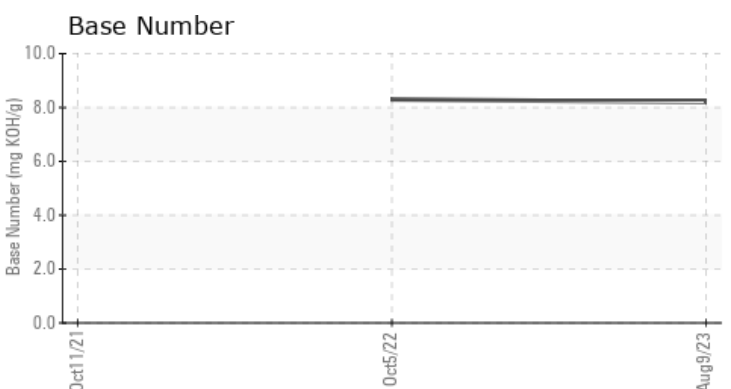
## GRAPHS

Soot %	%	<b>0.9</b>	0.6	0.9	---
Nitration (PA)	%	<b>97</b>	106	102	---
Sulfation (PA)	%	<b>59</b>	63	62	---
Glycol	%	<b>NEG</b>	NEG	NEG	---
Fuel	%	<b>&lt;1.0</b>	<1.0	<1.0	---
Silicon	ppm	<b>▲ 32</b>	8	8	---
Sodium	ppm	<b>39</b>	17	30	---
Potassium	ppm	<b>▲ 56</b>	31	44	---

Iron	ppm	<b>45</b>	32	40	---
Copper	ppm	<b>3</b>	1	1	---
Lead	ppm	<b>&lt;1</b>	<1	<1	---
Tin	ppm	<b>&lt;1</b>	<1	<1	---
Aluminum	ppm	<b>▲ 11</b>	8	11	---
Chromium	ppm	<b>2</b>	2	1	---
Molybdenum	ppm	<b>60</b>	65	52	---
Nickel	ppm	<b>&lt;1</b>	0	<1	---
Titanium	ppm	<b>&lt;1</b>	0	<1	---
Silver	ppm	<b>0</b>	0	0	---
Manganese	ppm	<b>1</b>	<1	<1	---
Vanadium	ppm	<b>0</b>	0	<1	---

We advise that you check the air filter, air induction system, and any areas where dirt may enter the component. Oil and filter change at the time of sampling has been noted. We recommend an early resample to monitor this condition. All component wear rates are normal. Sodium and/or potassium levels are high. Elemental levels of silicon (Si) and aluminum (Al) indicate alumina-silicate (coarse dirt) ingress. Test for glycol is negative. The BN result indicates that there is suitable alkalinity remaining in the oil.
